Tree Impact Assessment Report

City and Southwest Metro Station Upgrade Works Package 5 & 6

P5 Document No. SMCSWSW5-DEW-WEC-EM-REP-000542

P6 Document No. SMCSWSW6-DEW-WEC-EM-REP-000632

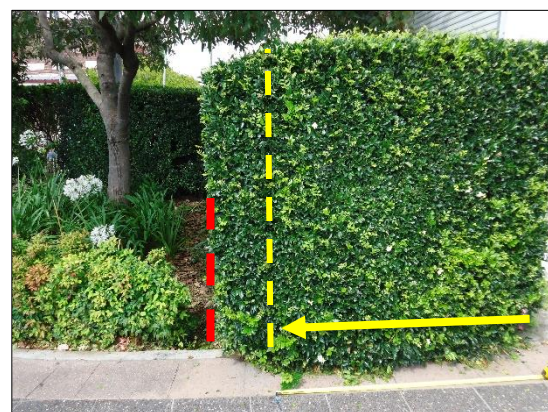
Photograph 3: Branches identified for removal from tree 591 to provide clearance for the proposed concourse roof structure. Branch A is 40mm in diameter at 2.7m height, branch B is 20mm in diameter at 2.7m height, branch C is 120mm in diameter at 2.1m height, branch D is 120mm in diameter at 2.2m height. The removal of identified branches constitutes approximately 35% of the total live canopy volume of the tree.

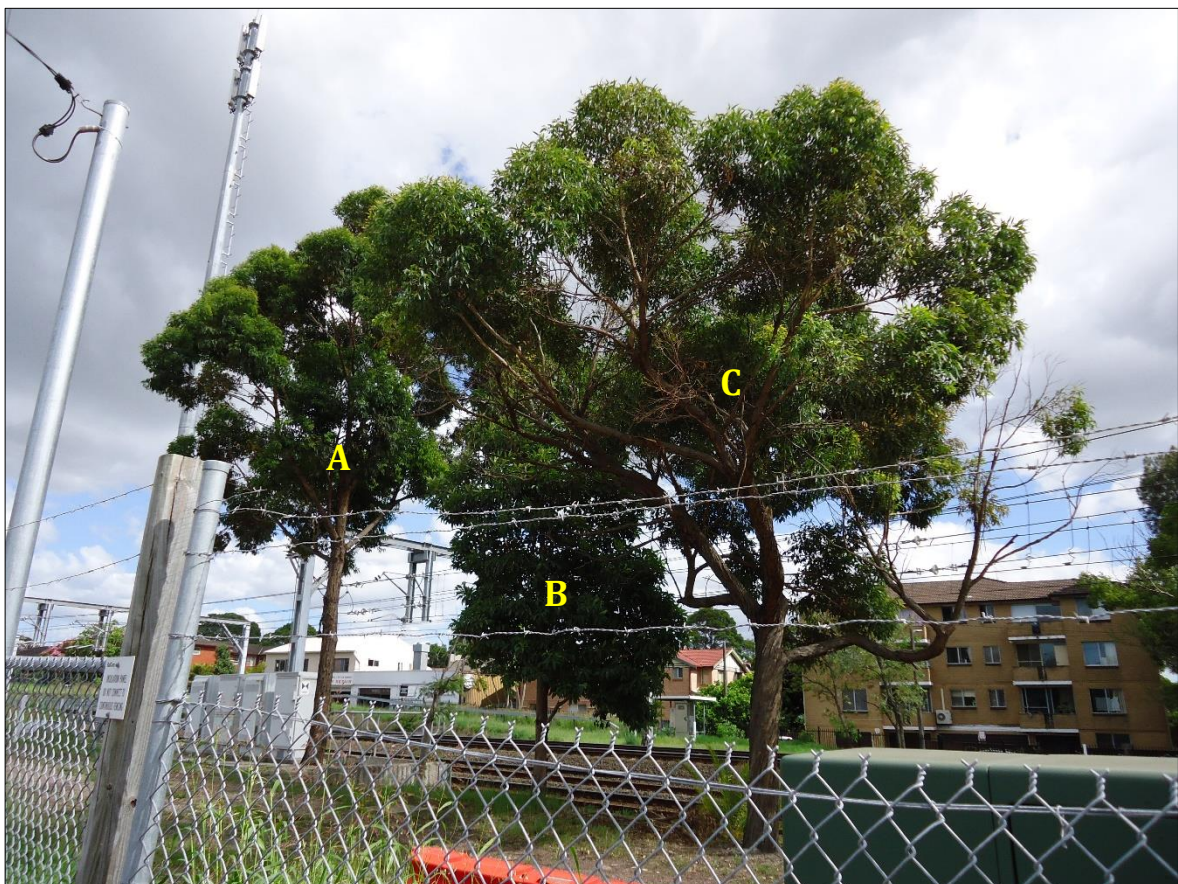
Trees A, Tallowwood and B Brush Box were found to be in good health and condition. They are considered to have a medium useful life expectancy and landscape significance. Tree C Tallowwood was found to have normal vigour and fair condition. Deadwood and canopy dieback was observed within the tree indicating a possible decline in health and condition. As such the tree is considered to have a short useful life expectancy. Image 2 shows the subject trees. The trees provide some screening and relief from the rail corridor and associated infrastructure along Lillian Street.

Image 2: The three additional trees identified for removal as part of the Southwest Metro Package works.

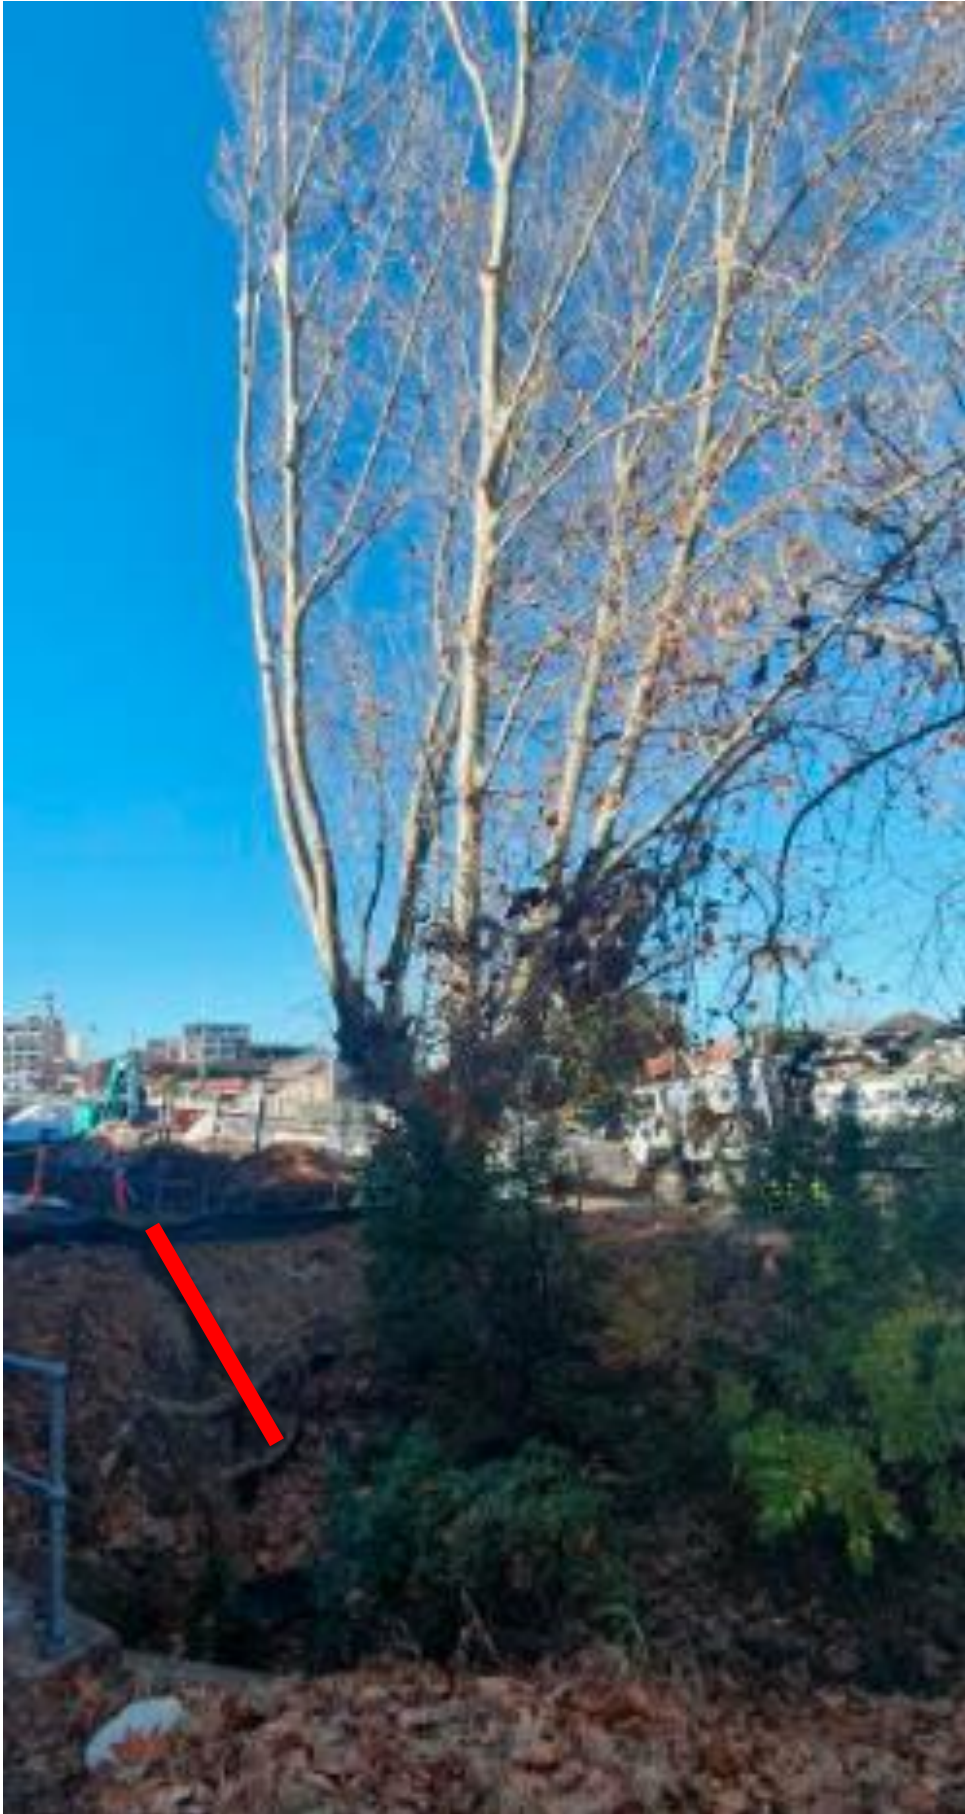
Image of the subject tree (Tree 94) taken on the 15th June 2021 (red line shows approximate location of required excavations).

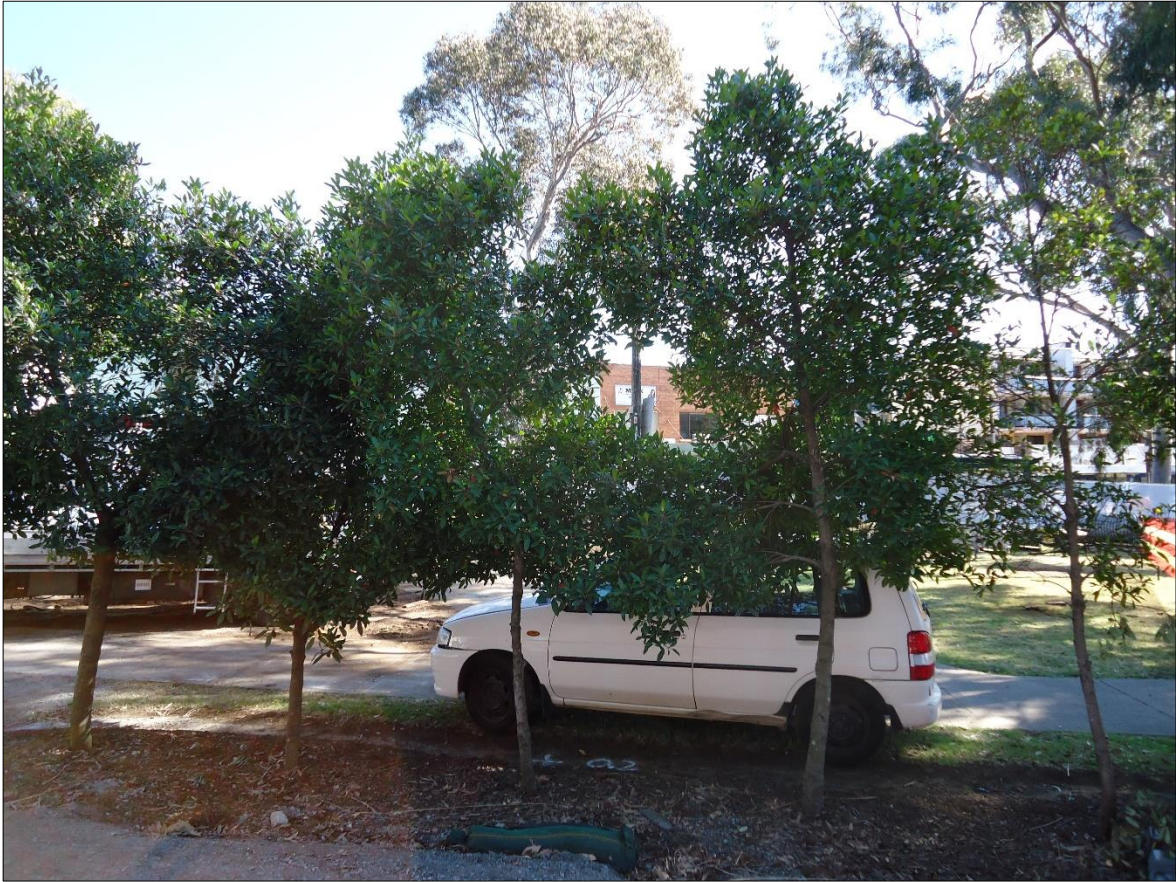
Photograph 1: Showing the five *Elaeocarpus reticulatus* (Blueberry Ash) to be removed.

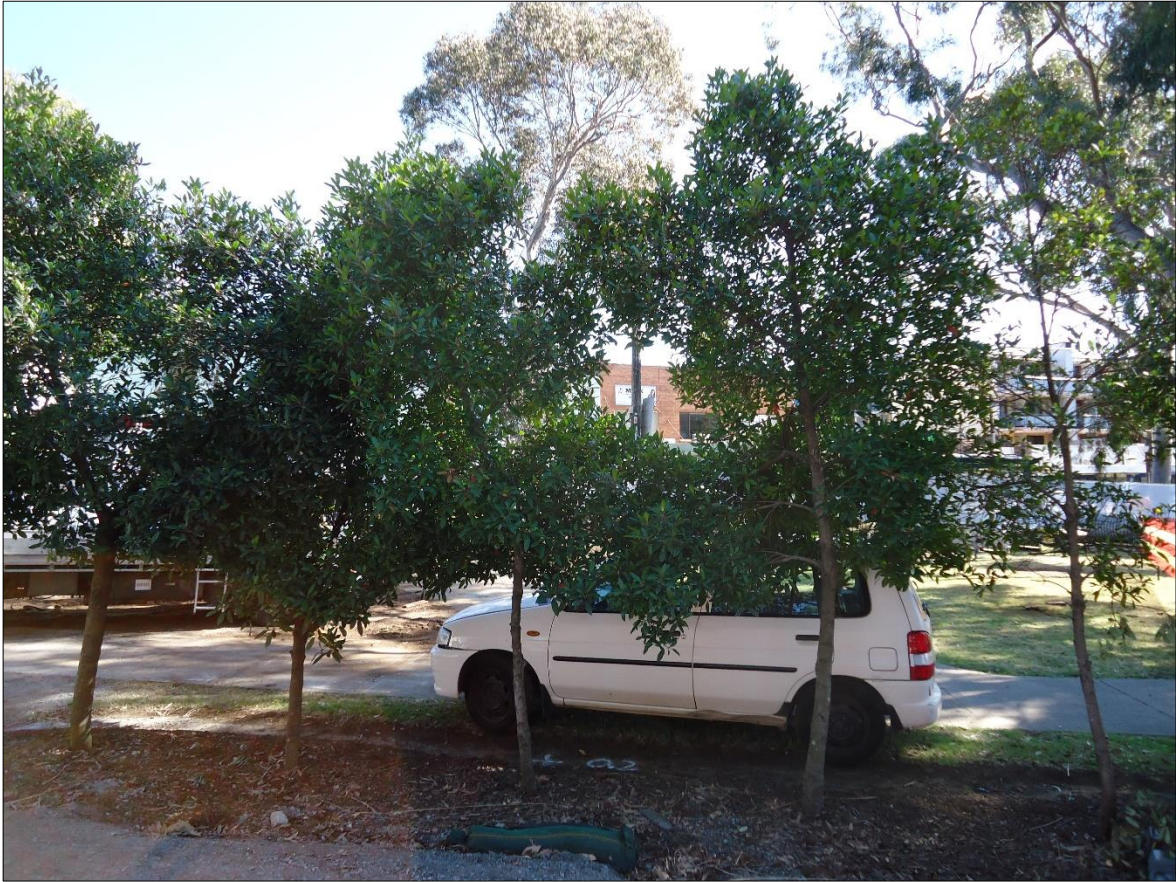
Photograph 1: Showing the five *Elaeocarpus reticulatus* (Blueberry Ash) to be removed.

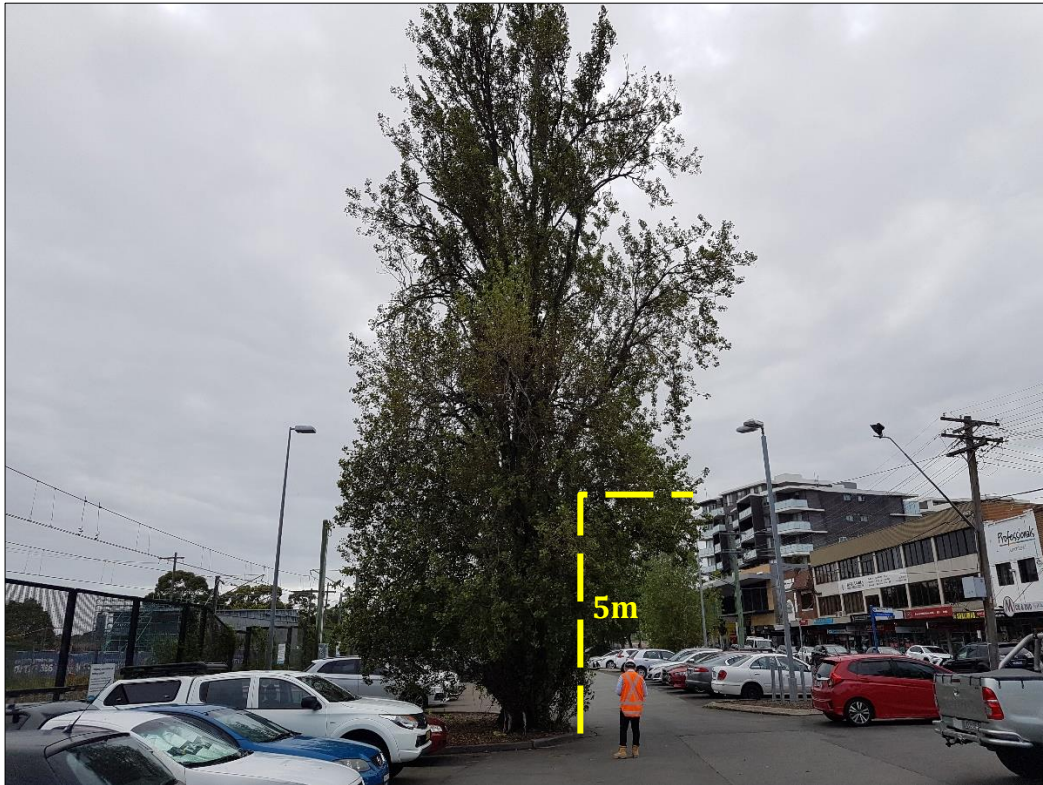
Photograph 1: Tree 1 *Populus nigra 'Italica'* (Lombardy Poplar as seen from the carpark area adjacent The Boulevard. 5m of vertical clearance is required from the outside edge of kerb adjacent the base of the tree.
