# Tree Impact Assessment Report

## City and Southwest Metro Station Upgrade Works Package 5 & 6

**P5 Document No. SMCSWSW5-DEW-WEC-EM-REP-000542**

**P6 Document No. SMCSWSW6-DEW-WEC-EM-REP-000632**

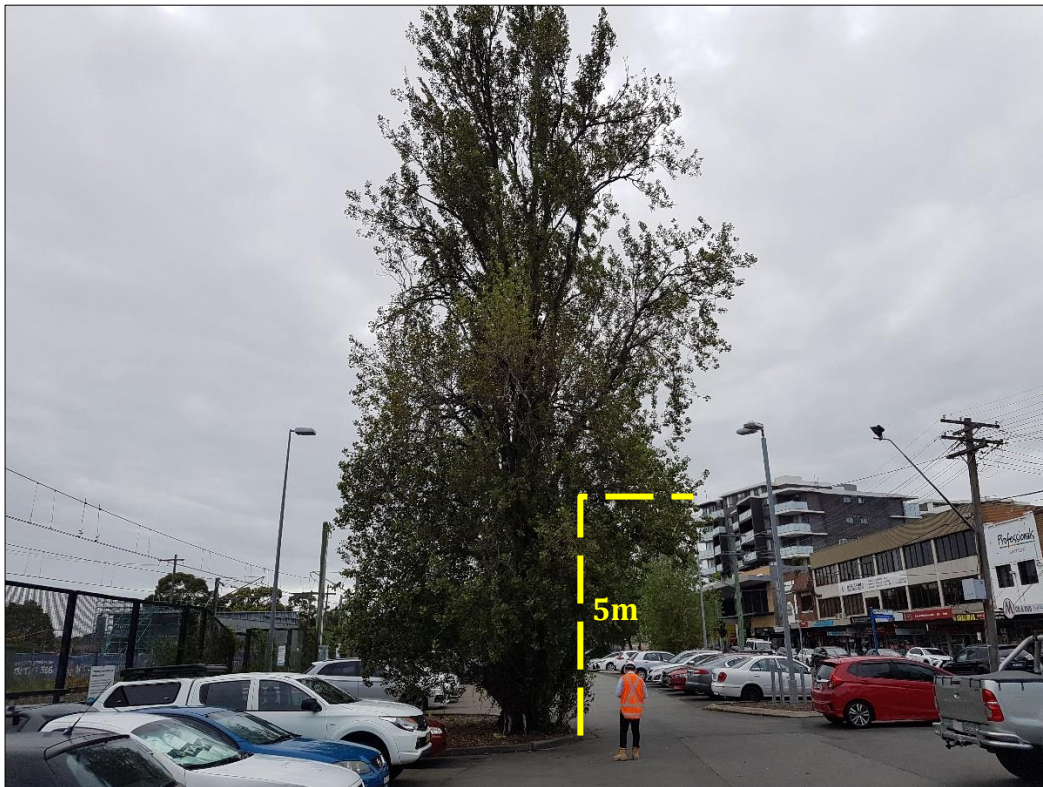
**Photograph 1:** Tree 1 *Populus nigra* 'Italica' (Lombardy Poplar as seen from the carpark area adjacent The Boulevard. 5m of vertical clearance is required from the outside edge of kerb adjacent the base of the tree.

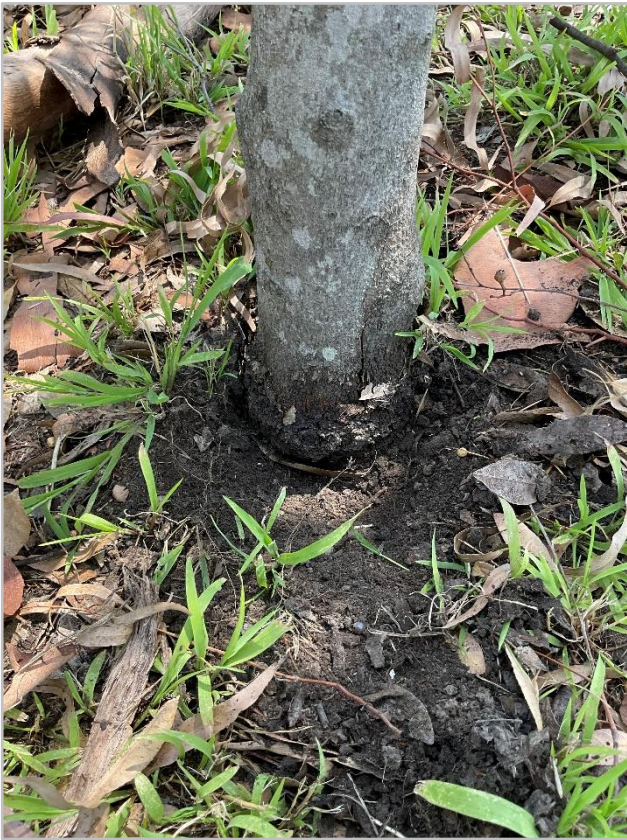
*Tree socketing in the ground from possible root rot*

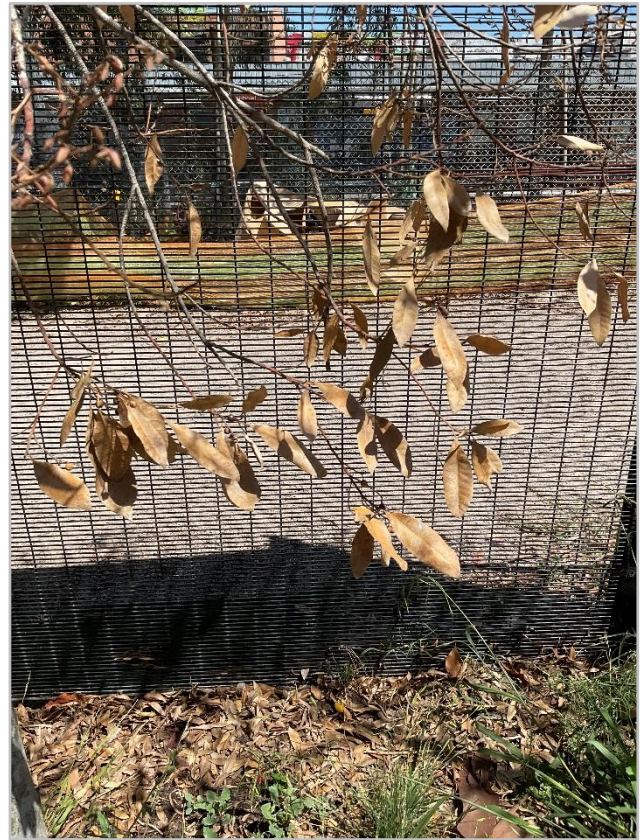
*Dead foliage*
