Construction Monitoring Report

April 2023 to December 2023 - Package 5 & 6

Sydney Metro City & Southwest

Construction Monitoring Report – April 2023 to December 2023 Package 5 & 6

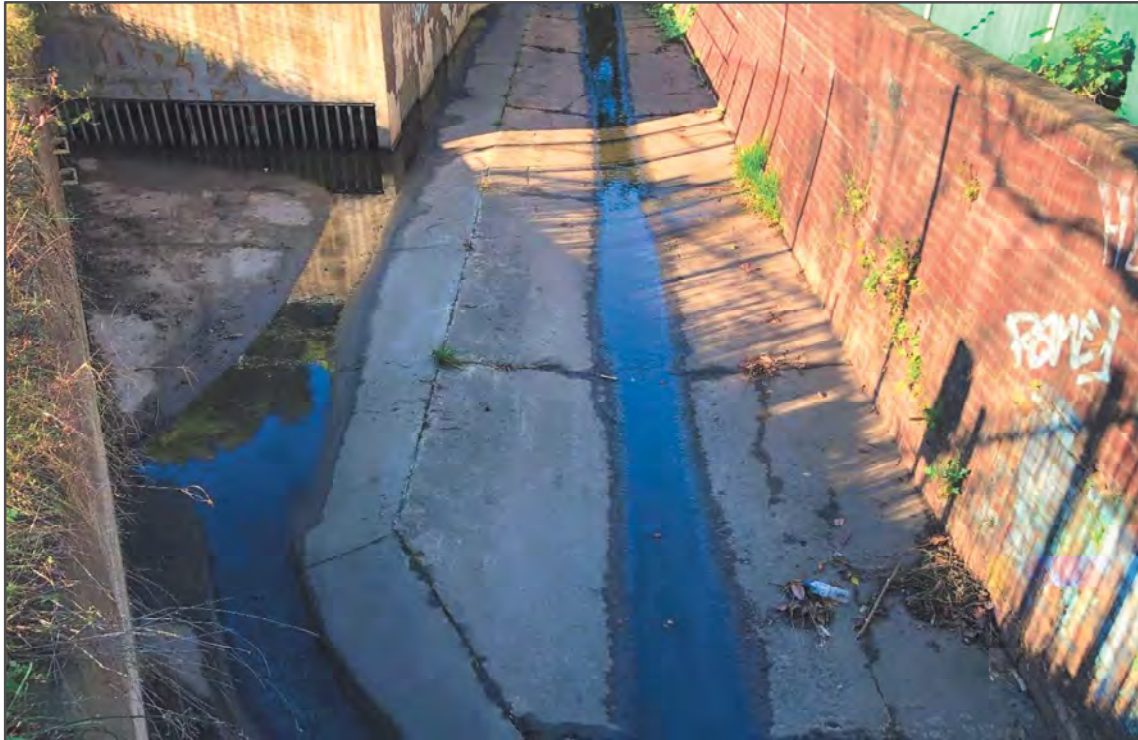
Photograph 1. Condition observed from sampling location of WP1 during the monitoring event – 30 June 2023.

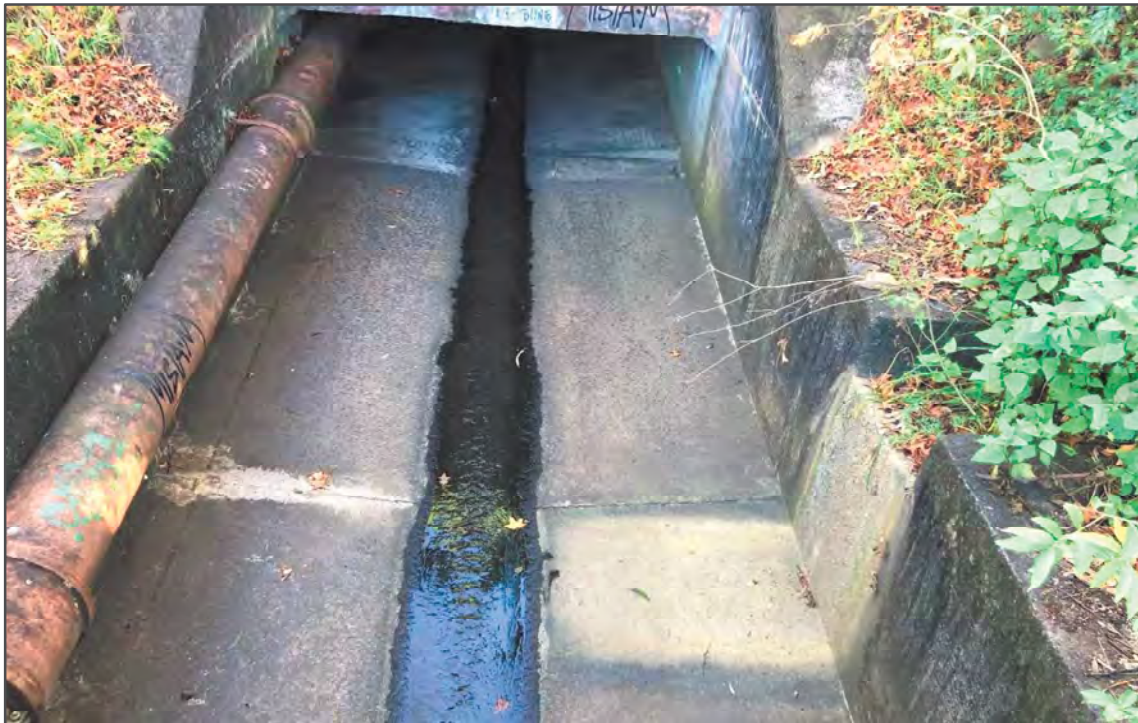
Photograph 2. No stormwater in-flow observed from the discharge point WP1-DP1 which was located within the rail corridor and immediately downstream / north from WP1 during the monitoring event – 30 June 2023.

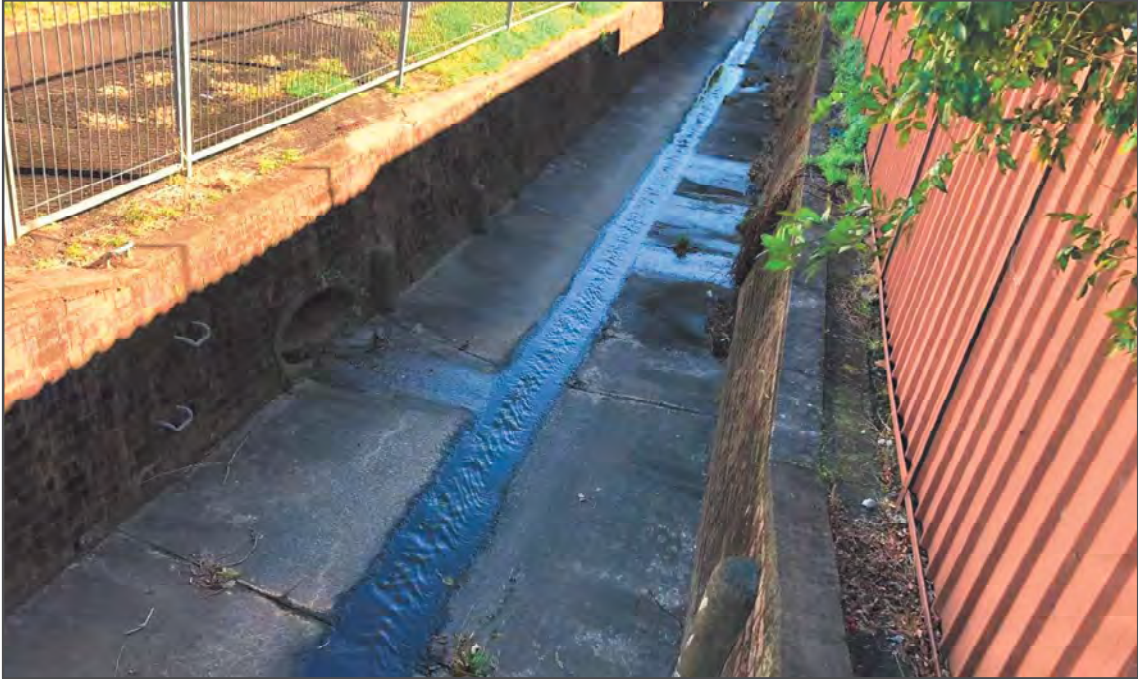
Photograph 3. Condition observed from sampling location of WP2 during the monitoring event – 30 June 2023.

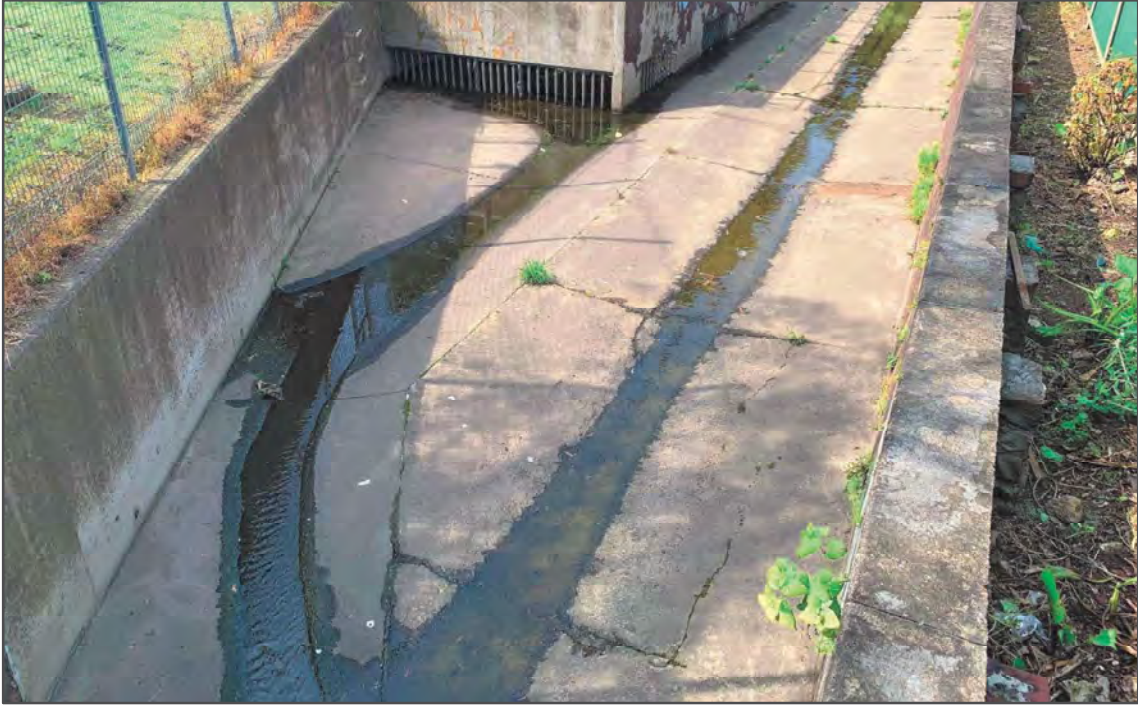
Photograph 1. Condition observed from sampling location of WP1 during the monitoring event – 15 September 2023.

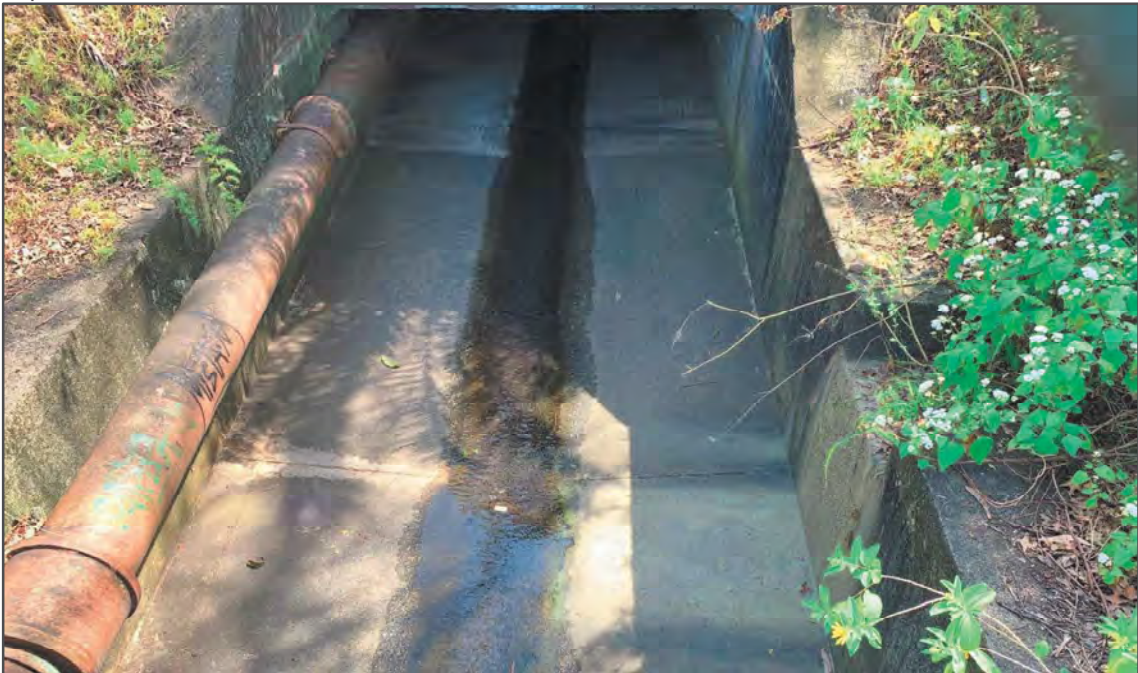
Photograph 2. No stormwater in-flow observed from the discharge point WP1-DP1 that was located within the rail corridor and immediately downstream / north from WP1 during the monitoring event – 15 September 2023.

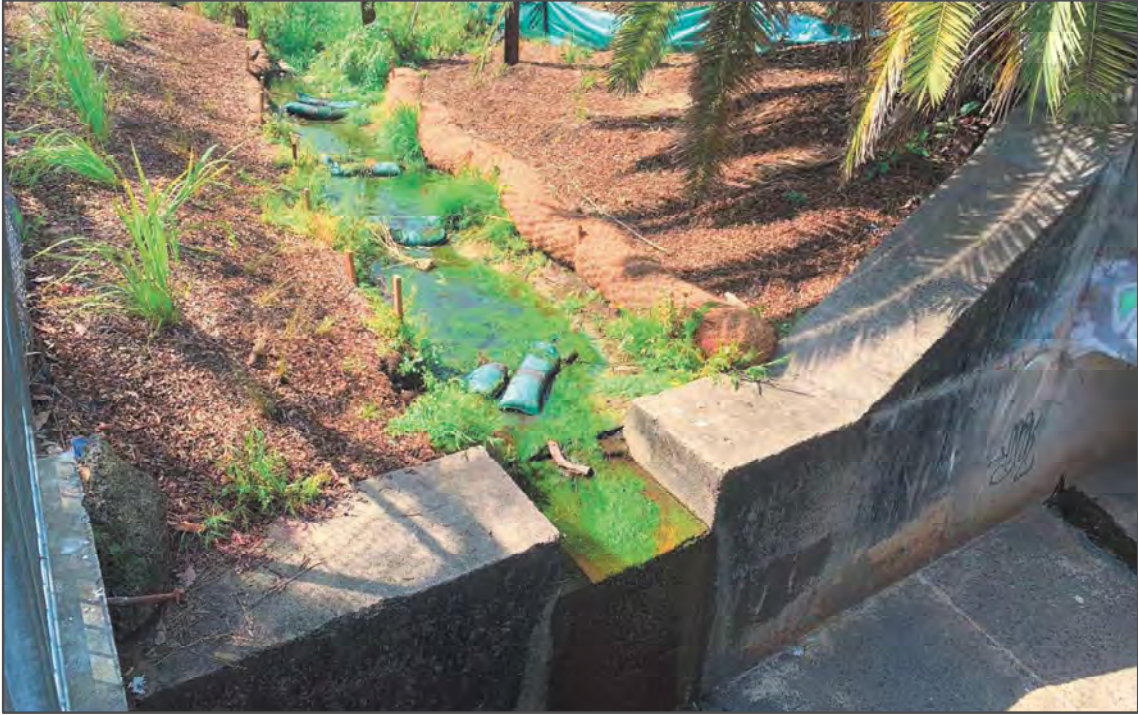
Photograph 3. Condition observed from downstream discharge point WP2-DP1 that was located within the rail corridor and immediately upstream / south from WP2 during the monitoring event. Significant algae growth was observed at this location at the time of monitoring – 15 September 2023.

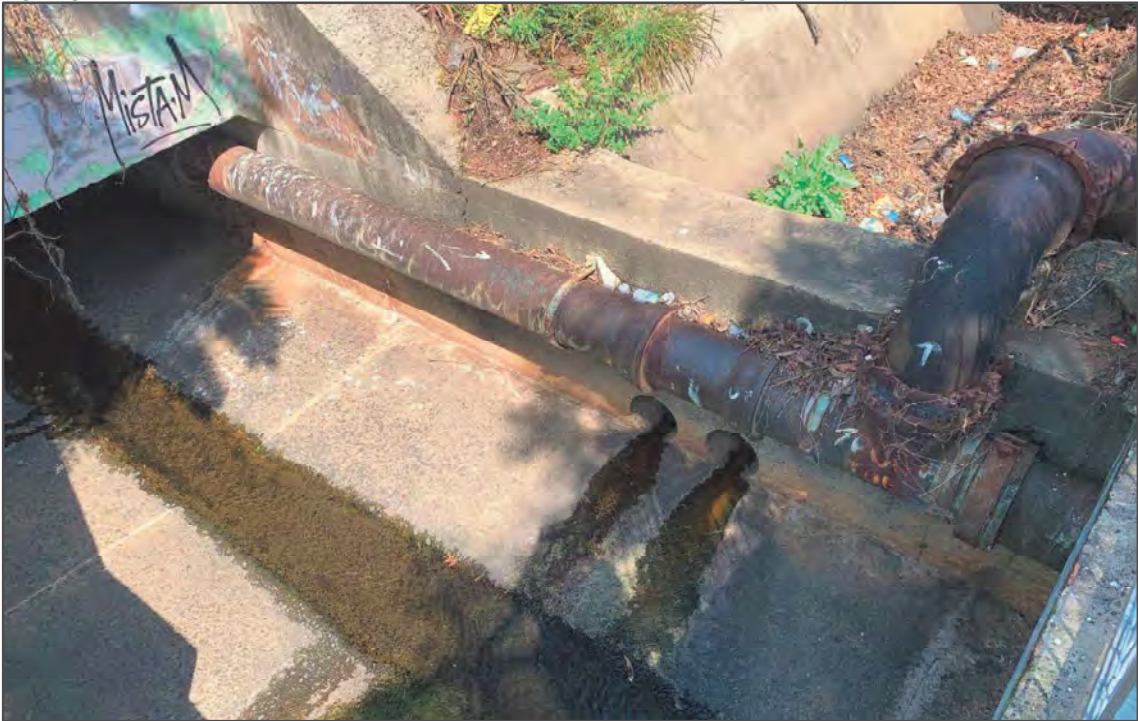
Photograph 4. Condition observed from downstream discharge point WP2-DP2 that was located within the rail corridor and immediately upstream / south from WP2 during the monitoring event – 15 September 2023.

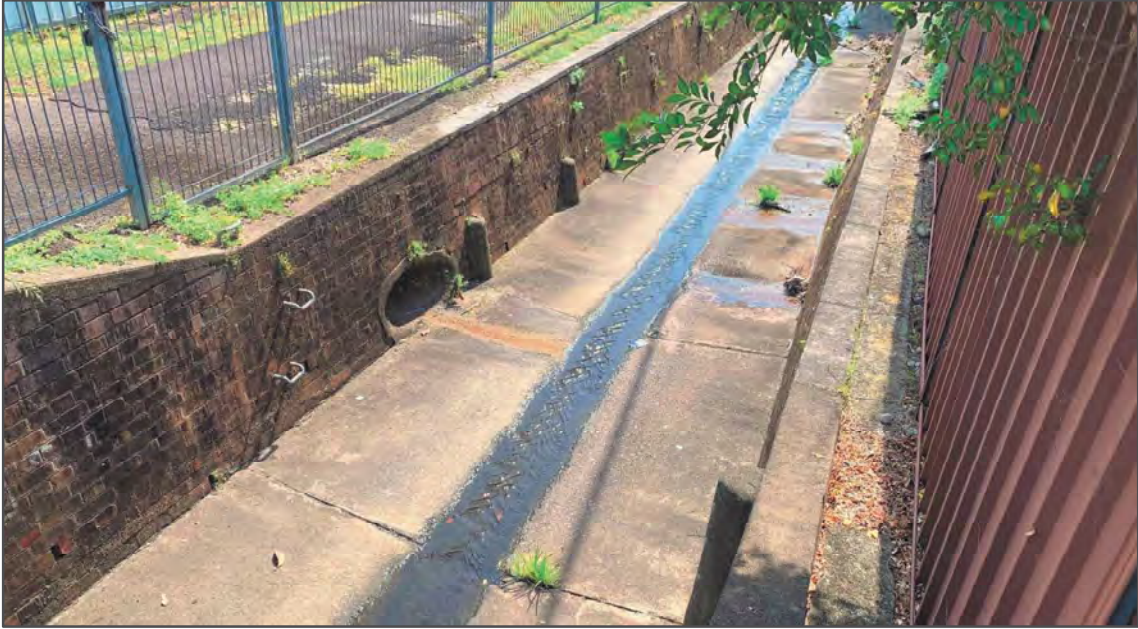
Photograph 5. Condition observed from sampling location of WP2 during the monitoring event – 15 September 2023.

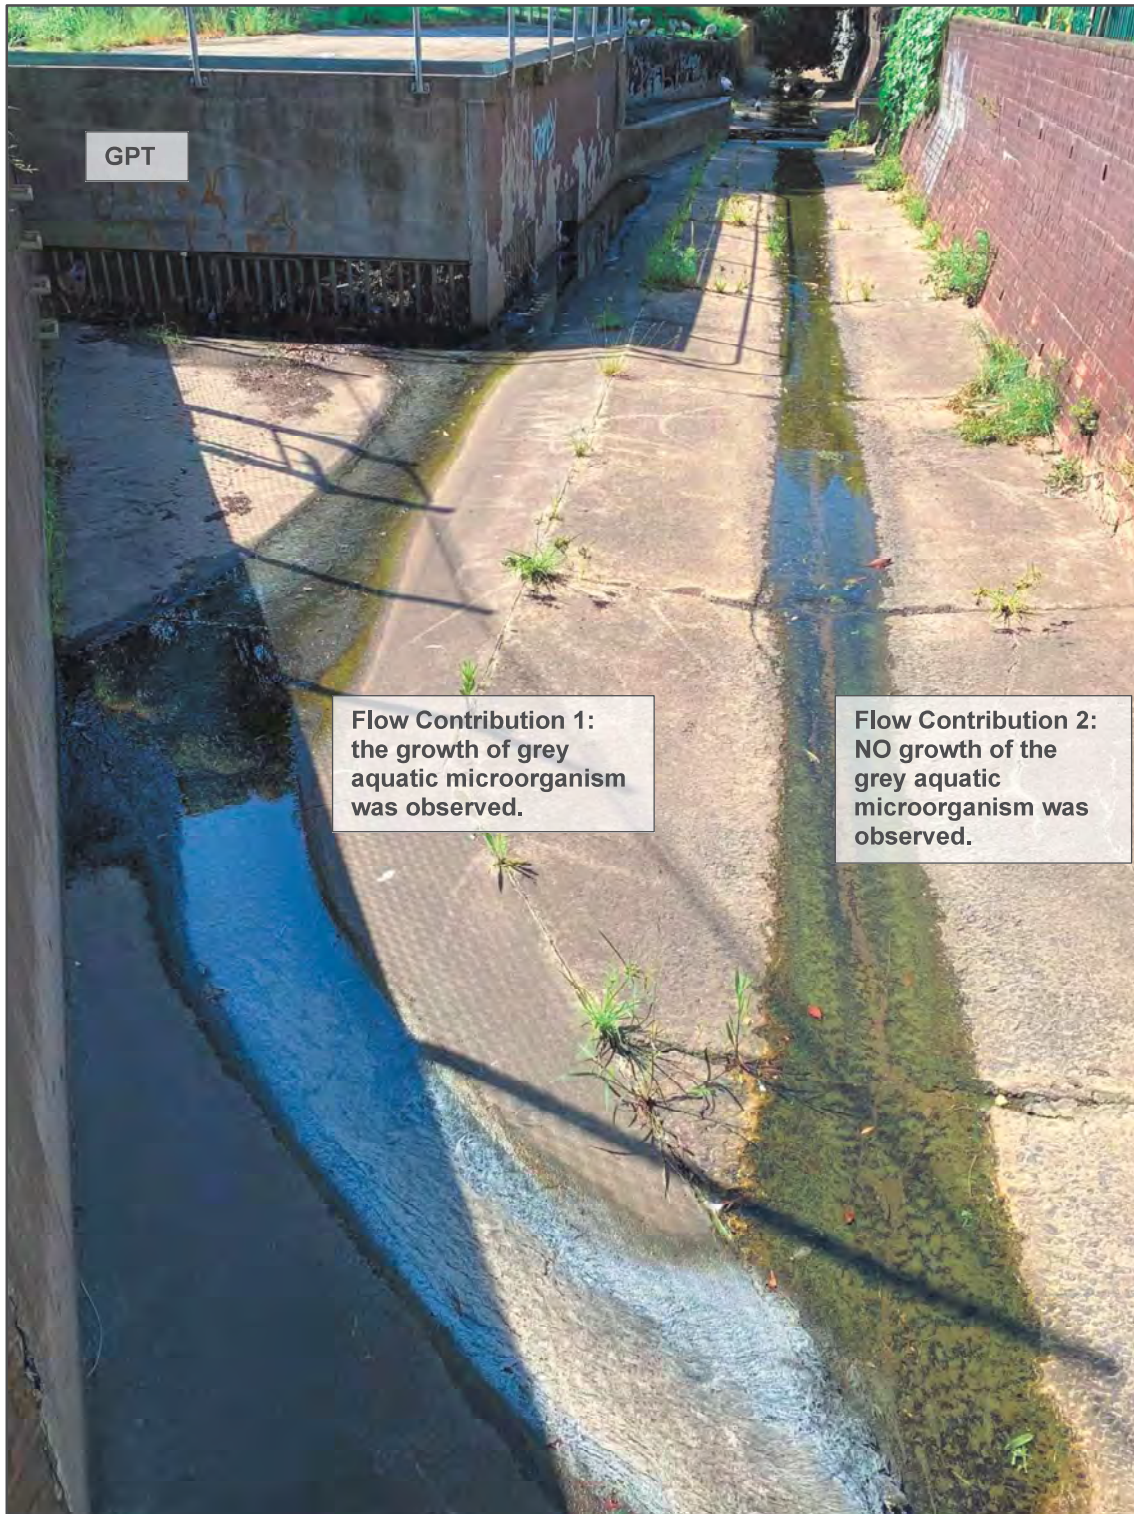
Photograph 1. Condition observed from the two upstream flow contributions of WP1 – 6 December 2023.

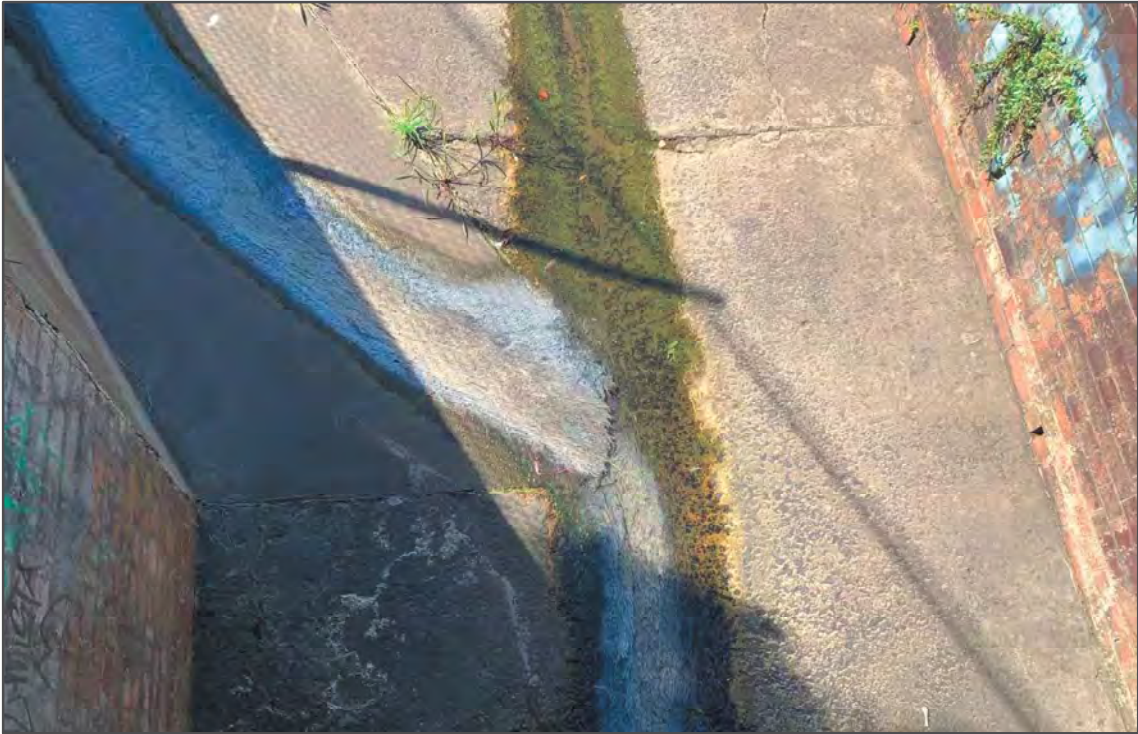
Photograph 2. Condition observed from sampling location of WP1 during the monitoring event – 6 December 2023.

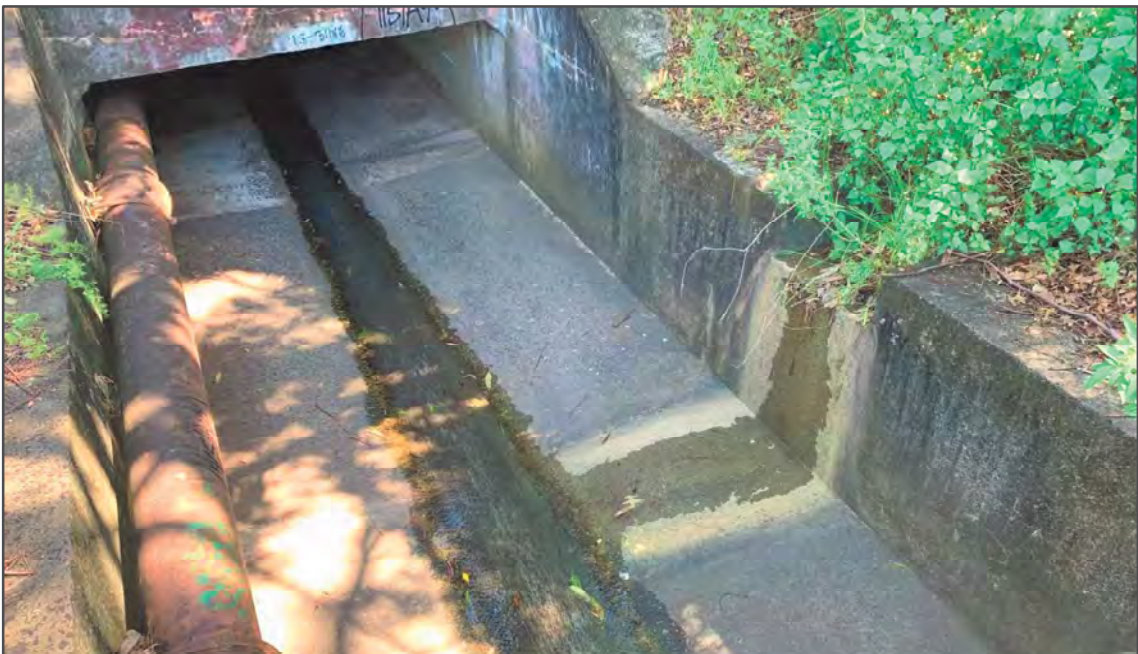
Photograph 3. No stormwater in-flow observed from the discharge point WP1-DP1 that was located within the rail corridor and immediately downstream / north from WP1 during the monitoring event – 6 December 2023.

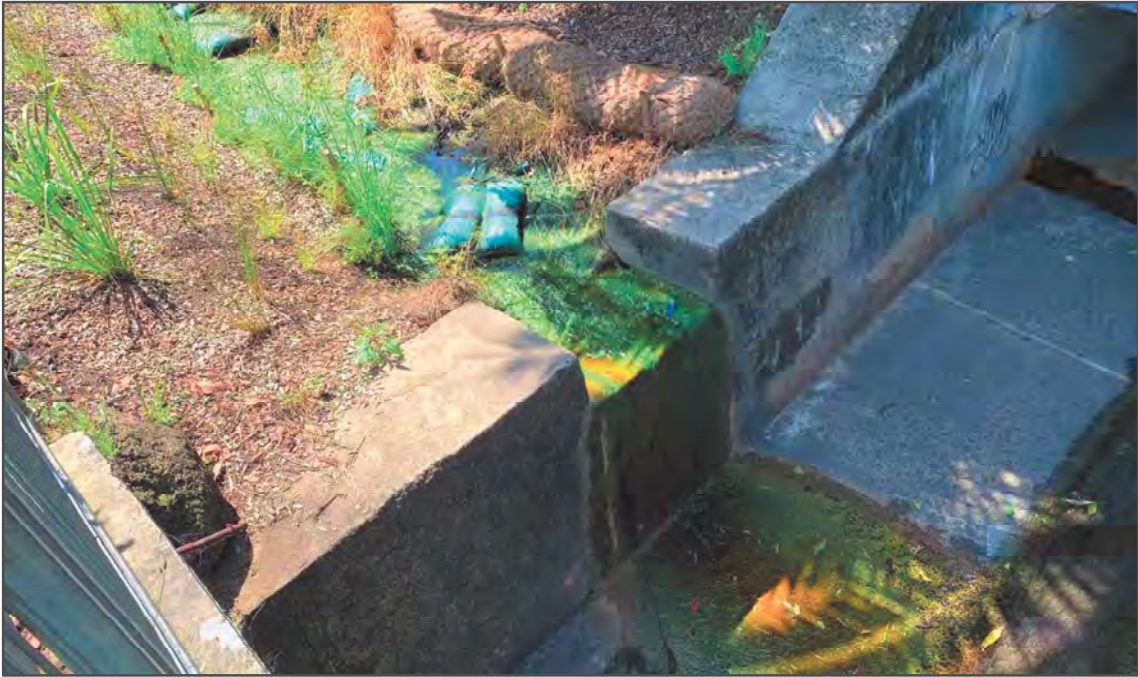
Photograph 4. Condition observed from downstream discharge point WP2-DP1 that was located within the rail corridor and immediately upstream / south from WP2 during the monitoring event. Significant algae growth was observed at this location at the time of monitoring – 6 December 2023.

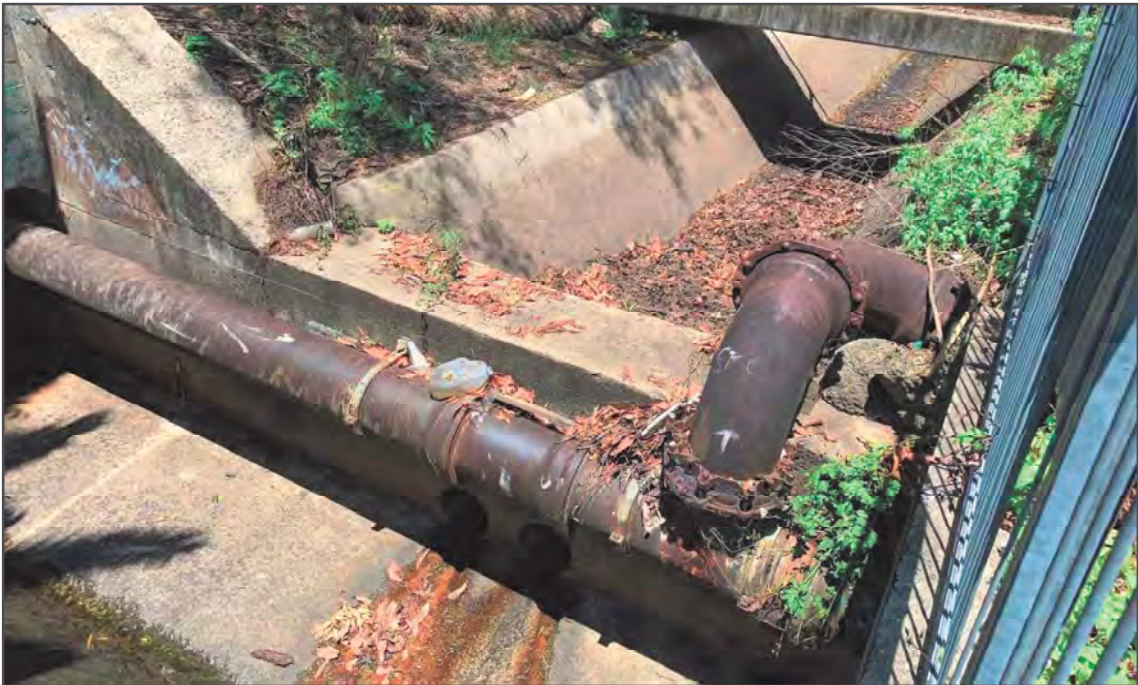
Photograph 5. Condition observed from downstream discharge point WP2-DP2 that was located within the rail corridor and immediately upstream / south from WP2 during the monitoring event – 6 December 2023.

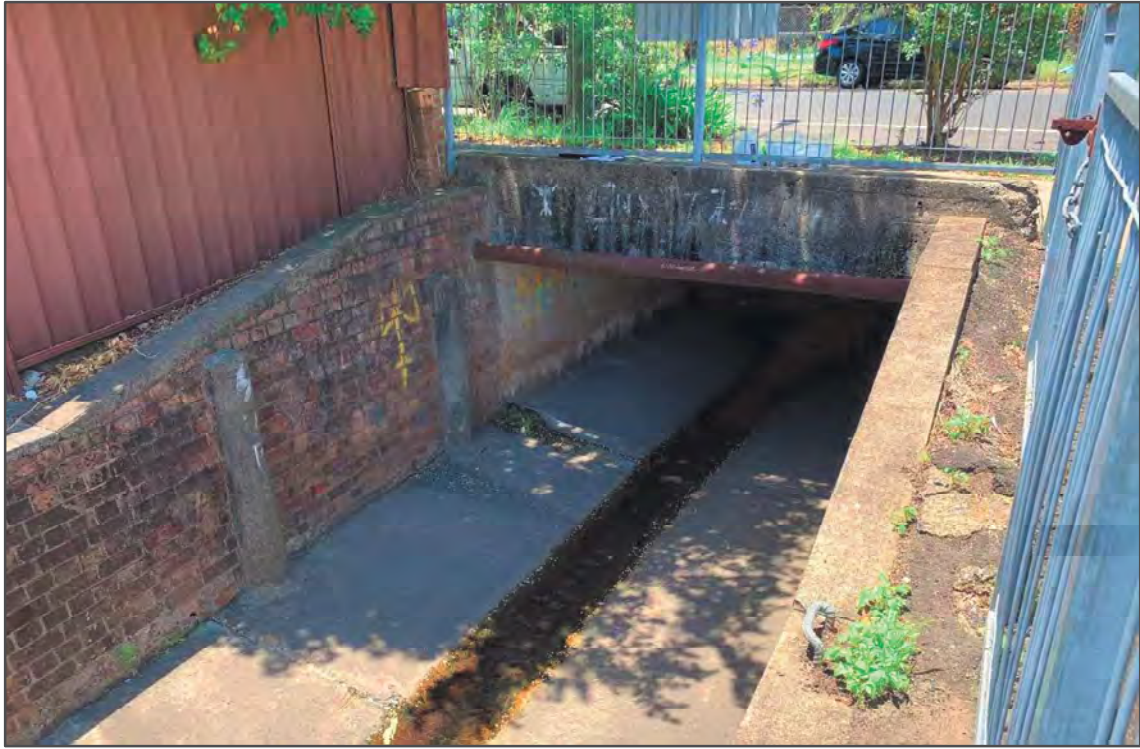
Photograph 6. Condition observed from sampling location of WP2 during the monitoring event – 6 December 2023.

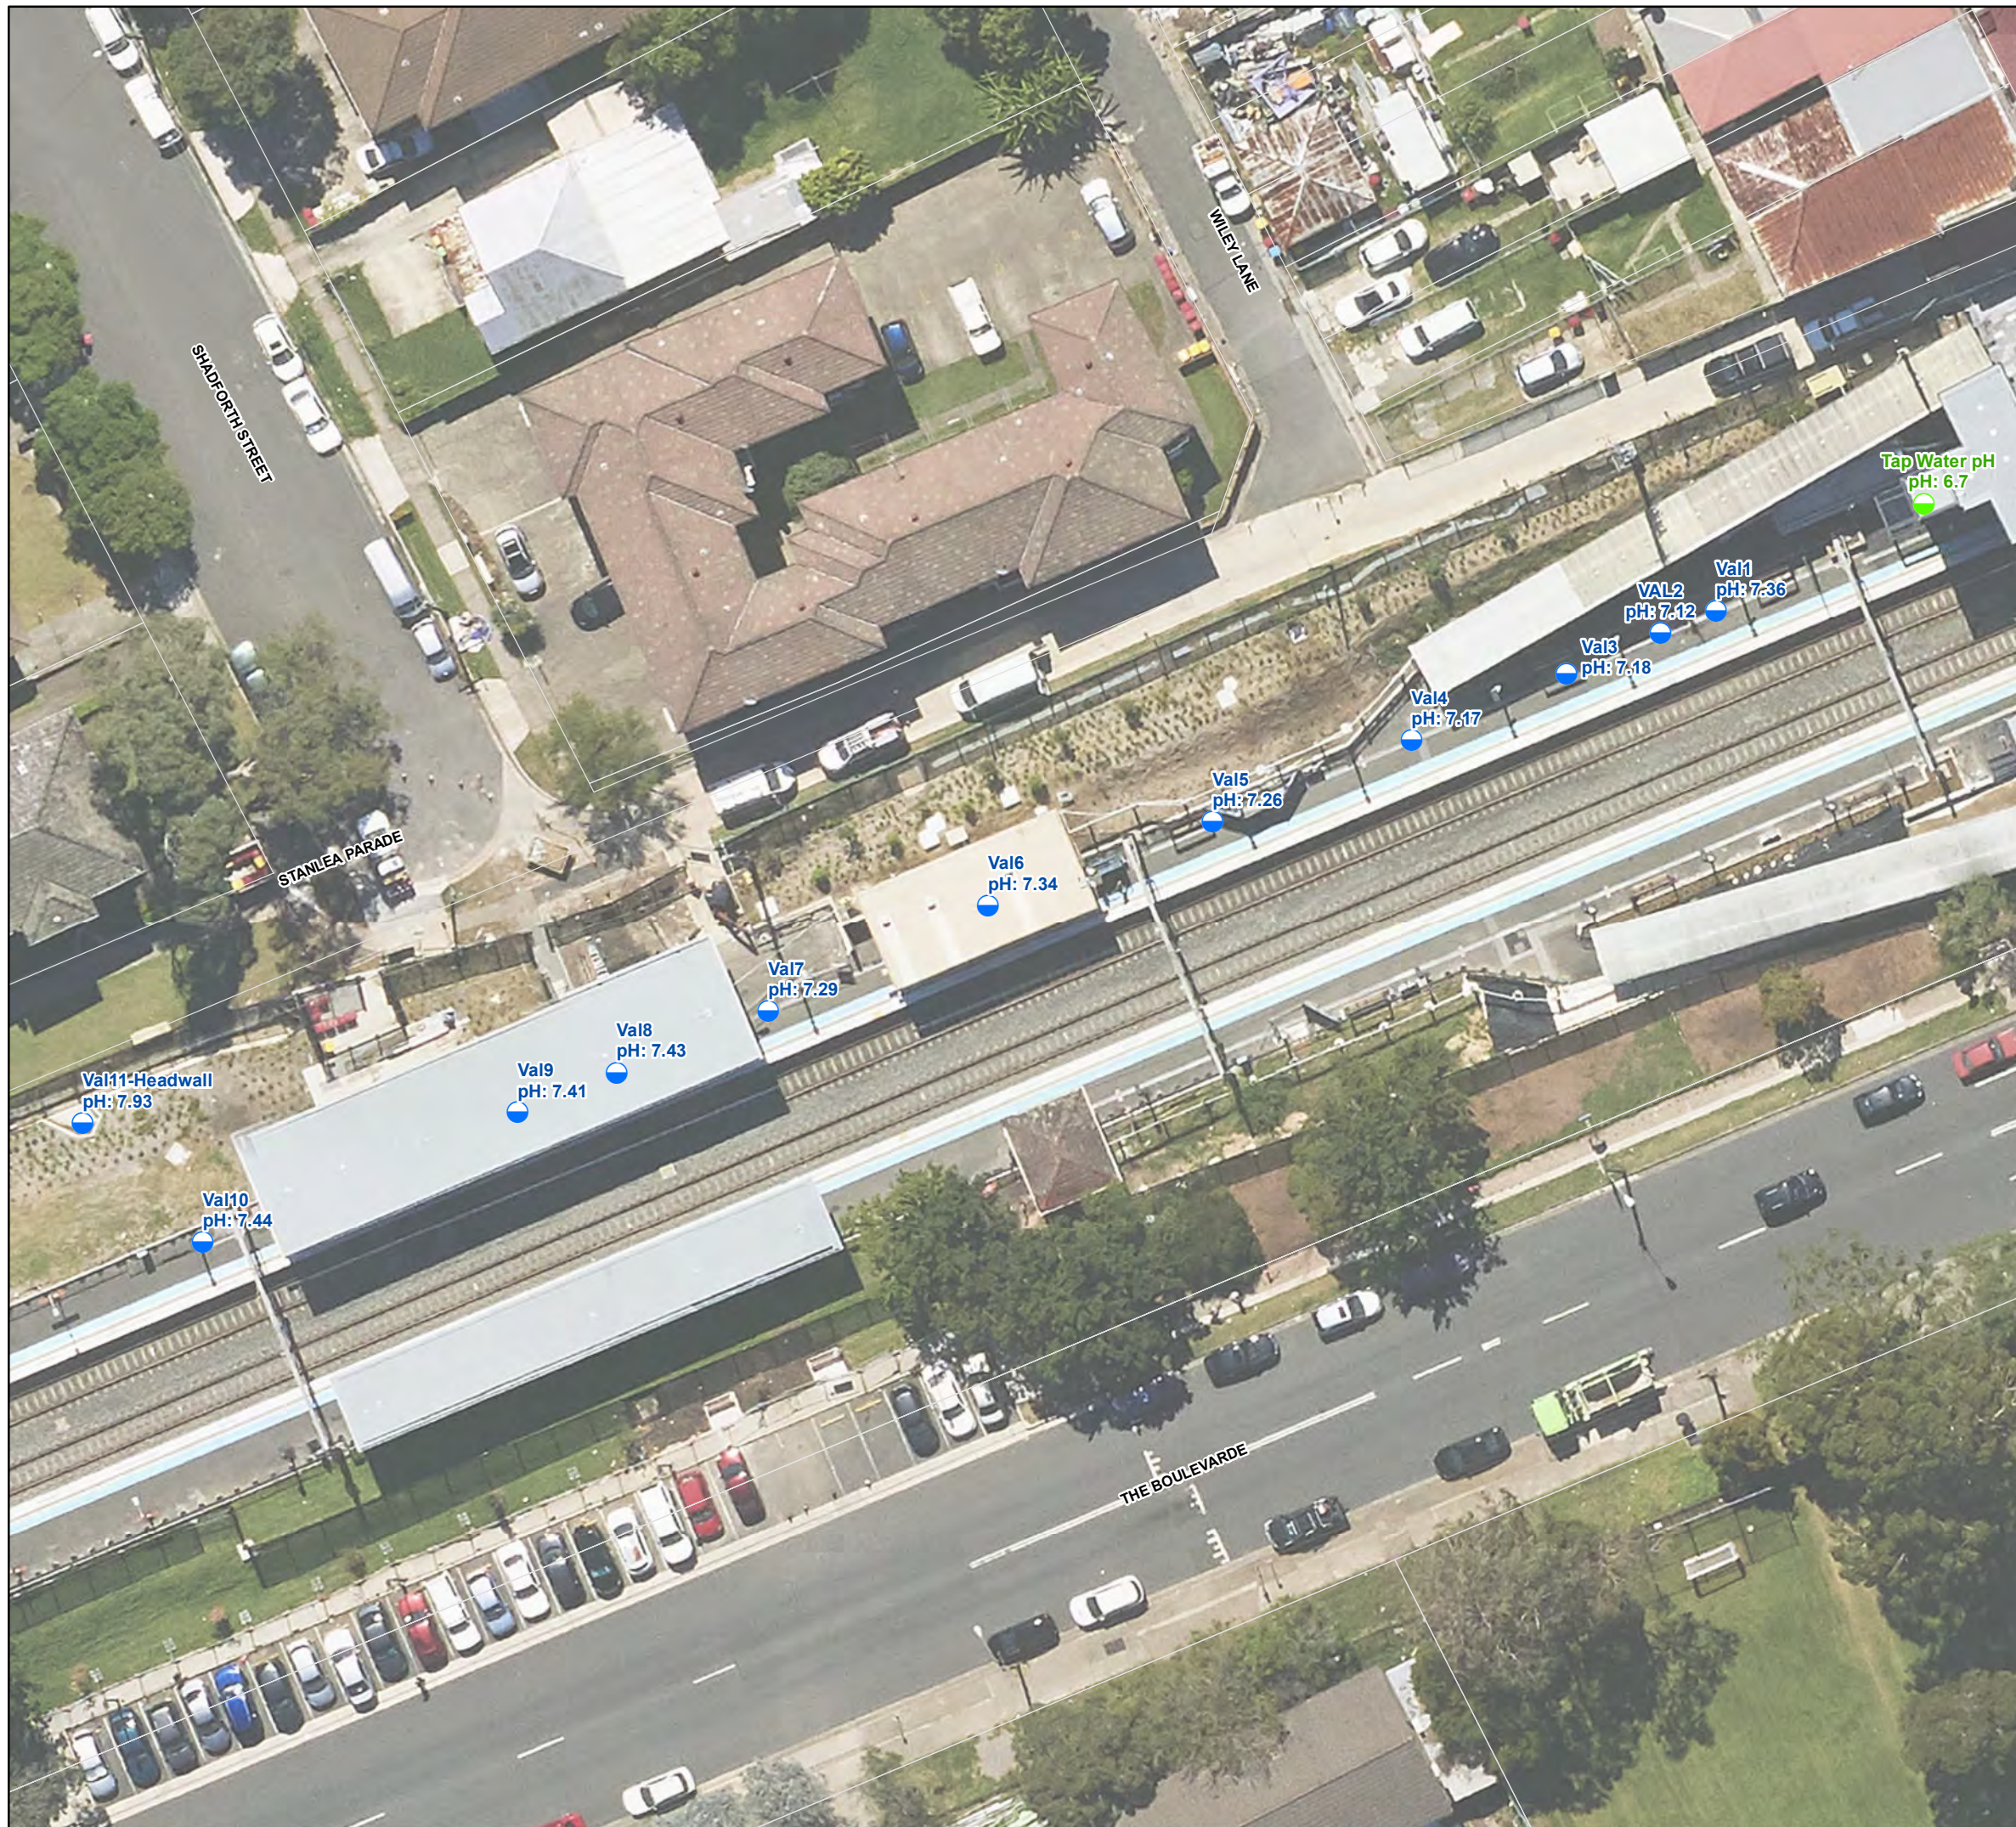
Platform 1 Aco Drain pH Validation Test

Validation testing was undertaken at the Platform 1 Drainage system on 21 April 2023. Stantec had previously identified soil eroded from an exposed slope at the northeastern end of Platform 1 that had accumulated in the drainpipes as the source of the elevated pH in stormwater flowing through the drainpipes. Stantec recommended cleaning out the soil from the drainage system. DTI cleaned out the drainage system to the extent practicable and Stantec then undertook validation testing of the drainage system to assess the effectiveness of the mitigation measures undertaken.

- pH measured at the discharge point of Platform 1 drainage system (i.e., Val11-Headwall: pH 7.93) was within the applicable assessment criteria range (i.e., 6.5 to 8.5). However, the increase of the pH measurements observed between location Val10 (pH 7.44) and Val11-Headwall (pH 7.93) suggests that the alkaline soil/ sediment material noted during previous site inspections may have not been removed completely within the two inaccessible drainage pits.
- Due to lack of rainfall and the impracticality of applying tap water directly to the garden bed and station roof, pH levels of the water discharged at these two locations are currently unknown.

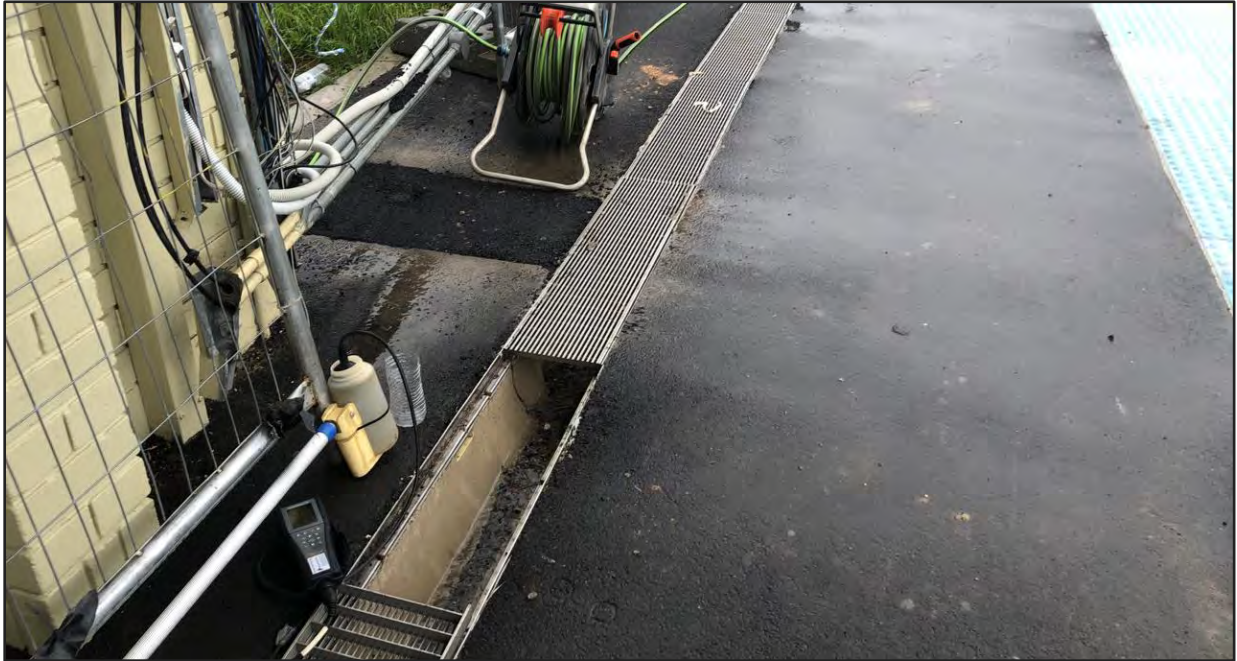
Photo 1. Aco drain condition prior to the sediment removal on 5 October 2022.

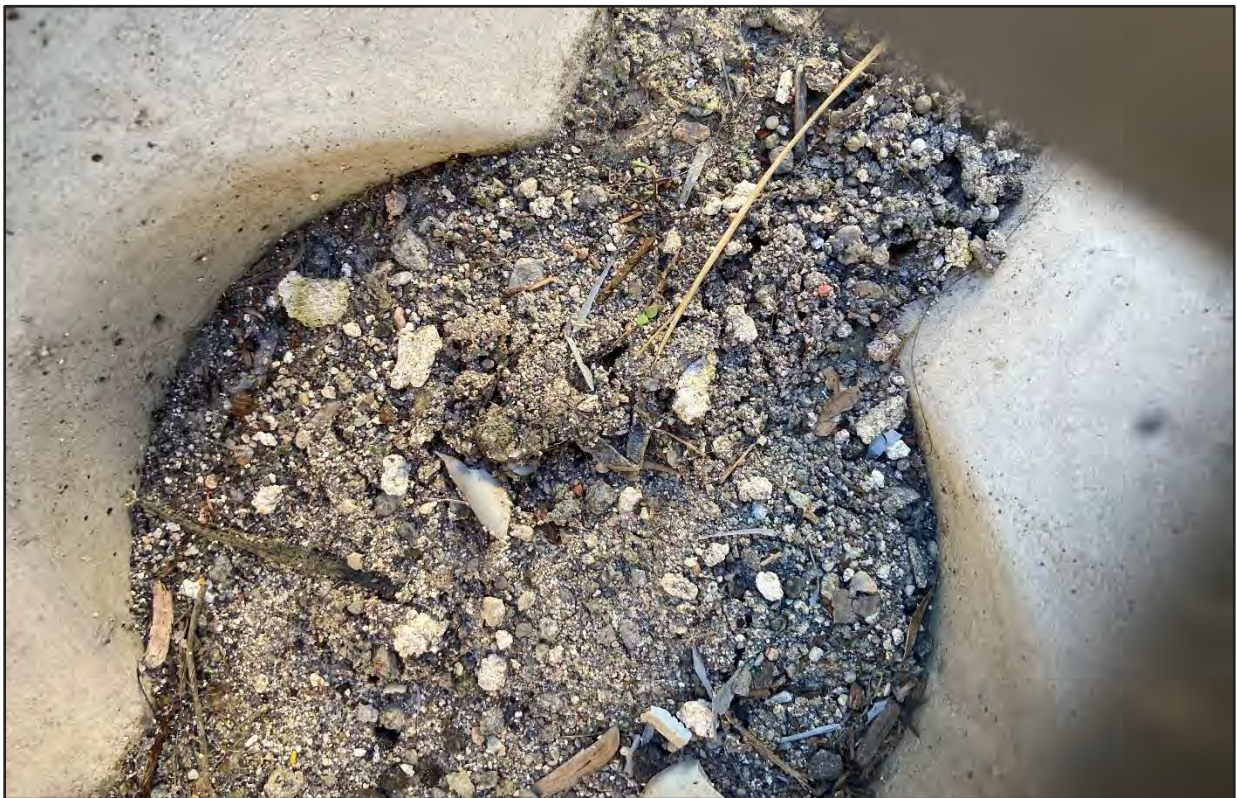
Photo 2. Aco drain condition prior to the sediment removal on 17 March 2023.

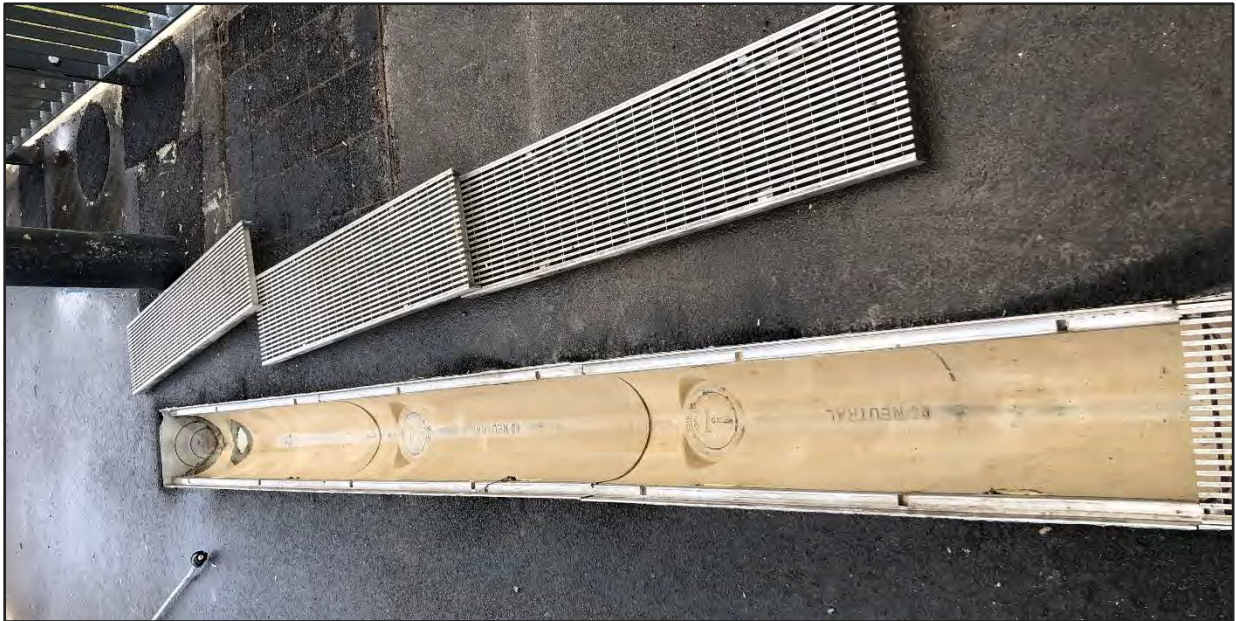
Photo 3. Aco drain condition after the sediment removal on 21 April 2023.

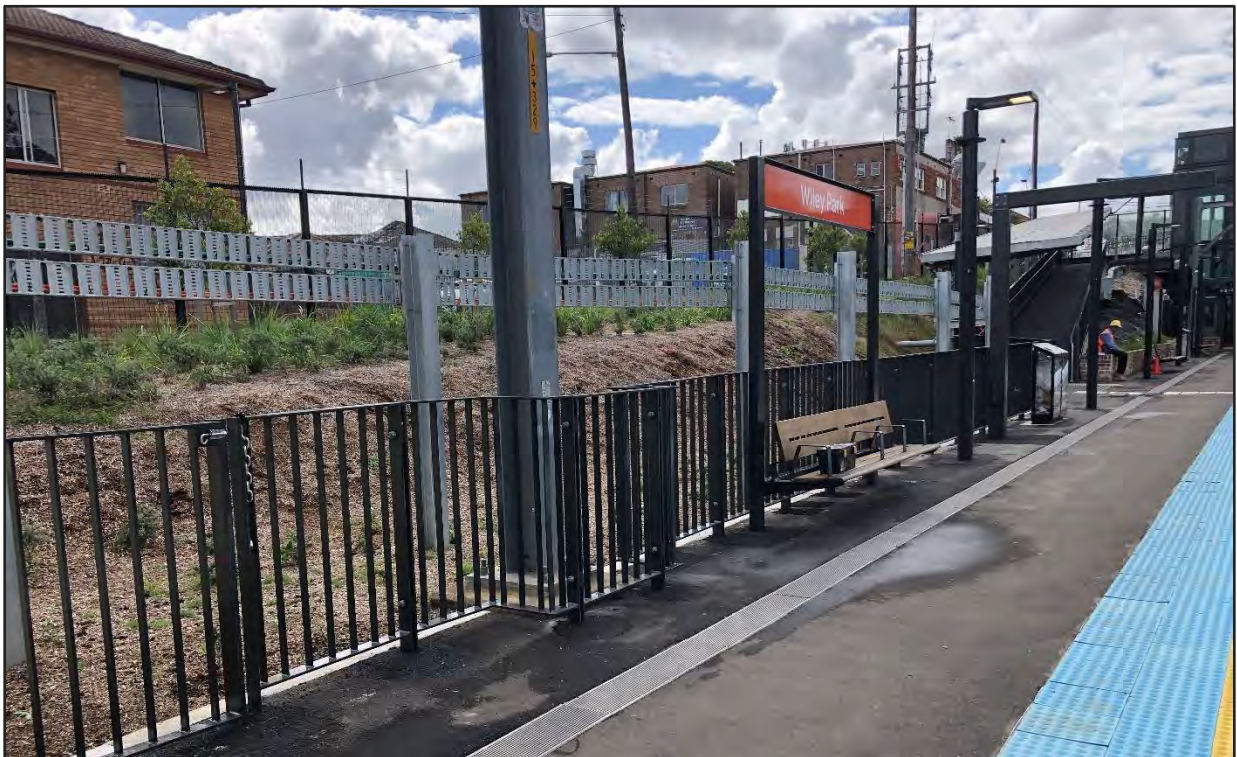
Photo 4. General current condition of Platform 1, Wiley Park Station. Date: 21 April 2023.

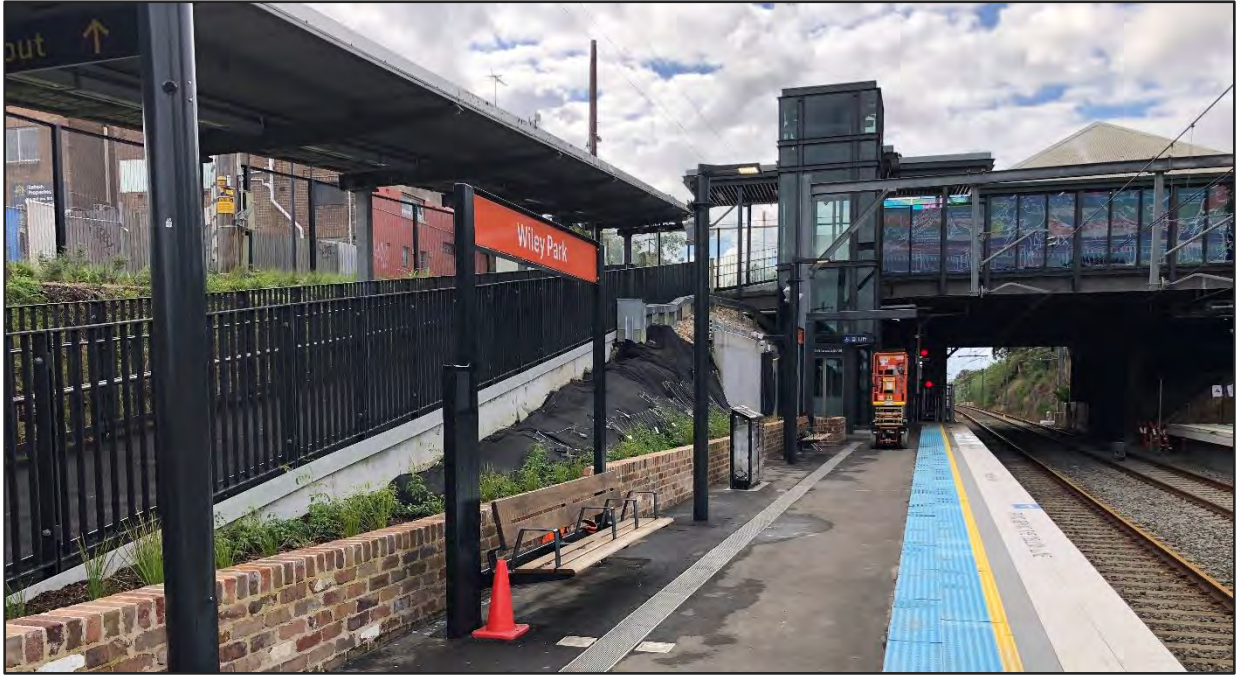
Photo 5. General current condition of Platform 1, Wiley Park Station. Date: 21 April 2023.

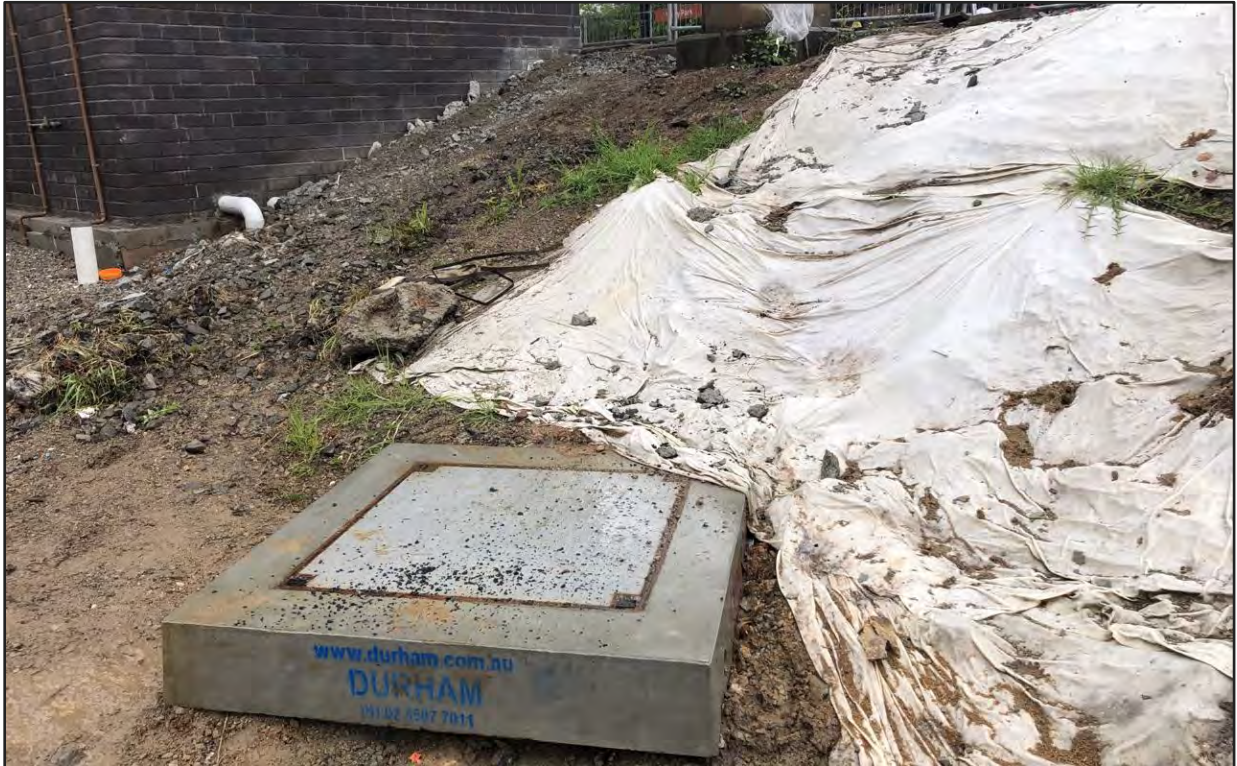
Photo 6. No access was obtained for the two drainage pits located between the downstream (south-western) end of the aco drain and the downstream discharge headwall for inspection and validation test. Date: 5 October 2022.

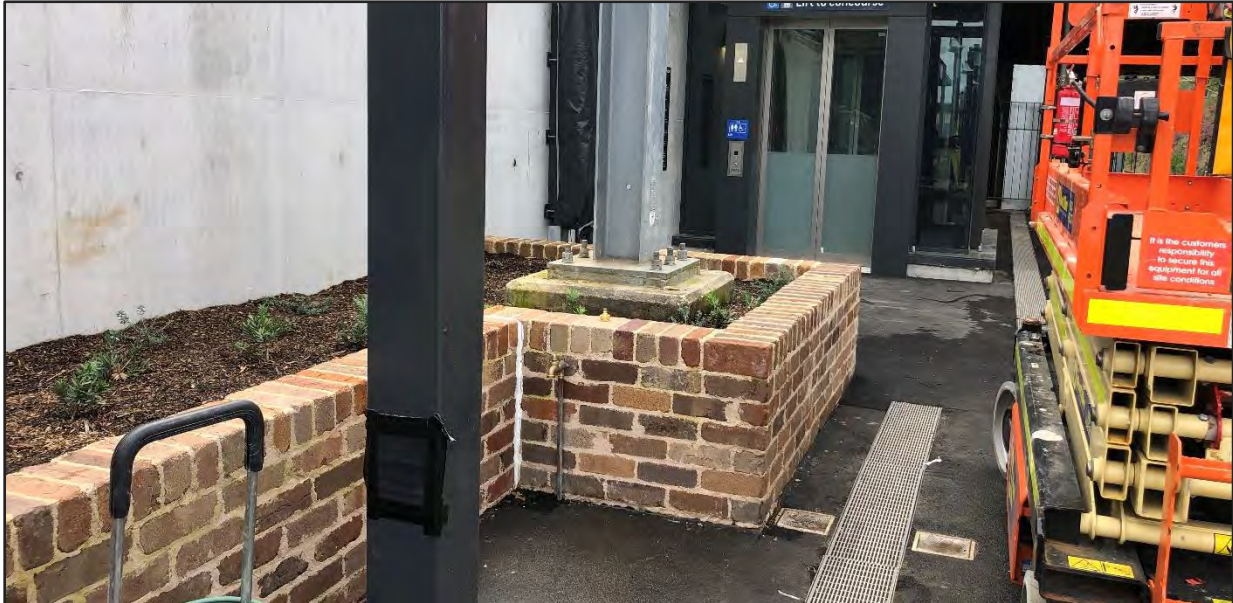
Photo 7. Garden bed located around the north-eastern end of the Platform 1 drainage system. Date: 21 April 2023.
