Tree Impact Assessment Report

City and Southwest Metro Station Upgrade Works Package 5 & 6

P5 Document No. SMCSWSW5-DEW-WEC-EM-REP-000542

P6 Document No. SMCSWSW6-DEW-WEC-EM-REP-000632

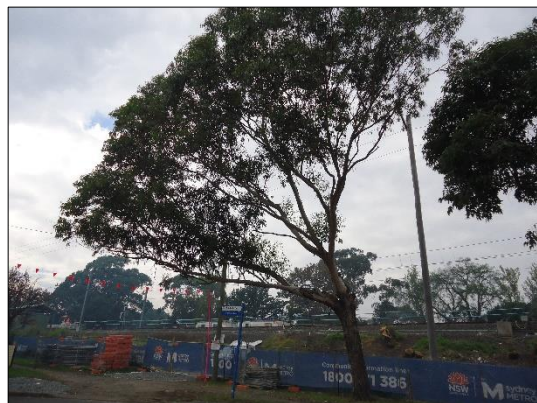
Photograph 2: Tree 2 *Eucalyptus pilularis* (Blackbutt) identified for removal to accommodate Metro services Building driveway and access.

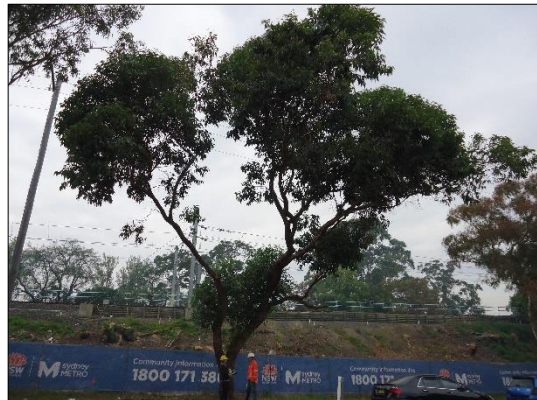
Photograph 3: Tree 3 *Eucalyptus robusta* (Swamp Mahogany) identified for removal to accommodate ULX and permanent fencing.

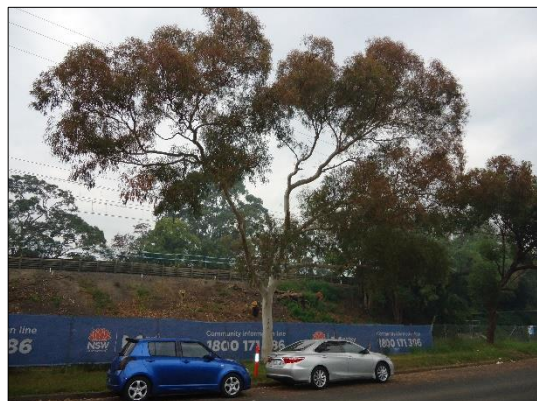
The Wallangarra White Gum (tree 4) is listed as Endangered under the Biodiversity Conservation Act 2016 and Vulnerable under the Environmental Protection Biodiversity Conservation Act 1999. However, the subject specimen is located outside of its naturally occurring range and appears to have been planted as part of the streetscape.

Photograph 4: Tree 4 *Eucalyptus scoparia* (Wallangarra White Gum) identified for removal to accommodate ULX and permanent fencing.

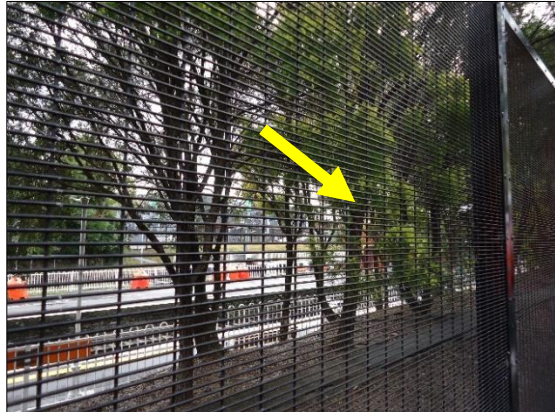
Photograph 3: Tree 627 *Leptospermum petersonii* (Lemon-scented Teatree) identified for selective pruning works create clearances to allow for the new GST alignment.

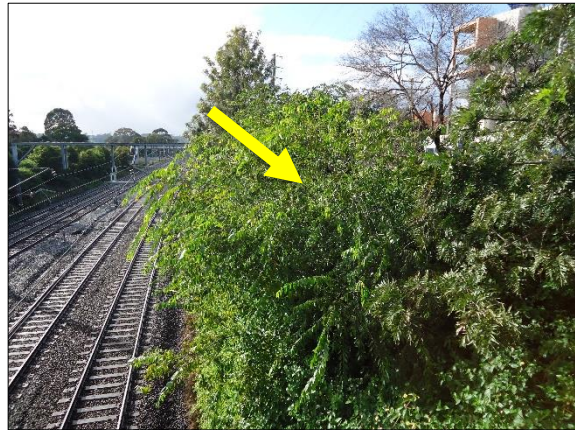
Photograph 5: Tree 6 *Celtis sinensis* (Hackberry) located within rail corridor. Tree to be removed to accommodate the new GST alignment. The surrounding Lantana along the rail embankment is also to be removed.

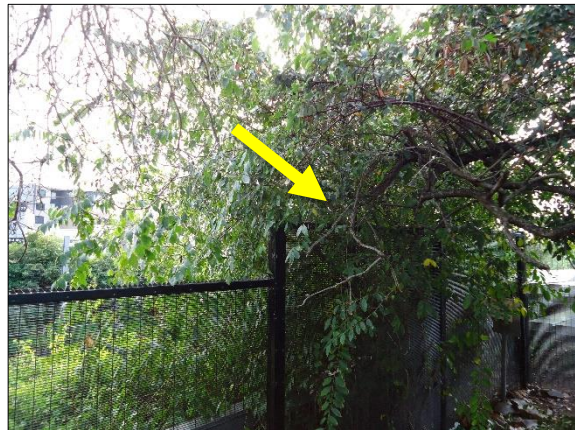
Photograph 6: Tree 7 *Celtis sinensis* (Hackberry) located within rail corridor. Tree to be removed to accommodate the new GST alignment.

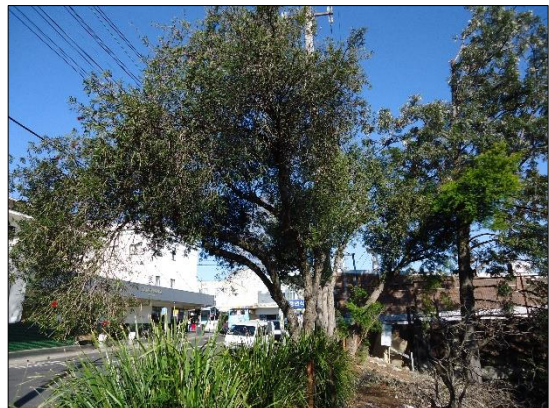
Photograph 4: Tree 519 *Callistemon viminalis* (Weeping Bottlebrush) located adjacent the northern side of South Parade.

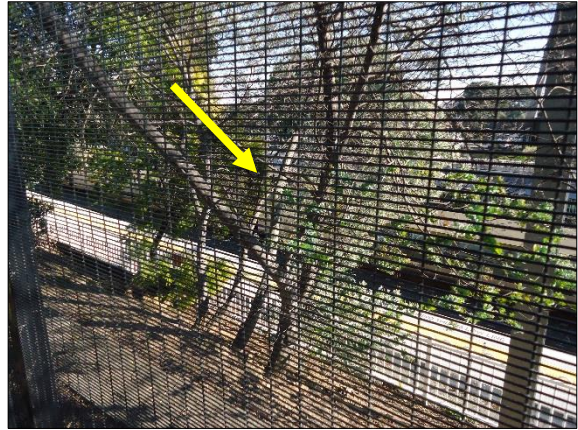
dead. Tree 615 was also found to be in a state of declining health and beyond reasonable attempts to remediate. The AIA report also identifies trees 615 and 620 as being exempt from local tree preservation controls. The additional trees to be removed are not representative of an endangered or threatened species or ecological community. Photographs of the assessed trees have been attached to the rear of this report as Appendix 2 Site Photographs.

Photograph 5: Tree 615 *Acacia podalyrifolia* (Queensland Silver Wattle) located adjacent Platform 2. The adjacent Queensland Silver Wattle's are near dead.

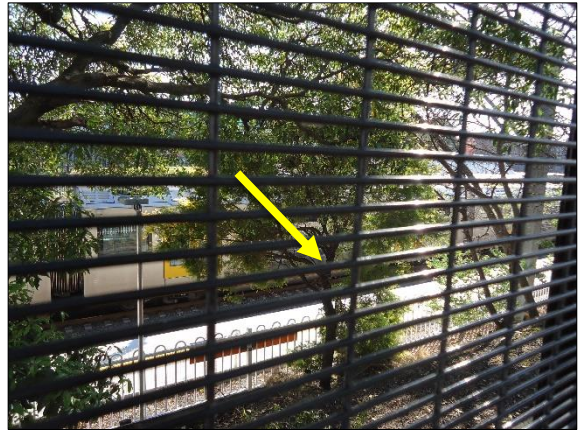
Photograph 6: Tree 5 *Melaleuca bracteata* (Black Teatree) located adjacent Platform 2.

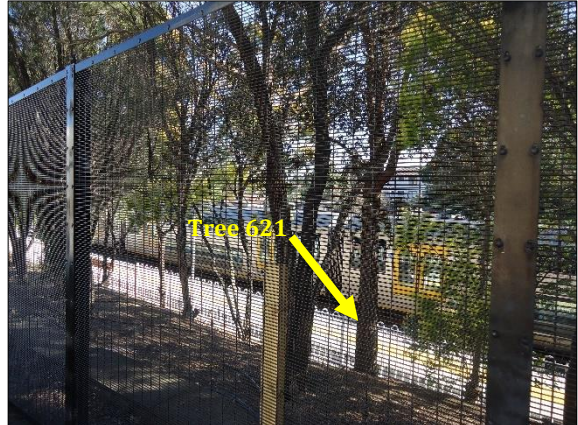
Photograph 7: Showing trees adjacent Platform 2. Tree 621 *Syncarpia glomulifera* (Turpentine) is shown for reference.

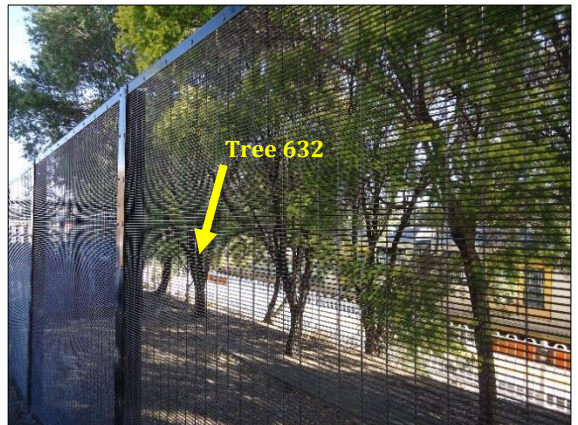
Photograph 8: Showing trees adjacent Platform 2. Tree 621 *Callistemon viminalis* (Weeping Bottlebrush) is shown for reference.

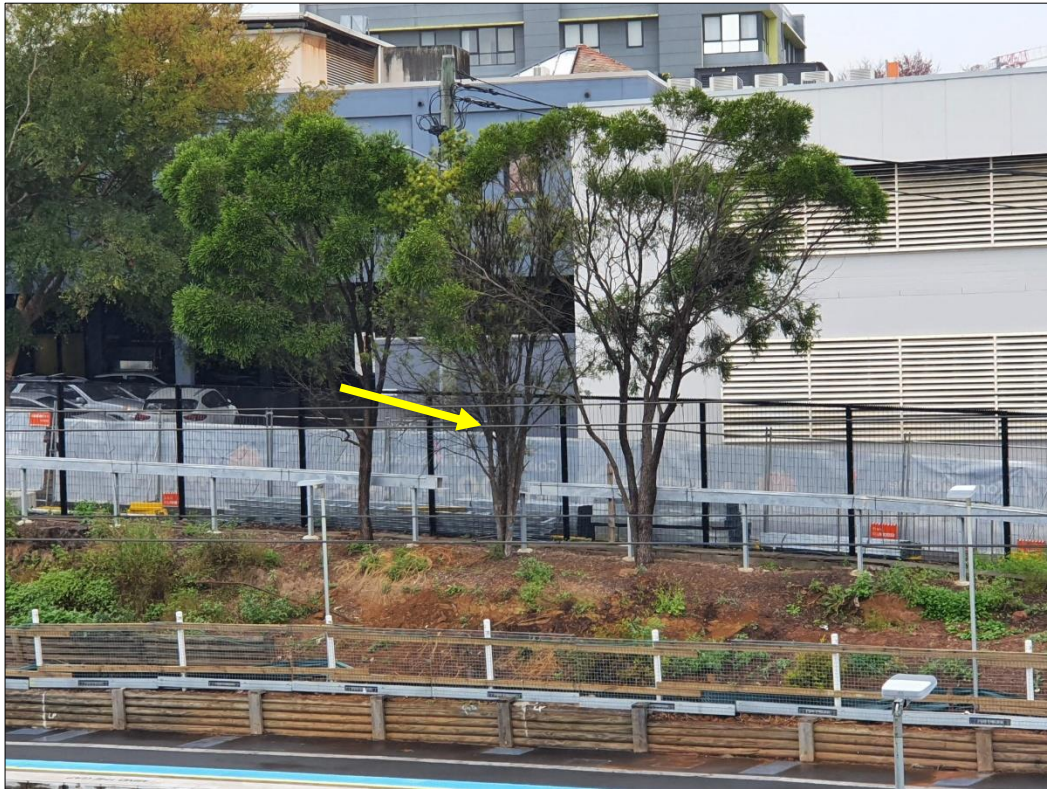
Photograph 1: Tree 618 *Callistemon viminalis* (Weeping Bottlebrush) as seen from the northern side of the rail corridor.

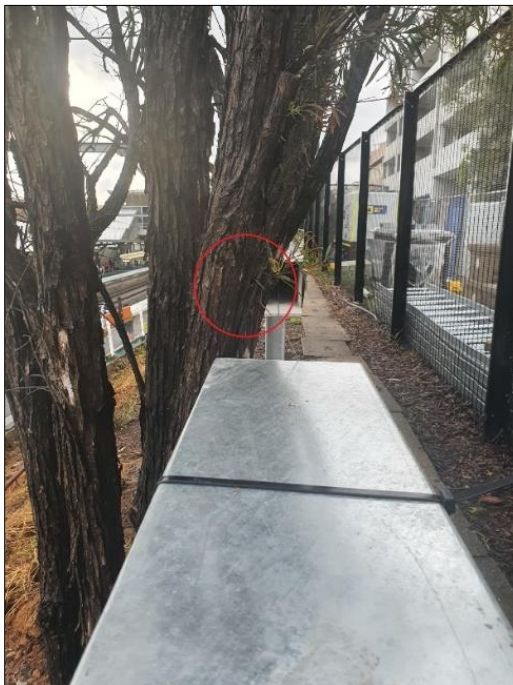
Photograph 2: Looking east along the alignment of the GST. Selective stem removal is required to allow for the GST alignment.

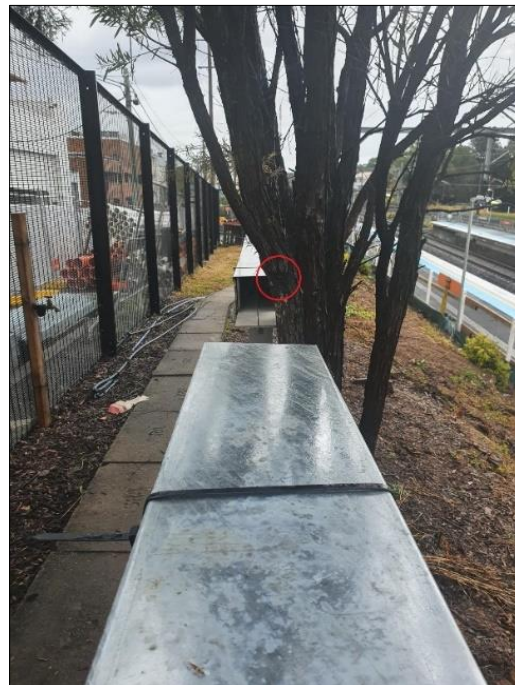
Photograph 3: Looking west along the alignment of the GST. Selective stem removal is required to allow for the GST alignment.

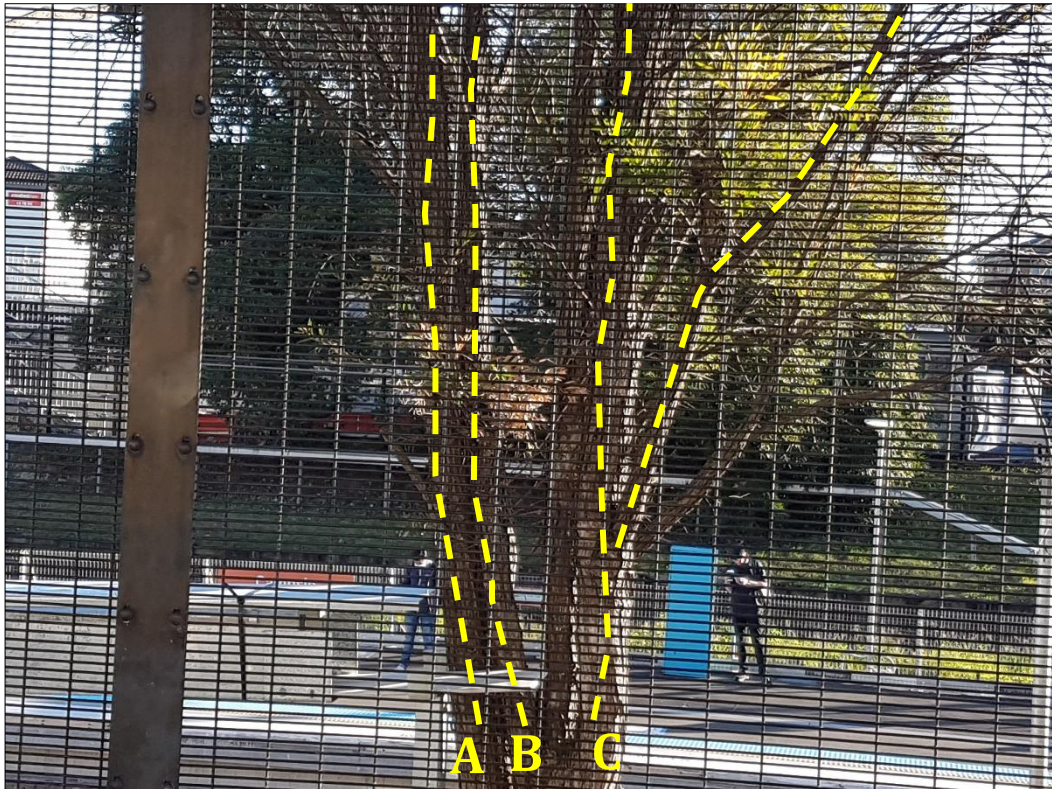
stem is to be removed at the nearest appropriate growth point. Stems B and C both originate from the same parent stem. The total pruning works constitute approximately 50% of the total canopy volume of the tree and are considered to be major pruning works. A reduction in growth, physiological function and a shortening of the trees useful life expectancy can be expected as a result of the works. Pruning wounds for branches A, B and C shall expose internal woody tissues which may become points of infection for decay causing fungi. **Appendix 2** photograph 4 shows branches identified for pruning.

- 6.2 The prescribed pruning works are considered to be major and are likely to significantly impact upon the health, condition and vitality of the tree in the short-term. The visual impacts of the pruning works are not considered to be significant given the size and position of the tree.

Photograph 4: Stems A, B and C to be removed. Stem A is 160mm in diameter and is to be reduced to below the GST (approx. 0.7m height). Stem s B and C are 90mm and 130mm in diameter and are to be removed to the nearest appreciate growth point. The two branches originate off the same stem.

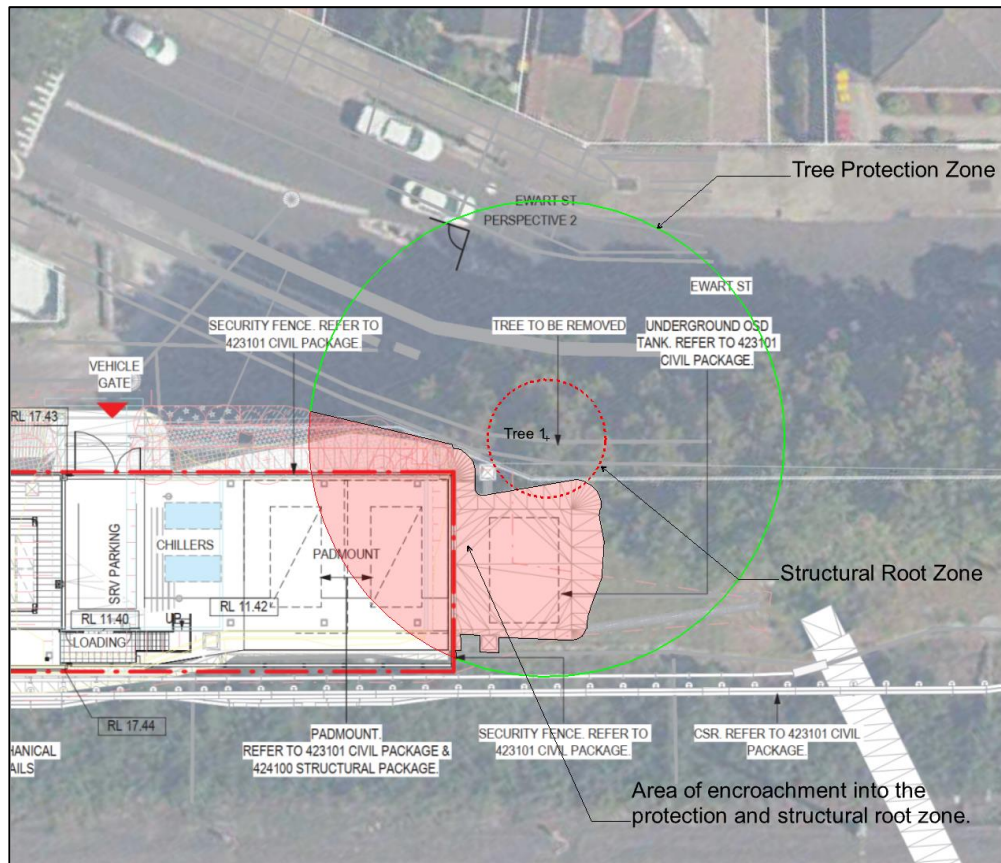
The additional tree removals consist of one *Platanus x acerifolia* (London Plane) tree 1, one *Cupaniopsis anacardioides* (Tuckeroo) tree 2 and four *Callistemon viminalis* (Bottlebrush) trees 4 to 7 where there is direct design clash and 100% impact to the TPZ and SRZ requiring removal. The Overall Arrangement Site Plan – Service Building, drawing SMCSWSWM-MTM-WDH-AT_DWG-421120 shows the position of the service building and associated features with respect to tree 1. The alignment of the Padmount and underground OSD tank pose a significant (35%) encroachment into its TPZ and SRZ requiring its removal, refer to Image 2.

Image 2: Extract from Overall Arrangement Site Plan – Service Building showing the encroachment into the TPZ and SRZ of tree 1.

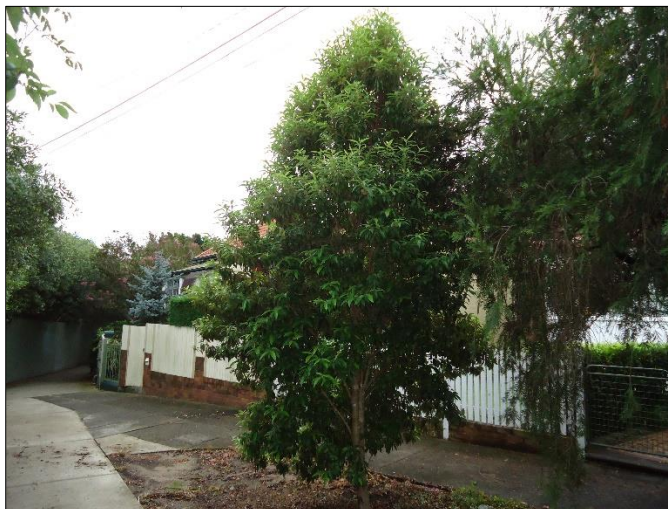
Photograph 3: Tree 3 *Backhousia citriodora* (Lemon-scented Myrtle). Tree is to be transplanted on the site.

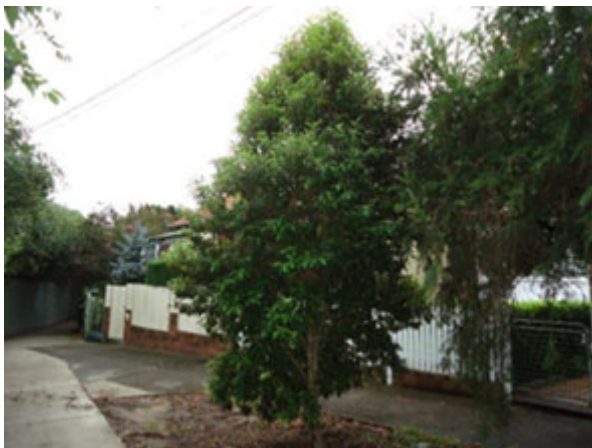
During the phone call with your colleague, it was noticed that the original photo was actually the wrong tree nominated to be relocated (refer to below correct image). Irrespective, the below correspondence is still relevant and we are seeking advise from Inner West Council whether they wish to retain the tree and transplant locally or shall the project add it to the tree offset planting requirements.

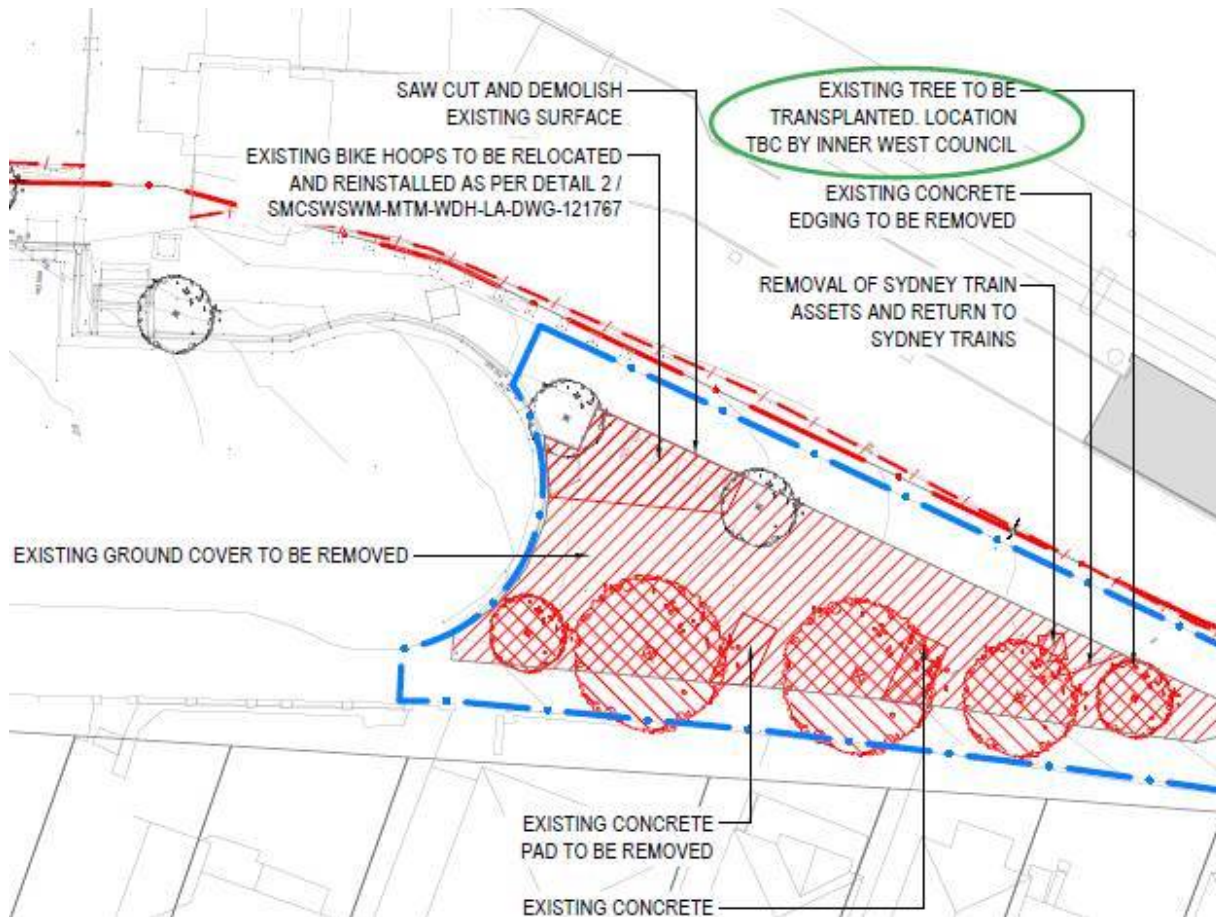
In short, the design has nominated a singular tree at Dulwich Hill Station to be relocated (see below design excerpt and street view image of tree circled in red). The tree is quite young and doesn't offer any significant value which leads me to ask whether IWC actually wish to retain the tree. Relocating the tree will pose a few logistical issues given that we (Downer) will need to remove the tree being in our PC and the transplant/ relocation works would need to be undertaken by IW Council given that the new location is likely to be outside of the project boundary.

The alternative to transplanting is for the project to remove the tree along with the remaining vegetation (separate tree clearance request) and add to the project tree offset planting. I believe this would be the most favourable option for both parties, however am seeking initial input from Inner West Council.

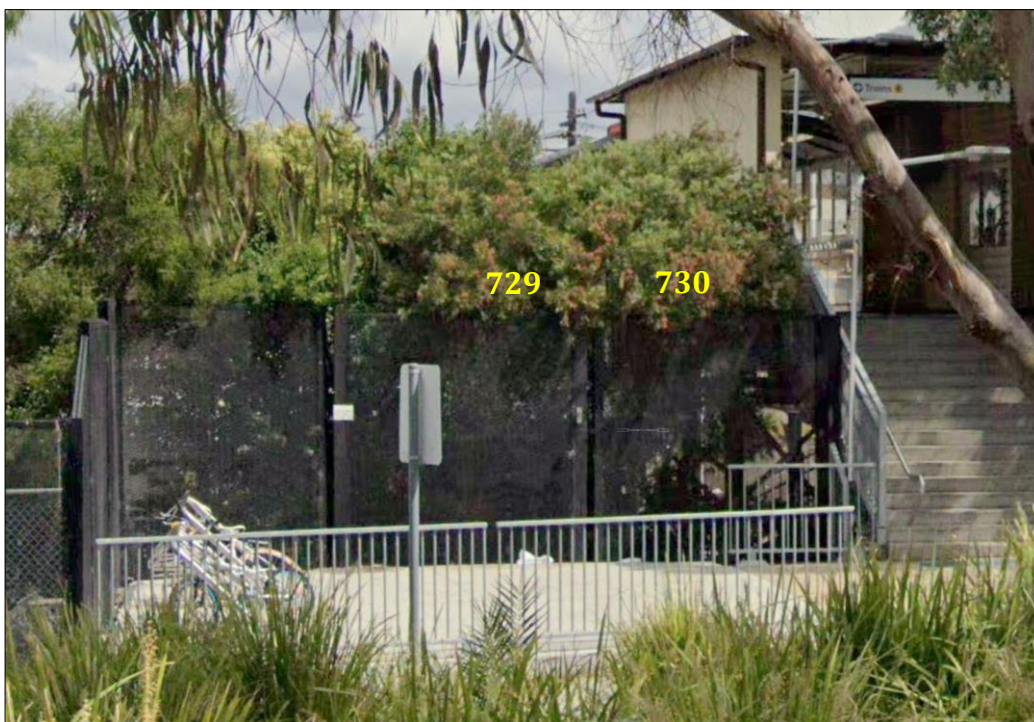
Image 2: Trees 729 and 730 are to be removed to accommodate the lift shaft works.

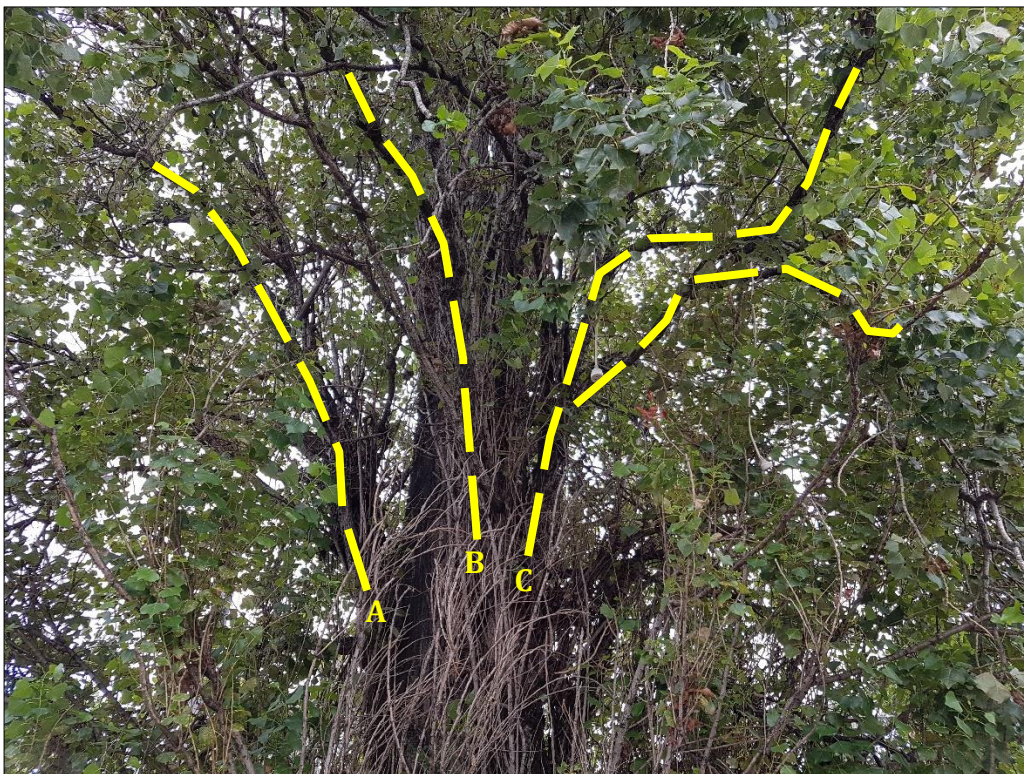
Photograph 2: Branches A, B and C identified for removal.

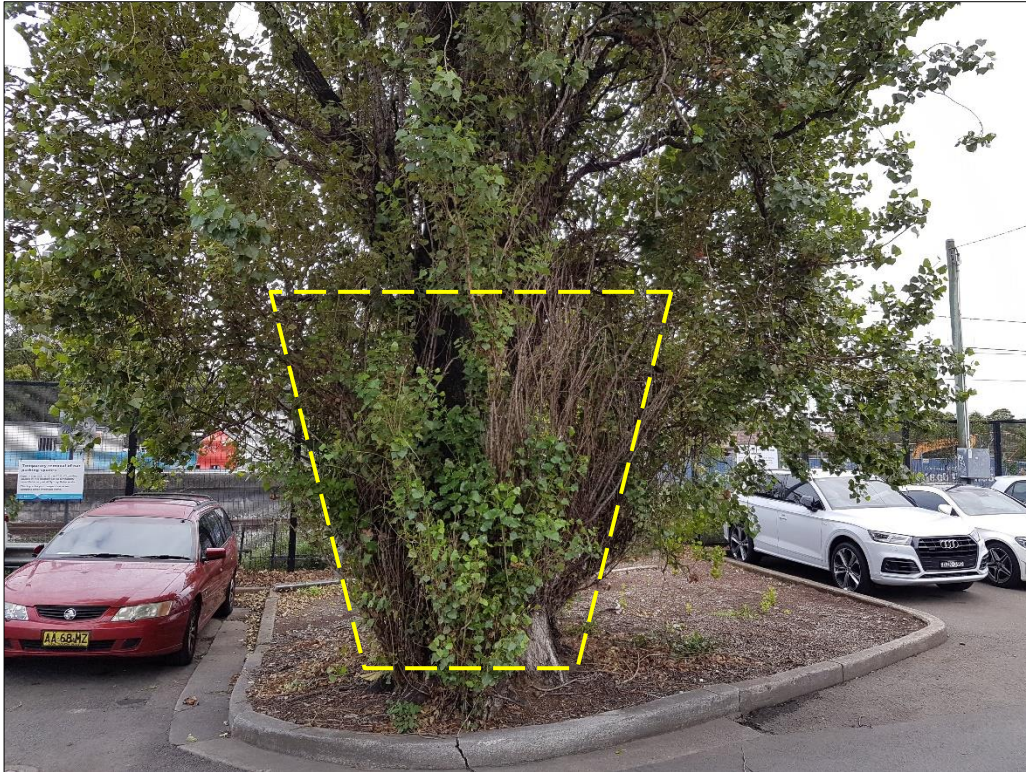
Photograph 3: Multiple epicormic shoots originating from the base of the trunk are to be removed.

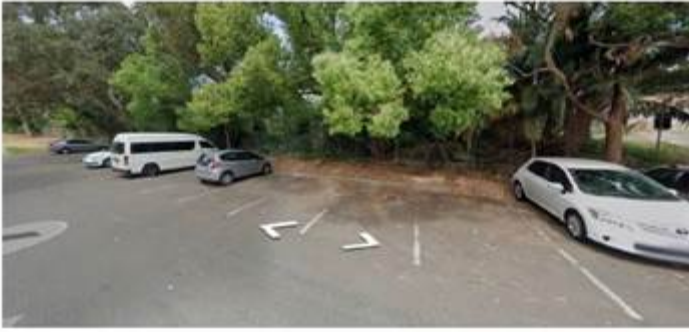
Figure 1: Street view of the subject trees taken from Urunga Parade, Punchbowl (neorap 2021).

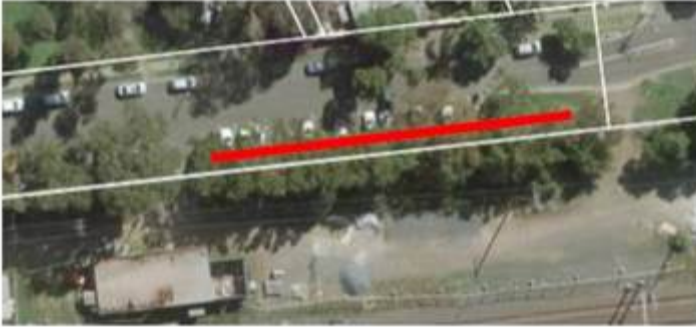
Figure 2: Location of the subject trees shown in red (neorap 2021).
