# Tree Impact Assessment Report

## City and Southwest Metro Station Upgrade Works Package 5 & 6

**P5 Document No. SMCSWSW5-DEW-WEC-EM-REP-000542**

**P6 Document No. SMCSWSW6-DEW-WEC-EM-REP-000632**

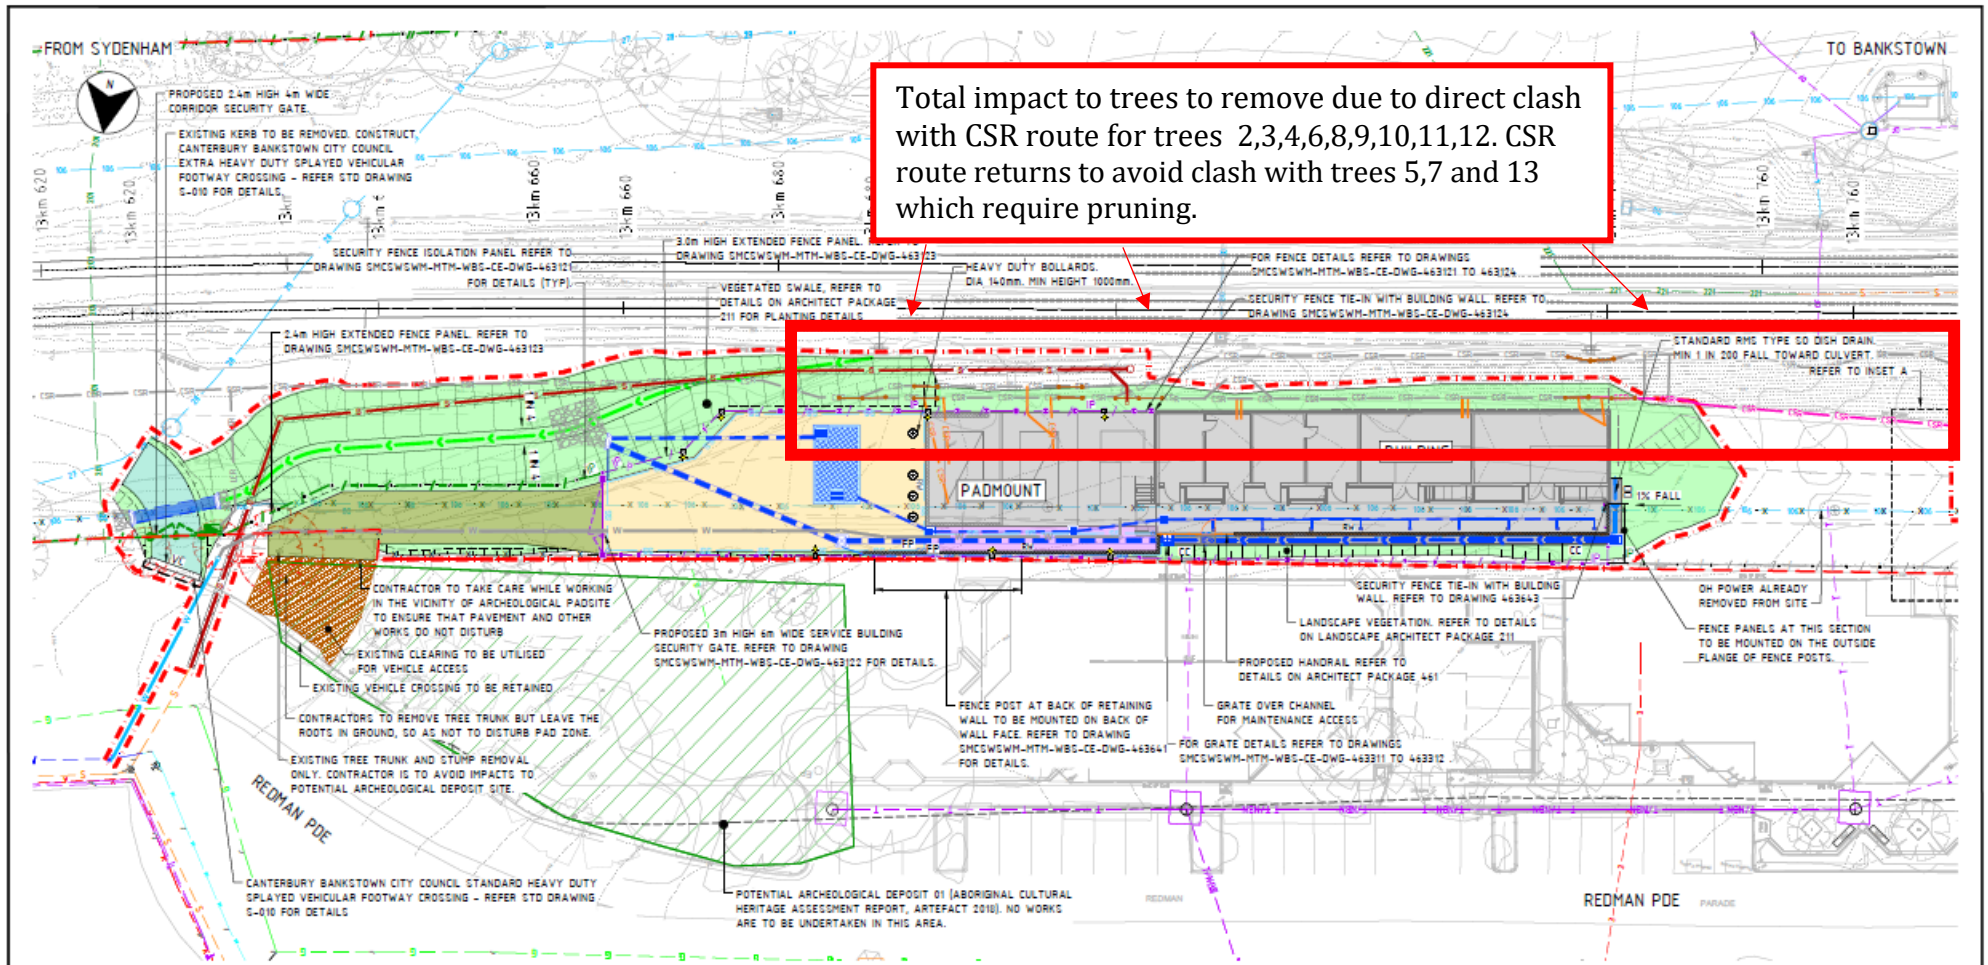
DRG NO. SMCSWSM/MTM/WBS-AT-DWG-211120

Total impact to trees to remove due to direct clash with CSR route for trees 2,3,4,6,8,9,10,11,12. CSR route returns to avoid clash with trees 5,7 and 13 which require pruning.

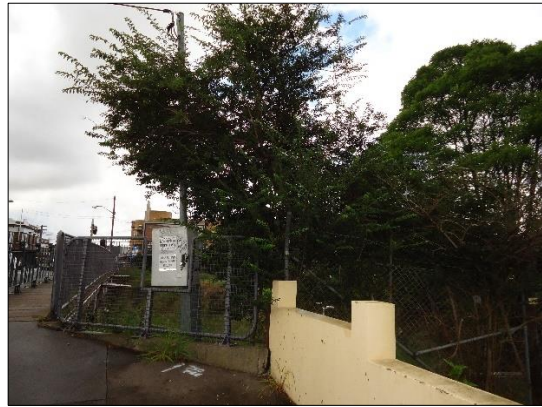
Tree 1 *Ligustrum sinensis* (Small-leafed Privet) is an identified species under the *Biosecurity Act 2015*. A general biosecurity duty exists within NSW to prevent, eliminate or minimise any biosecurity risk. The trees are not representative of a threatened or endangered species or ecological community.

**Photograph 1:** Tree 1 *Ligustrum sinensis* (Small-leaved Privet) to be removed for pilling works adjacent rail bridge.

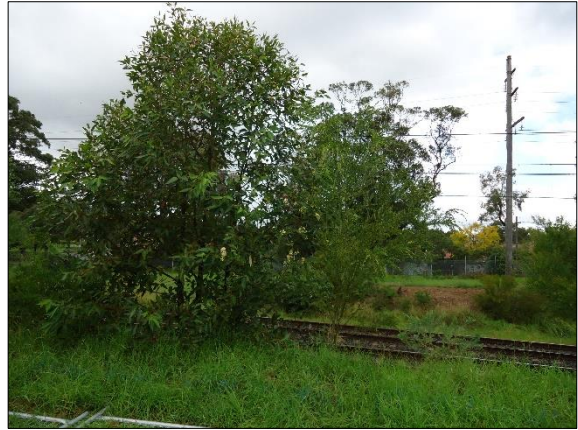
**Photograph 5:** Tree 7 *Eucalyptus robusta* (Swamp Mahogany) to be removed to accommodate the new GST alignment.

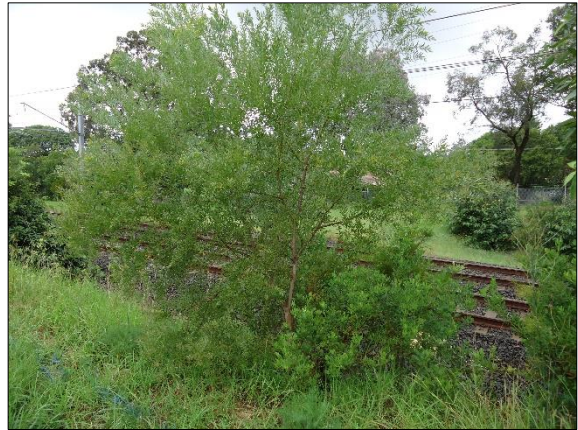
**Photograph 6:** Tree 8 *Acacia* sp (Wattle) to be removed for MSB works.

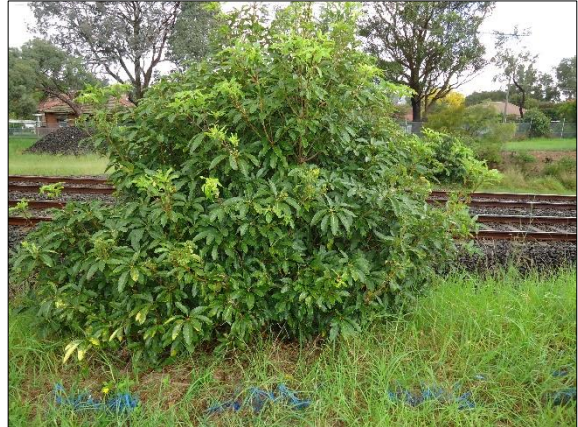
**Photograph 7:** Tree 9 *Pittorporum undulatum* (Sweet Pittosporum) to be removed for MSB works.

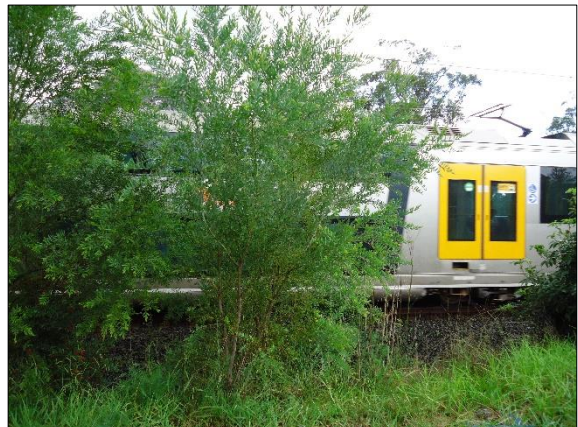
**Photograph 8:** Tree 10 *Acacia* sp (Wattle) to be removed for MSB works.

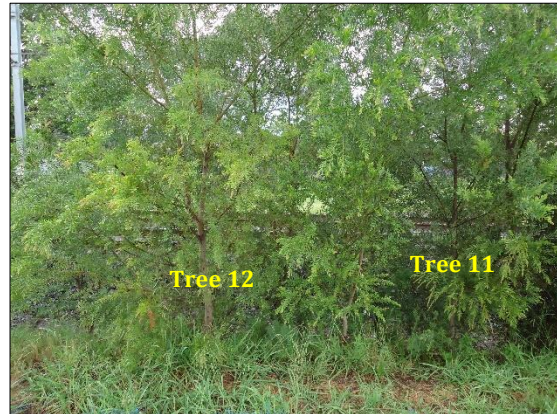
**Photograph 9:** Trees 11 and 12 *Acacia* sp (Wattle) to be removed for MSB works.

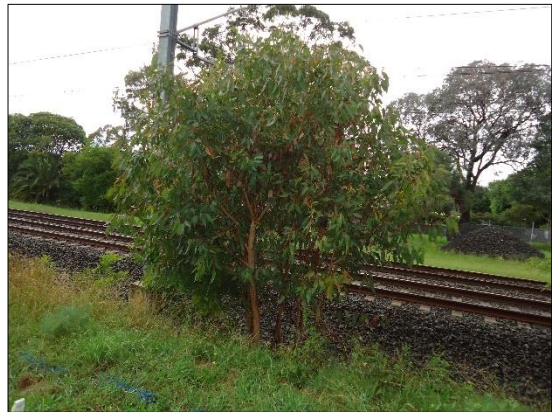
**Photograph 10:** Tree 13 *Eucalyptus robusta* (Swamp Mahogany) to be removed to accommodate the new sewer alignment.

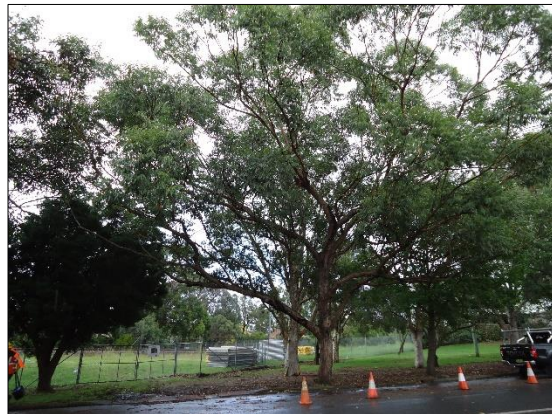
**Photograph 11:** Tree 14 *Eucalyptus robusta* (Swamp Mahogany) located within road reserve to be selectively pruned for site access clearances.

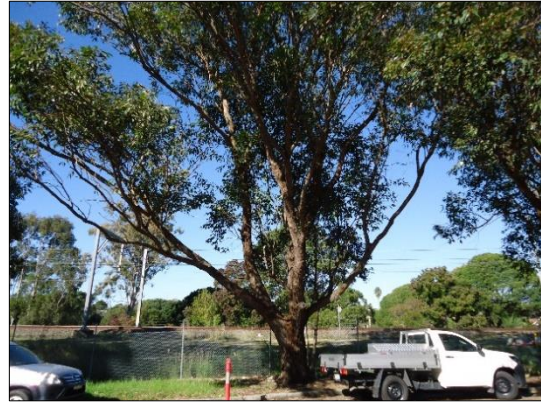
It was advised by Downer Group that two trees being a Swamp Mahogany, tree 1, and a Brown Pine, tree 2, are to be removed. Both trees were considered to be in good health and have medium useful life expectancies of 15 to 40 years. These trees are located within the road reserve area adjacent to the rail corridor and form part of the existing streetscape. Their removal, in particular the Swamp Mahogany is likely to be visually significant. The Swamp Mahogany and Brown Pine are not representative of an endangered or threatened species or ecological community. Photographs 1 and 2 show these trees.

**Photograph 1:** Tree 1 *Eucalyptus robusta* (Swamp Mahogany) to be removed due to direct clash with permanent design access road to MSB.

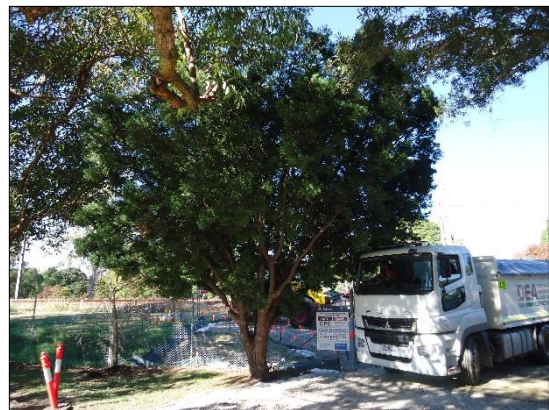
**Photograph 2:** Tree 2 *Podocarpus elatus* (Brown Pine) to be removed due to direct clash with permanent design access road to MSB.

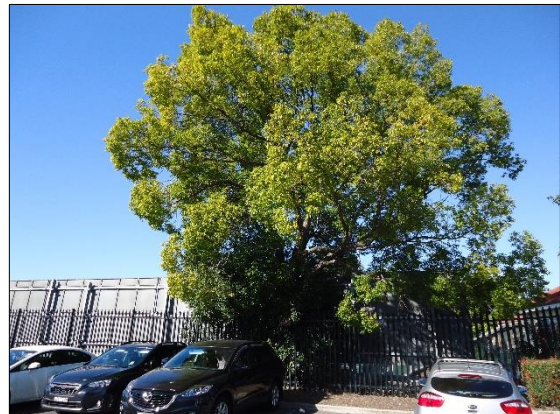
The new GST is aligned past tree 3, Camphor Laurel and shall require the removal of the suckers and epicormics from around the base of its trunk. Any excavation within 6m of the trunk (refer to **Appendix 1** Tree Assessment Schedule for TPZ offset) to install the troughing posts is to be undertaken using methods that do not damage tree roots. There is to be enough flexibility in the GST's design and alignment to reposition posts if roots greater than 30mm in diameter are exposed within the excavations. Although commonly regarded as a weed species this specimen is protected under local tree preservation controls due to its height. Photographs 3 and 4 show the tree and suckering around the base of the trunk to be removed.

**Photograph 3:** Tree 3 *Cinnamomum camphora* (Camphor Laurel) within northern side of rail corridor.

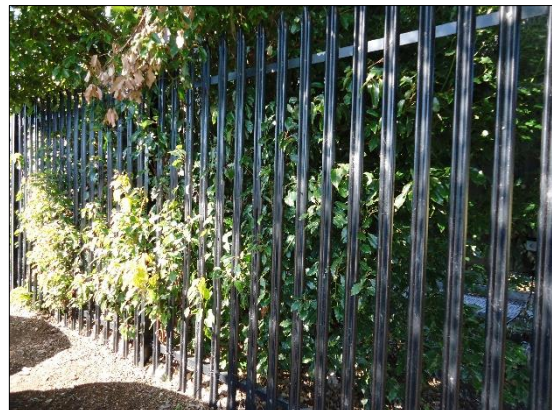
**Photograph 4:** Suckering around the base of tree 3 is to be removed to allow for the proposed alignment of the new GST.

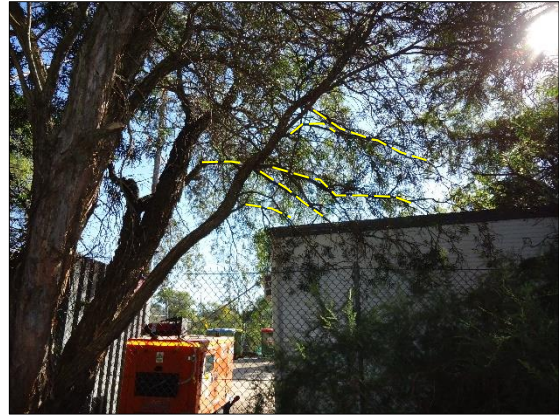
**Photograph 5:** Tree 4 *Callistemon slaignus* (Weeping Bottlebrush) to be selectively pruned to clear site sheds.

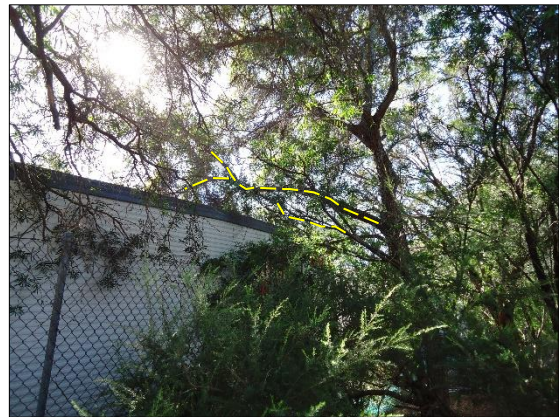
**Photograph 6:** Tree 5 *Leptospermum petersonii* (Lemon-scented Tee Tree) to be selectively pruned to clear site sheds.

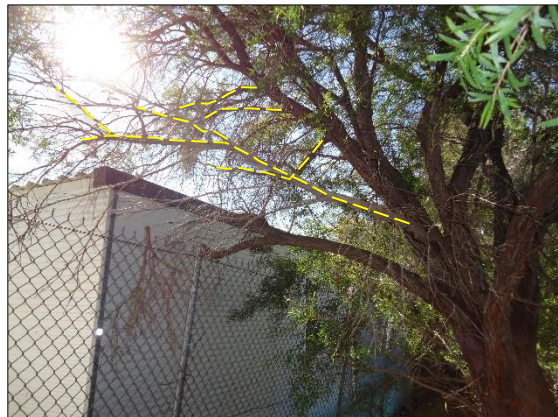
**Photograph 7:** Tree 6 *Leptospermum petersonii* (Lemon-scented Tee Tree) to be selectively pruned to clear site sheds.

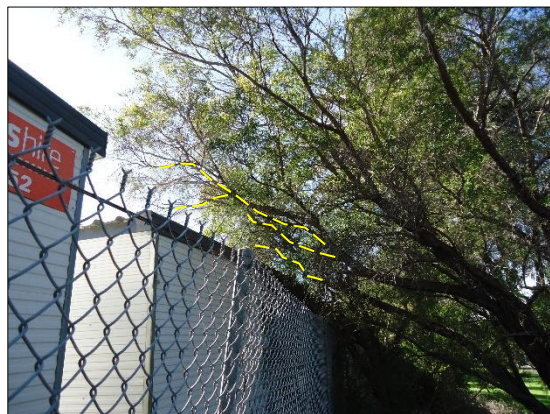
**Photograph 8:** Tree 7 *Leptospermum petersonii* (Lemon-scented Tee Tree) to be selectively pruned to clear site sheds. Additional pruning shall be required to provide clearances to new over head cabling.

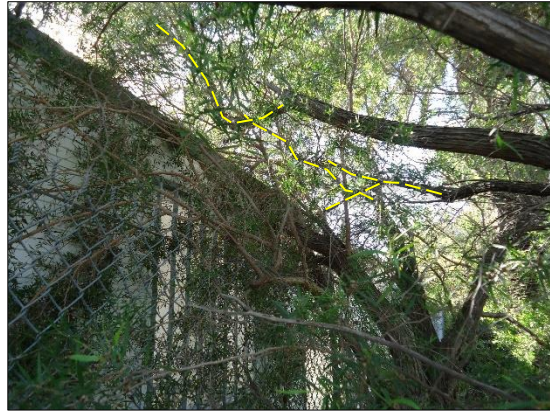
**Photograph 9:** Tree 8 *Leptospermum petersonii* (Lemon-scented Tee Tree) to be selectively pruned to clear site sheds.

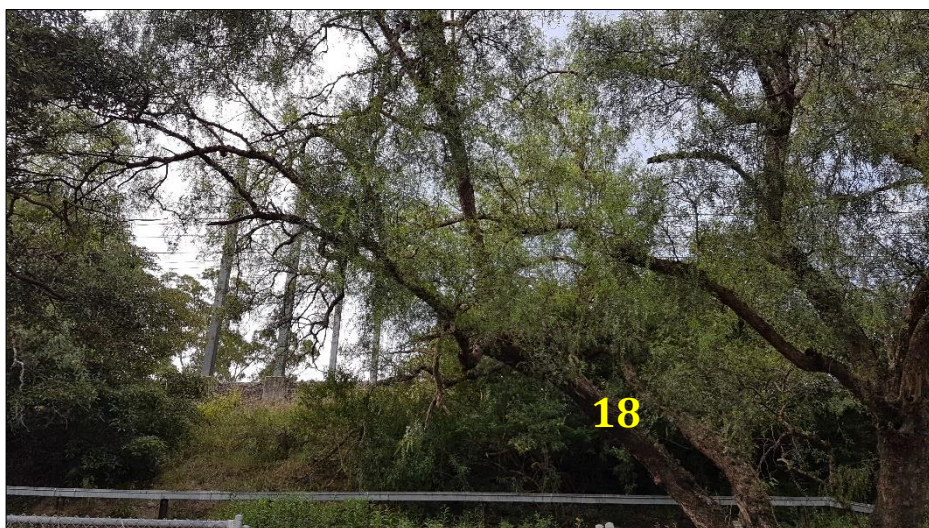
**Photograph 8:** Tree 17 *Schinus molle* (Peppercorn Tree) to be removed.

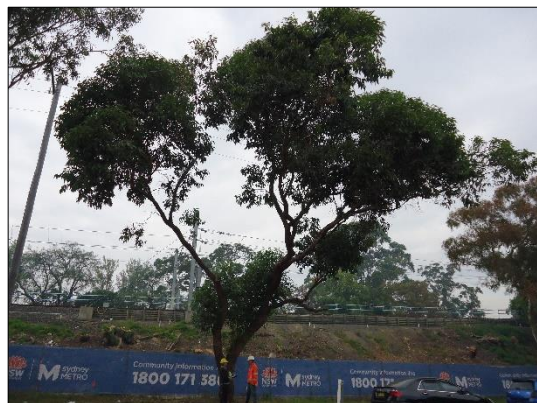
**Photograph 3:** Tree 3 *Eucalyptus robusta* (Swamp Mahogany) identified for removal to accommodate ULX and permanent fencing.

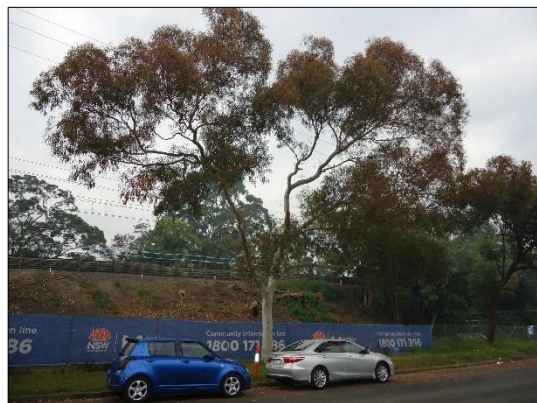
The Wallangarra White Gum (tree 4) is listed as Endangered under the Biodiversity Conservation Act 2016 and Vulnerable under the Environmental Protection Biodiversity Conservation Act 1999. However, the subject specimen is located outside of its naturally occurring range and appears to have been planted as part of the streetscape.

**Photograph 4:** Tree 4 *Eucalyptus scoparia* (Wallangarra White Gum) identified for removal to accommodate ULX and permanent fencing.

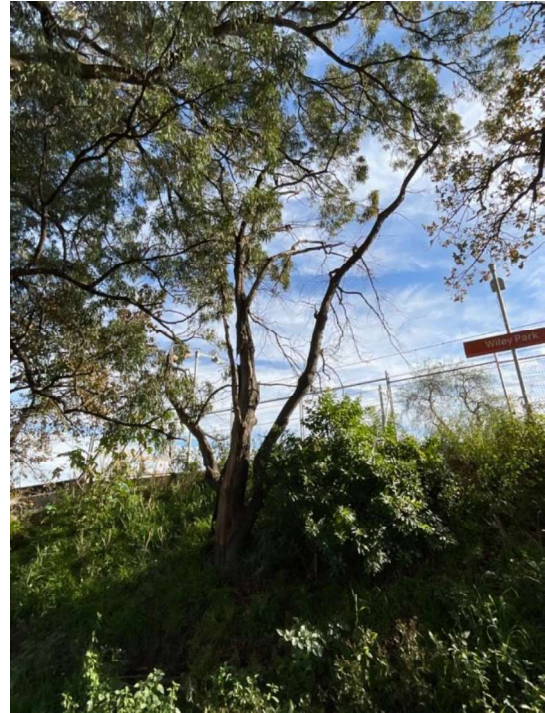
Figure 7. Tree 2 (Dead). (ArborScan, 2022)

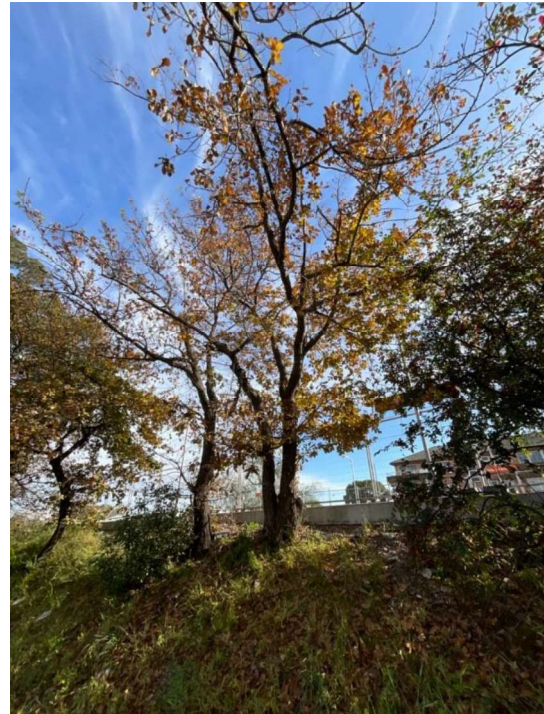
Figure 11. Tree 6. (ArborScan, 2022)

- 5.1.1 Twelve (12) trees have been recommended for removal based on the supplied design proposal. Includes trees 1-10, 13 & 16.
- 5.1.2 Trees recommended for removal were typically located within the alignment of the proposed security fence installation.

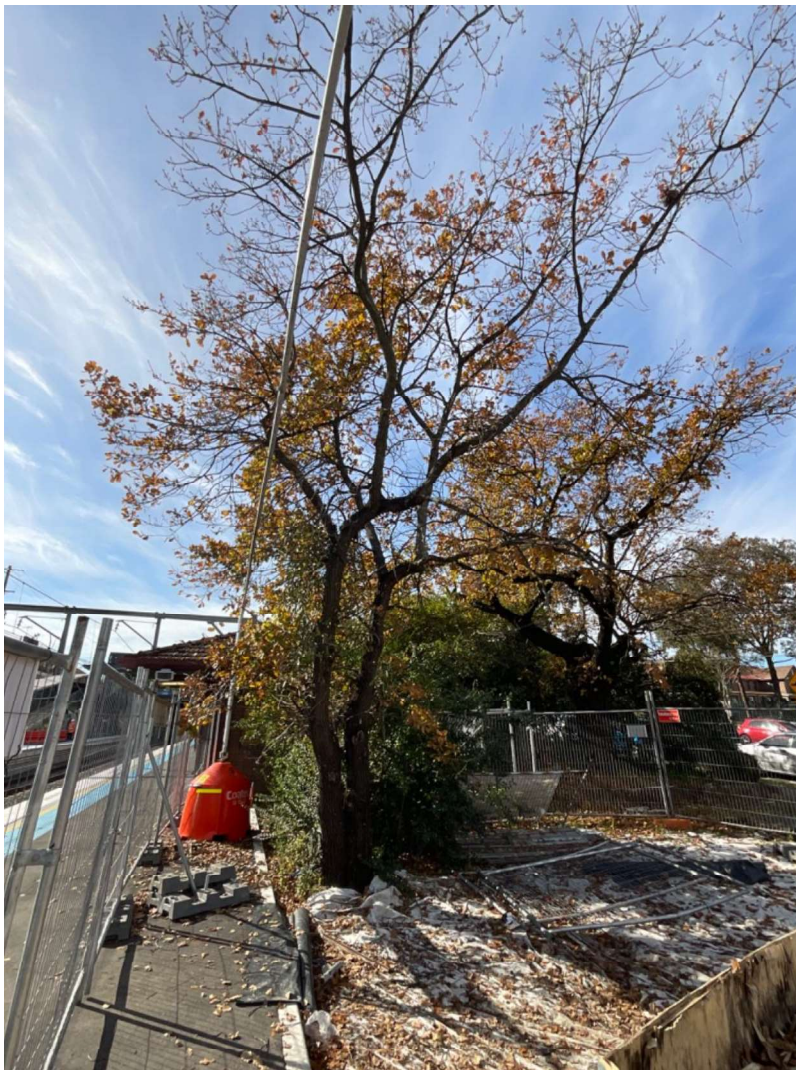
Figure 16. Tree 11. (ArborScan, 2022)

- 5.2.1 Seven (7) trees were recommended for retention and require specific and/or generic protection measures during construction to ensure that they remain viable following the completion of works. Includes trees 11, 12, 14, 15, 17, 18 & 19.

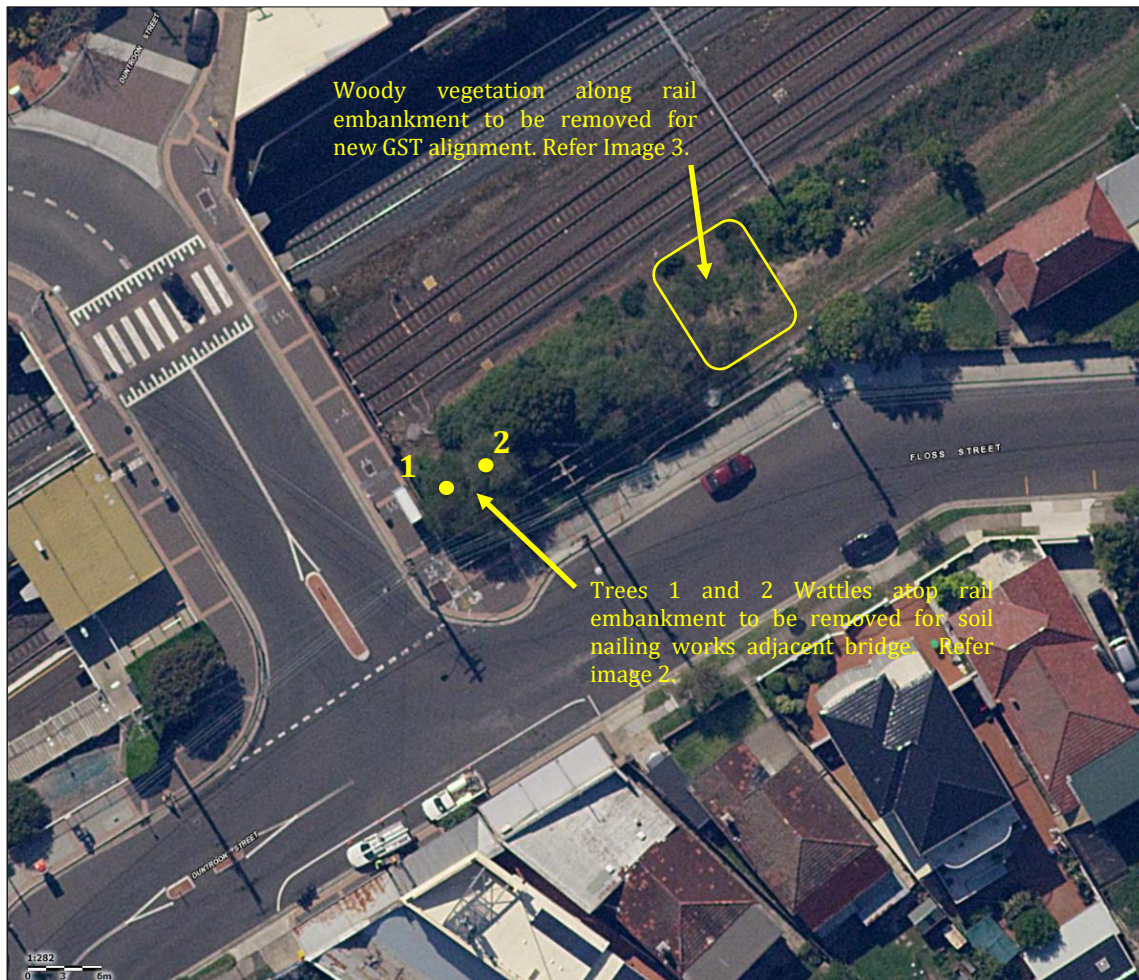
Additional tree and vegetation removal adjacent Floss Street involves two Wattles, trees 1 and 2, located adjacent the bridge and woody vegetation along the rail embankment. Image 1 shows their location.

**Image 1:** Aerial image of Hurlstone Park Station adjacent Floss Street showing additional tree and vegetation removal. (Source Six Maps accessed 10/03/2021).

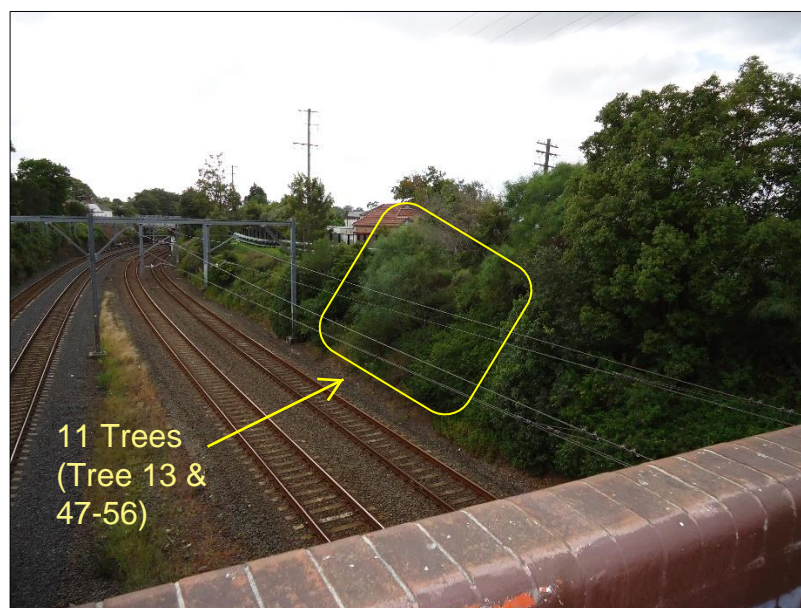
Woody vegetation located along the rail embankment was identified for removal to align the new GST. No access was gained to the rail corridor to assess the vegetation, but it has been confirmed in consultation with the project Ecologist to consist of; one *Pittosporum undulatum* (Sweet Pittosporum) tree 13, seven *Acacia saligna* (Golden Wreath Wattle) trees 47 to 53, one *Grevillea* sp (Grevillea), tree 54 and two *Yucca* sp (Yucca) trees 55 and 56. The vegetation is considered to have a short useful life expectancy and low landscape significance given its location within the rail corridor. Image 3 shows the approximate area to be cleared.

**Image 3:** Approximate area of woody vegetation along the rail embankment to be cleared to align the new GST.

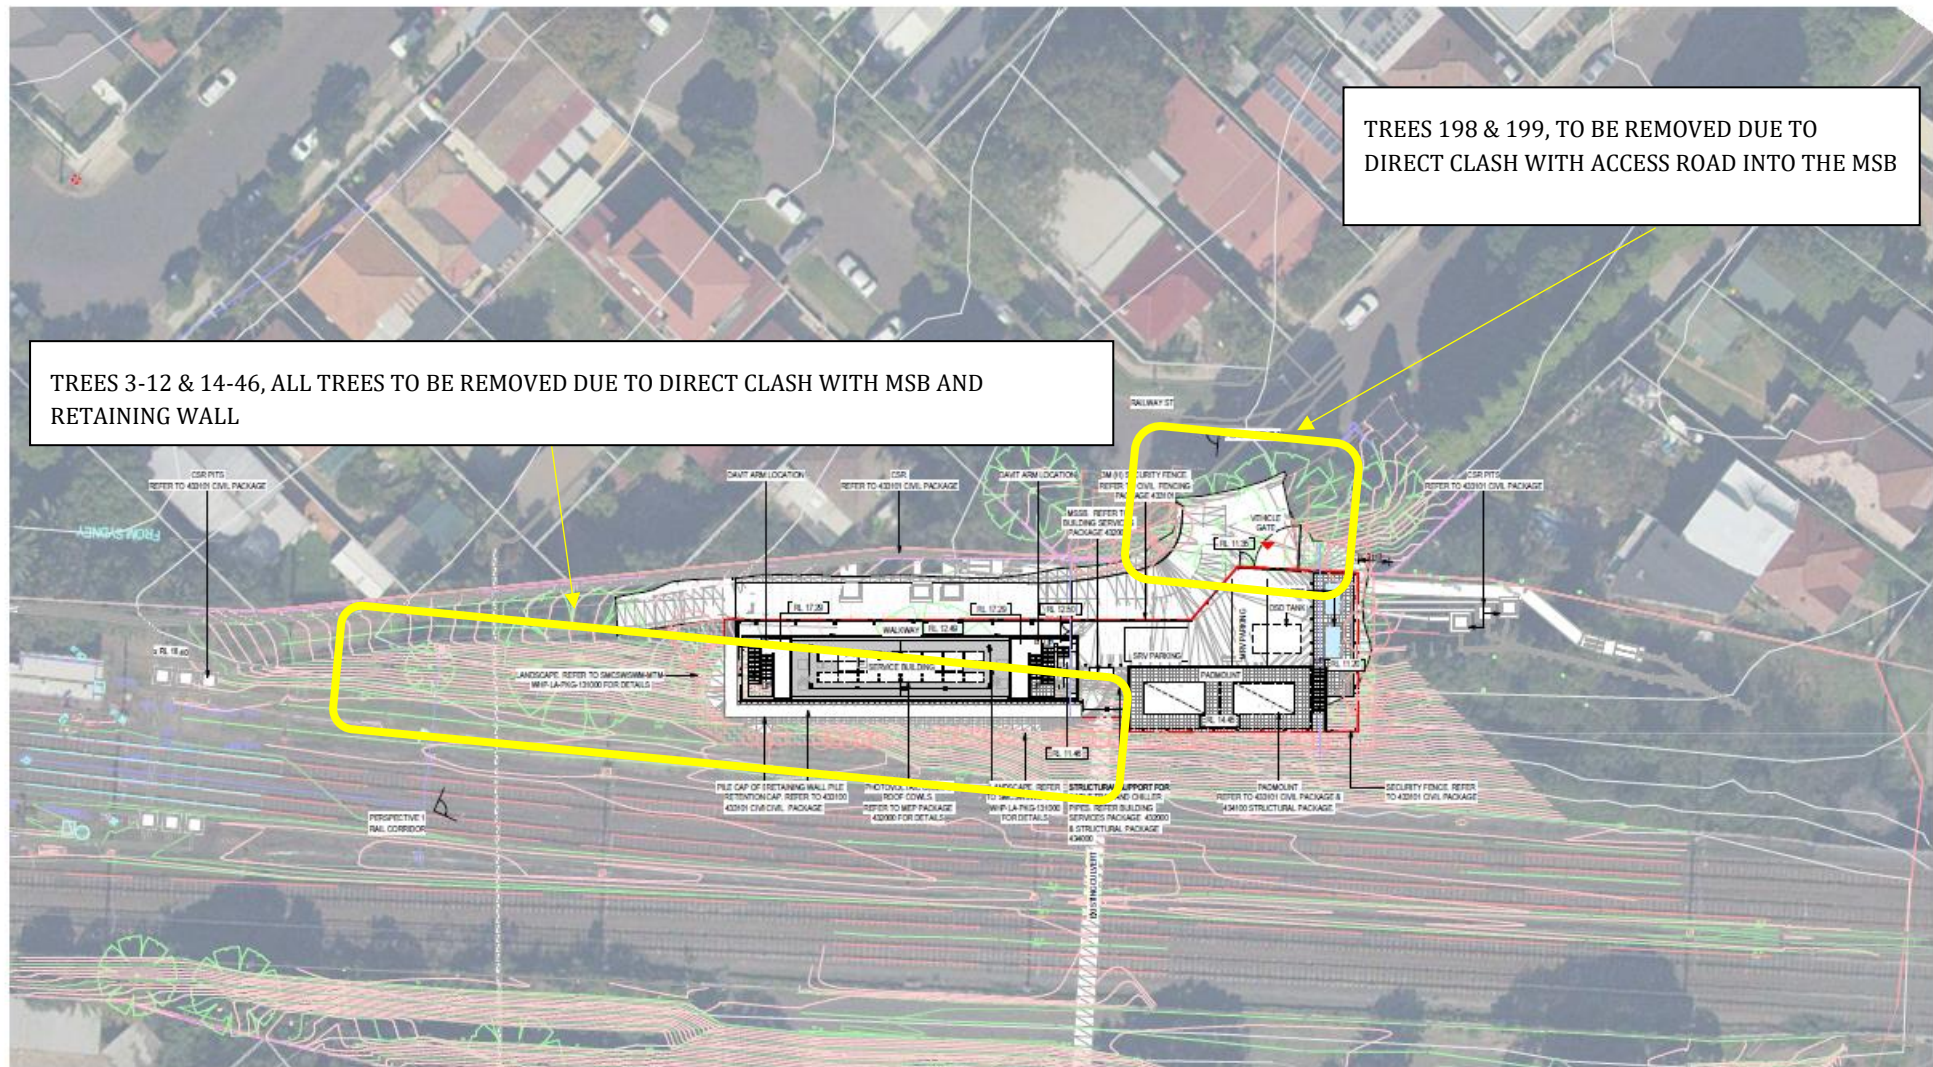
TREES 198 & 199, TO BE REMOVED DUE TO  
DIRECT CLASH WITH ACCESS ROAD INTO THE MSB

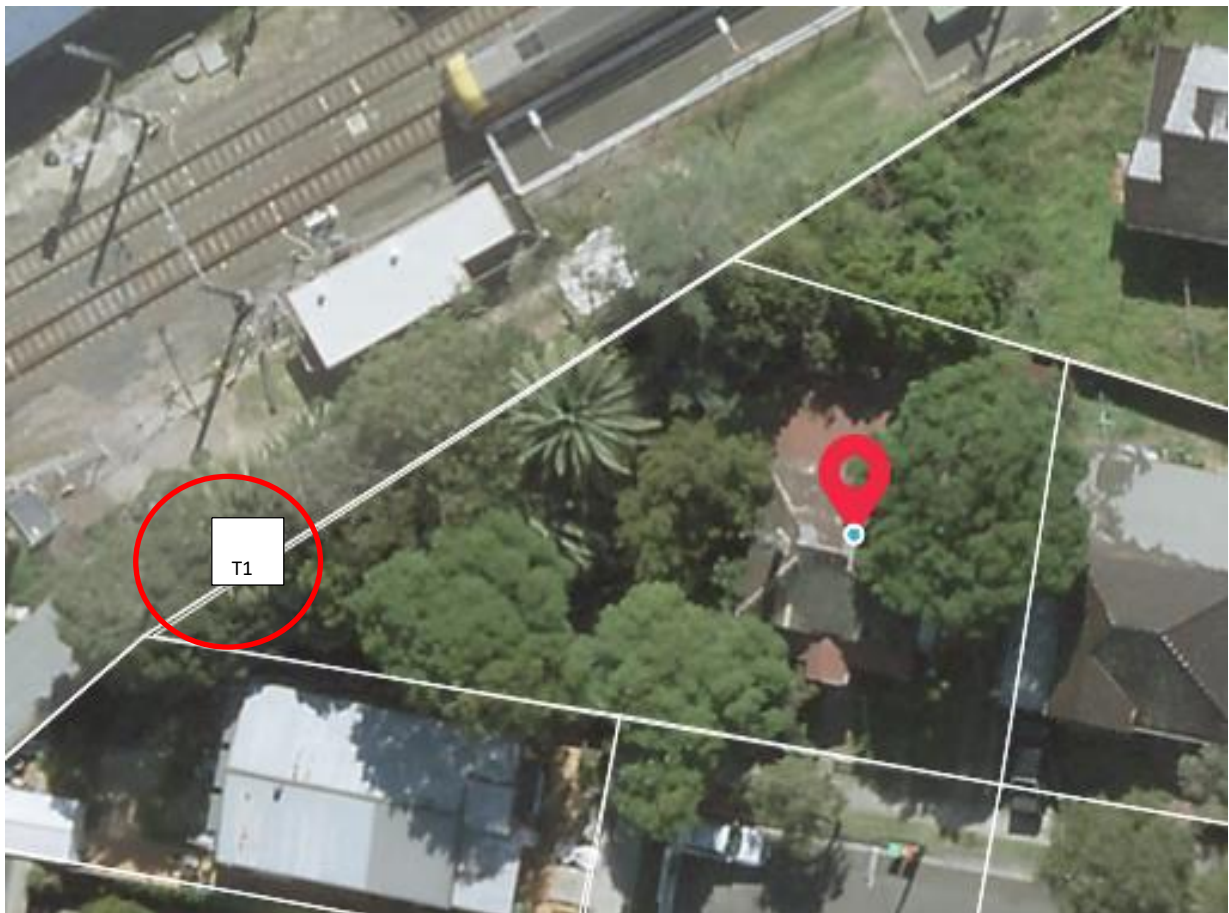
Figure 1

- 2.1 The subject tree are located in the rear yard of 7 Commons St, Hurlstone Park 2193. The tree can be seen in figure 1 below, numbered and outlined in red.

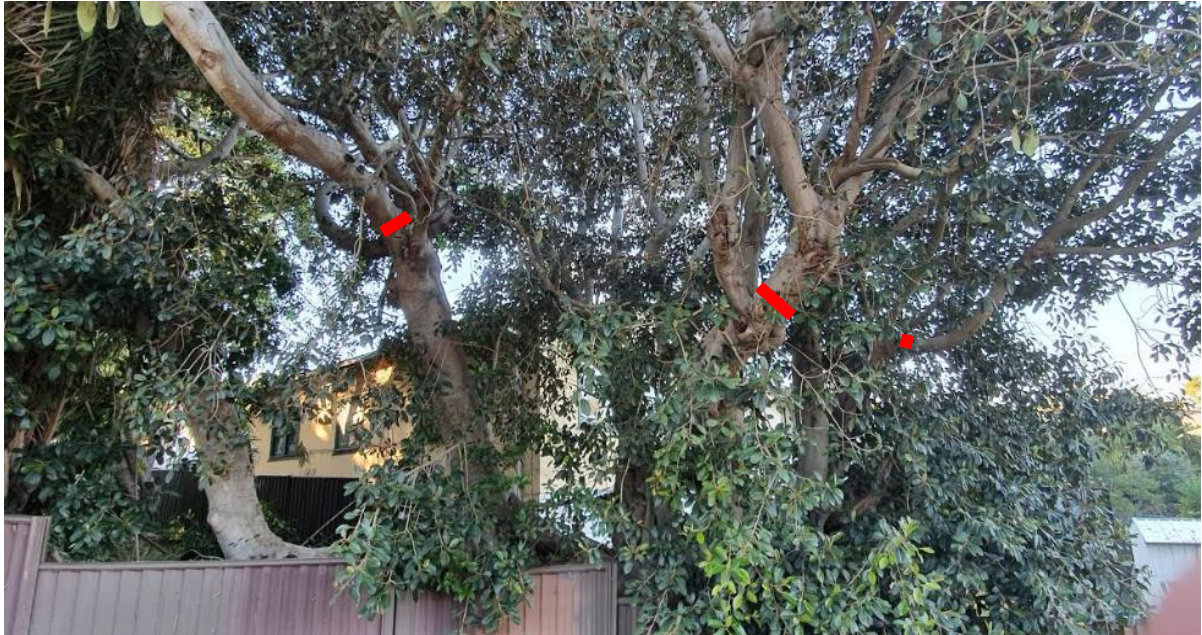
Branch No #	Branch / Stem Height (Mts)	Branch / Stem Diameter (mm)	Branch Order	Pruning Class	Canopy Percentage
1	3	80	2 <sup>nd</sup>	7.2.4, Selective	3%
2	3	250	2 <sup>nd</sup>	7.2.4, Selective	13%
3	3.6	180	2 <sup>nd</sup>	7.2.4, Selective	7%

**Figure 2:** Cut locations of limbs to be pruned marked in red.

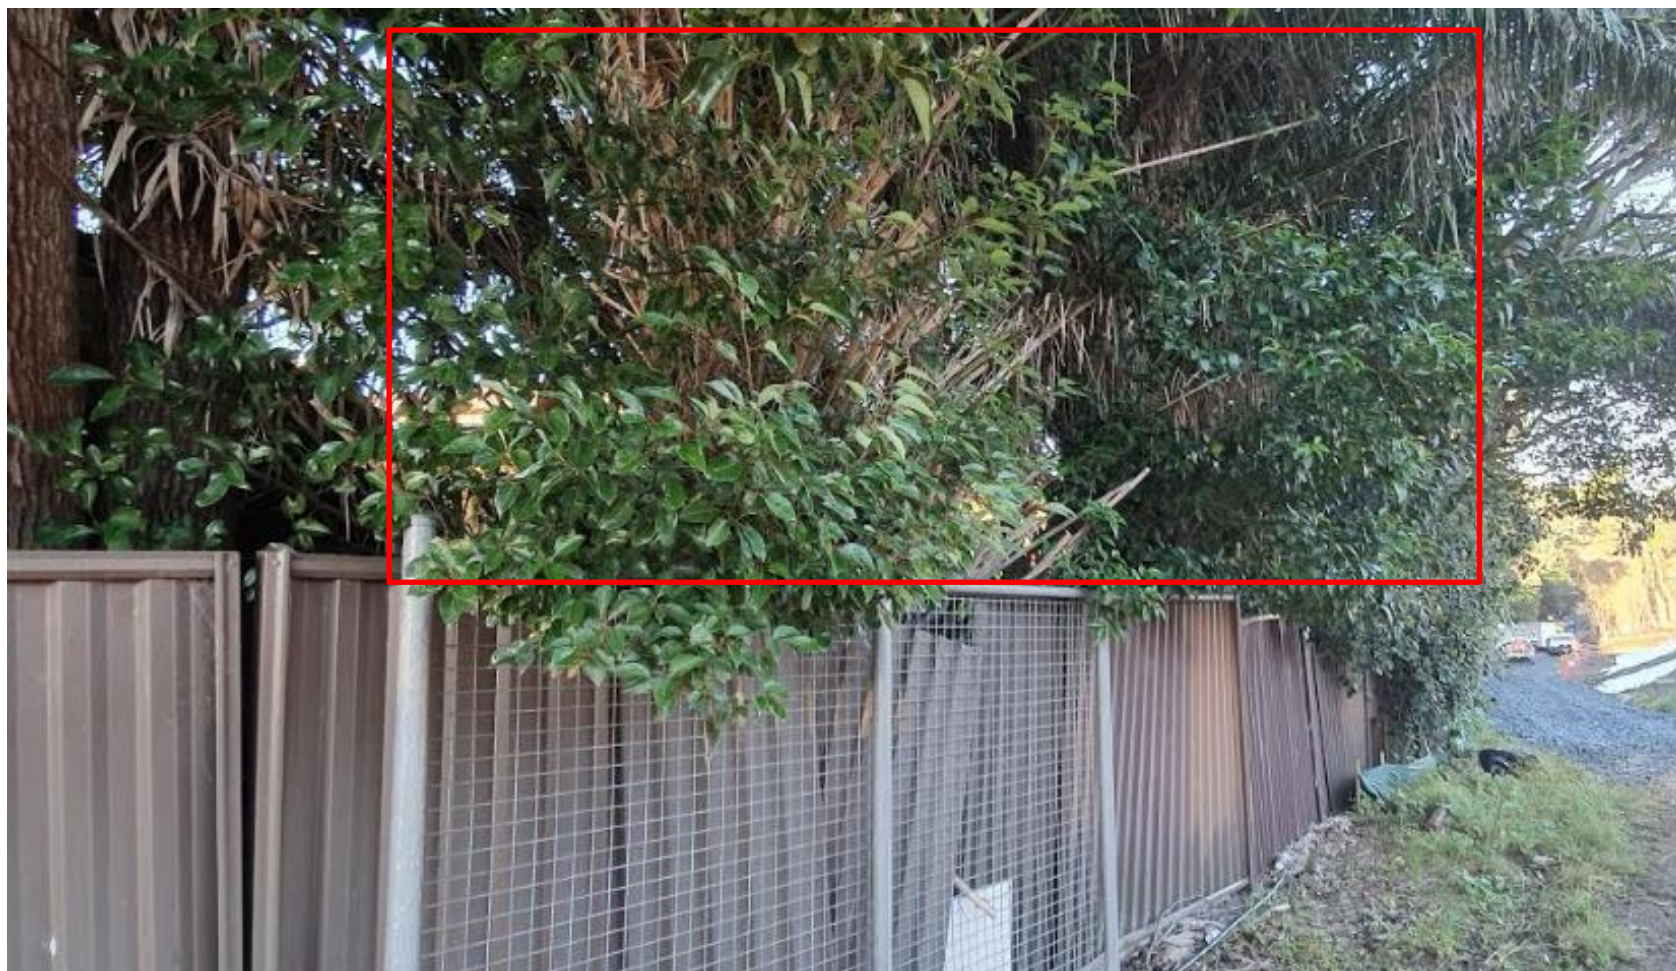
This area of foliage is minor regrowth from weed species and is requested to be pruned back to the fence line.

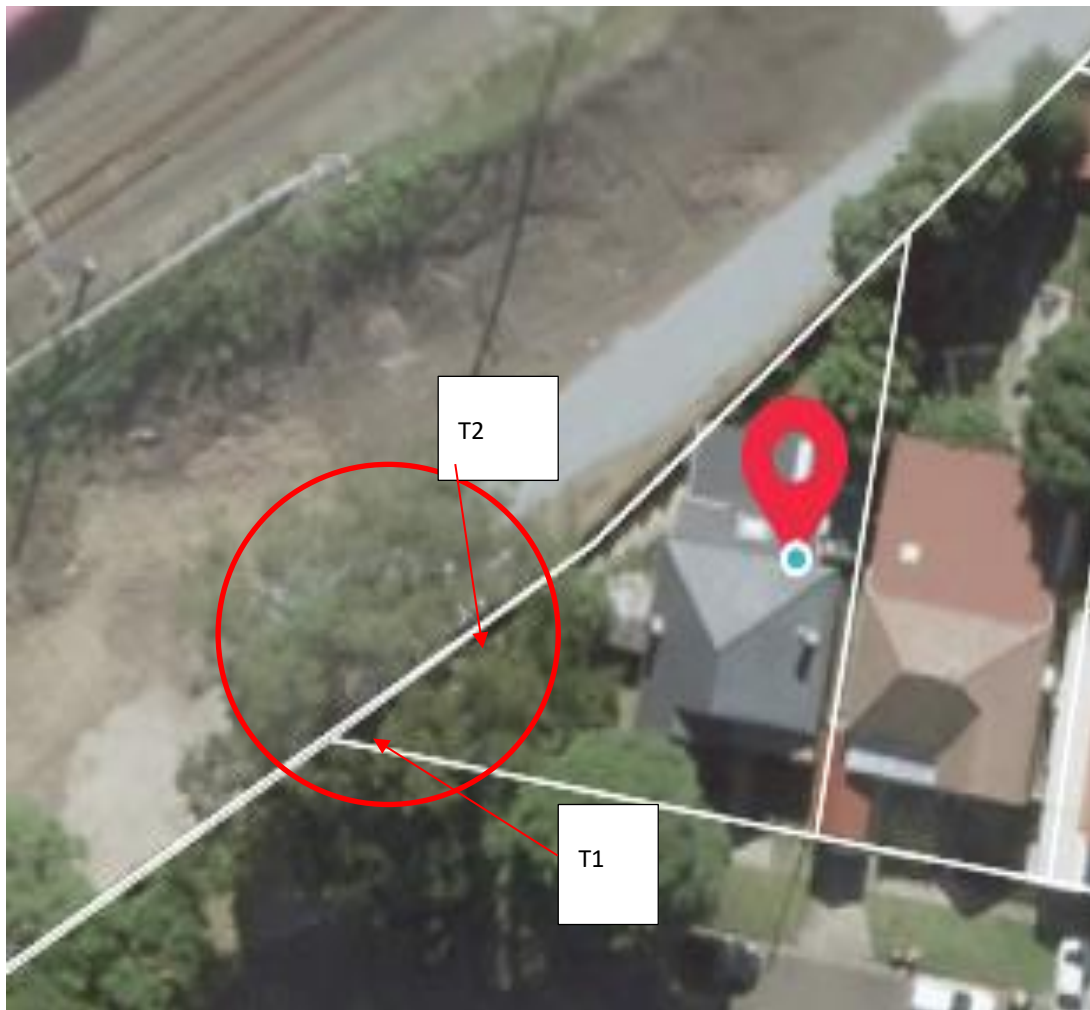
Figure 1

- 2.1 The subject trees are located in the rear yard of 5 Railway St, Hurlstone Park 2193. These trees can be seen in figure 1 below, numbered and outlined in red.

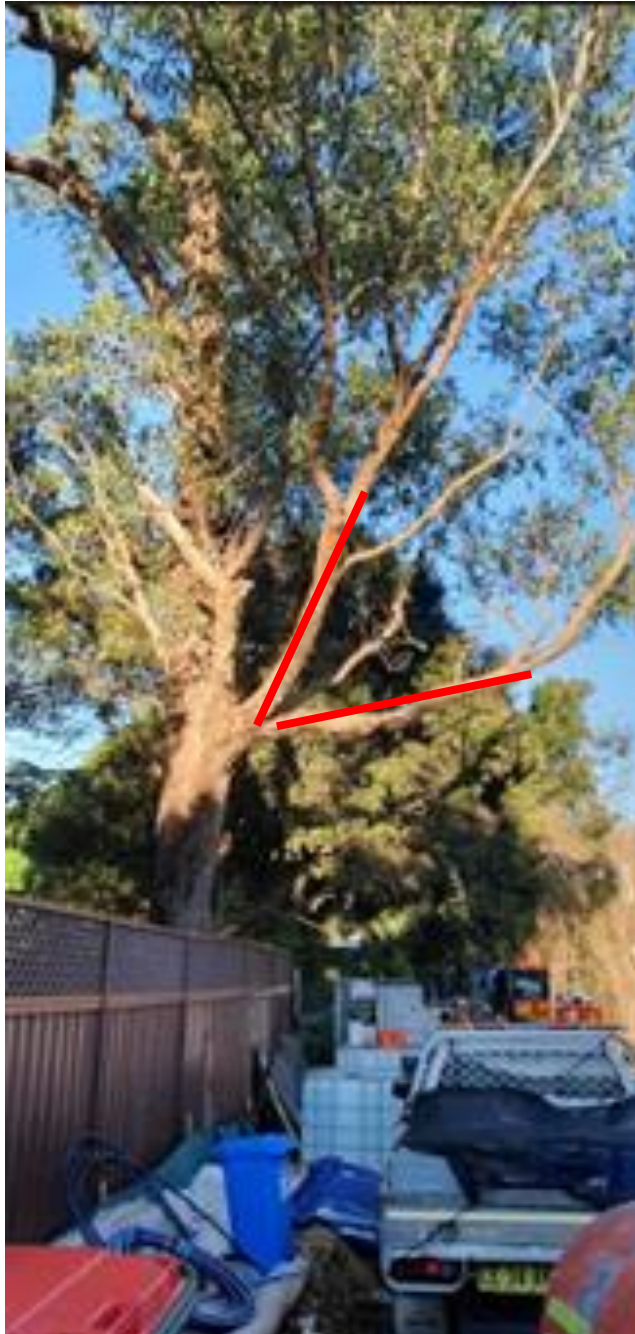
Branch No #	Branch / Stem Height	Branch / Stem Diameter	Branch Order	Pruning Class	Canopy Percentage
1	4.4m	180mm	2 <sup>nd</sup>	7.2.4, Selective	8%
2	4.5m	180mm	2 <sup>nd</sup>	7.2.4, Selective	9%

**Figure 3:** Limbs to be pruned marked in red.

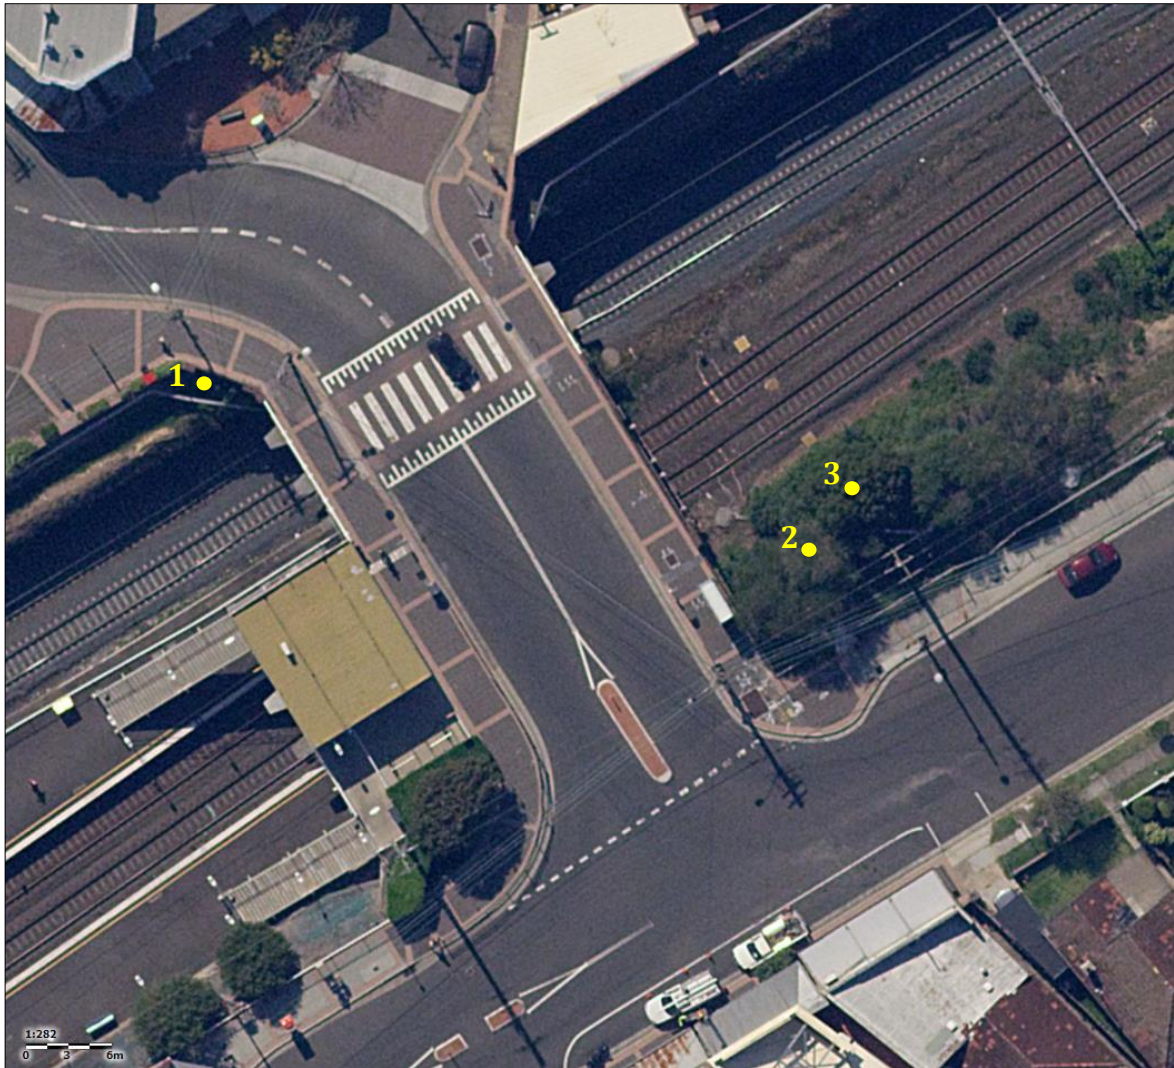
Tree 1 consists of a self-seeded multi-stemmed *Acer negundo* (Box Elder), refer Appendix 2 photograph 1. It has been assessed as having a short useful life expectancy and low landscape value. The wider Southwest Metro Package works require three 300mm diameter piles to be excavated at the location of the tree to

**Image 1:** Aerial image of Hurlstone Park Station showing the location of additional tree and vegetation removal. (Source Six Maps accessed 23/08/2021).

enable the construction of a materials throw screen. As such, the tree cannot be retained.

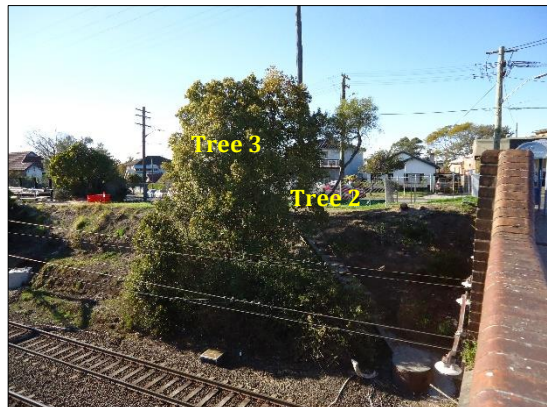
**Photograph 4:** Trees 2 and 3 as seen from the rail bridge.

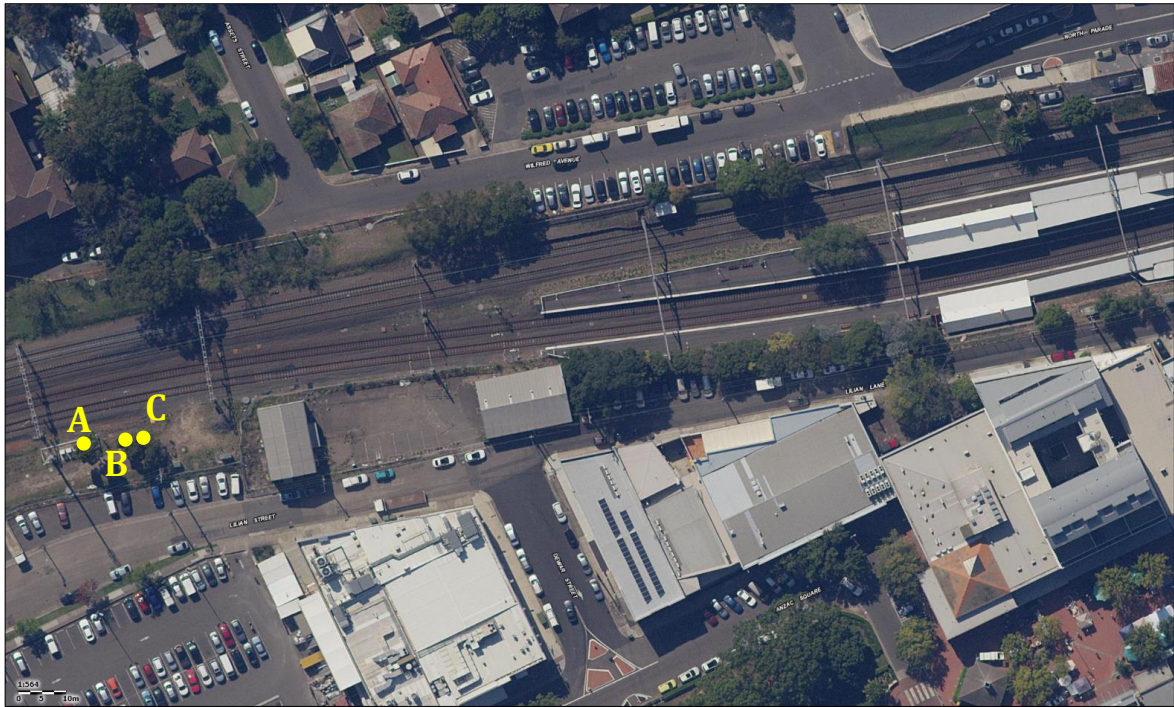
I can confirm that no tree removals were identified within the initial AIA report. Three additional trees located to the rear of the station adjacent the commuter car park off Lillian Street have been identified for removal based on direct design clash and 100% encroachment of TPZ and SRZ. Data for these trees can be found as Appendix 1 of this report. Image 1 shows the location of the additional tree removals.

Trees A, Tallowwood and B Brush Box were found to be in good health and condition. They are considered to have a medium useful life expectancy and landscape significance. Tree C Tallowwood was found to have normal vigour and fair condition. Deadwood and canopy dieback was observed within the tree indicating a possible decline in health and condition. As such the tree is considered to have a short useful life expectancy. Image 2 shows the subject trees. The trees provide some screening and relief from the rail corridor and associated infrastructure along Lillian Street.

**Image 1:** Aerial image showing location of additional tree removals.
