# Tree Impact Assessment Report

## City and Southwest Metro Station Upgrade Works Package 5 & 6

**P5 Document No. SMCSWSW5-DEW-WEC-EM-REP-000542**

**P6 Document No. SMCSWSW6-DEW-WEC-EM-REP-000632**

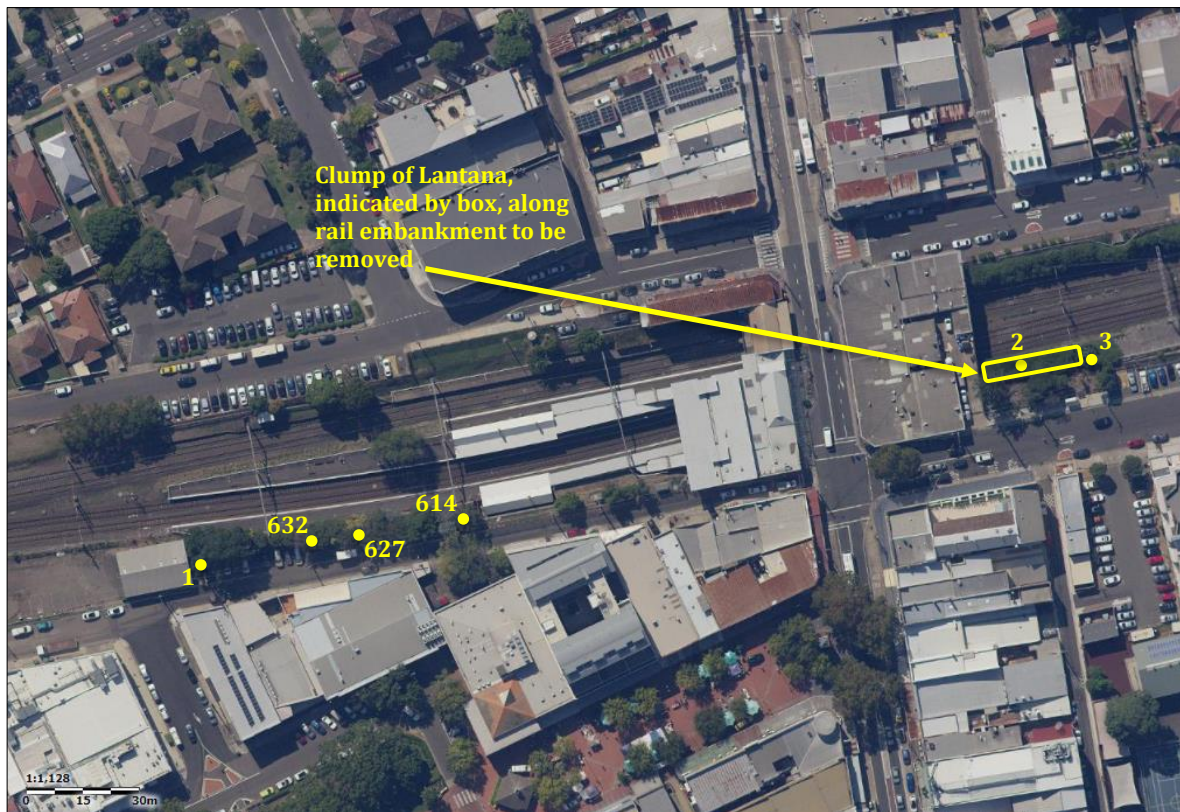
The proposed works involve the alignment of a new GST adjacent the southern side of the rail corridor. The western end of the GST transfers to an underground services alignment requiring a pit to be excavated. Tree 1 has been identified for

removal to accommodate the pit. The proposed GST is to be aligned within and follow the existing rail corridor fence. Trees 614 and 632 were identified for removal to accommodate the GST's alignment at and around the corners of the existing fence line. Selective pruning works to tree 627 were identified as being required to provide a workable area to install the GST. Three first order branches up to 25mm in diameter were identified for removal and constitute approximately 10-15% of the total canopy volume of the tree. The pruning is considered to be minor and is not expected to have a significant impact upon the health, condition or useful life expectancy of the tree. A reduction in short term growth and physiological function can be expected as a result of the pruning works. **Appendix 2** photographs 1 to 4 shows these trees.

**Image 1:** Aerial image of Campsie station showing the approximate locations of assessed trees. (Source: Six Maps accessed 21/06/2021).

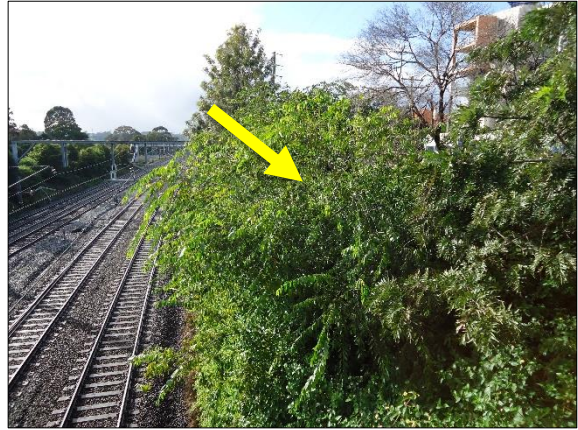
**Photograph 5:** Tree 6 *Celtis sinensis* (Hackberry) located within rail corridor. Tree to be removed to accommodate the new GST alignment. The surrounding Lantana along the rail embankment is also to be removed.

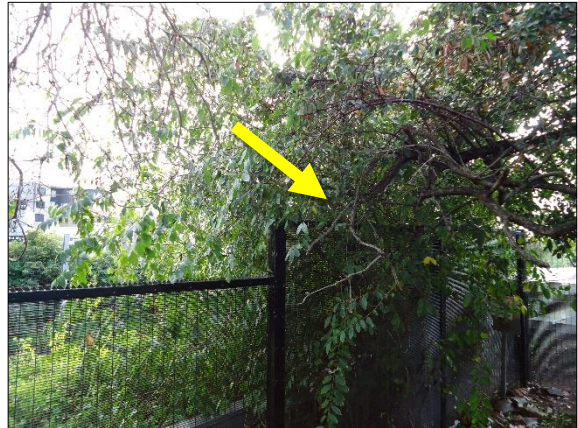
**Photograph 6:** Tree 7 *Celtis sinensis* (Hackberry) located within rail corridor. Tree to be removed to accommodate the new GST alignment.

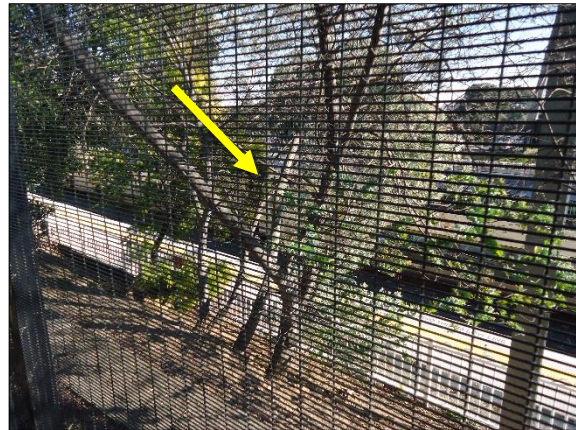
dead. Tree 615 was also found to be in a state of declining health and beyond reasonable attempts to remediate. The AIA report also identifies trees 615 and 620 as being exempt from local tree preservation controls. The additional trees to be removed are not representative of an endangered or threatened species or ecological community. Photographs of the assessed trees have been attached to the rear of this report as Appendix 2 Site Photographs.

**Photograph 5:** Tree 615 *Acacia podalyrifolia* (Queensland Silver Wattle) located adjacent Platform 2. The adjacent Queensland Silver Wattle's are near dead.

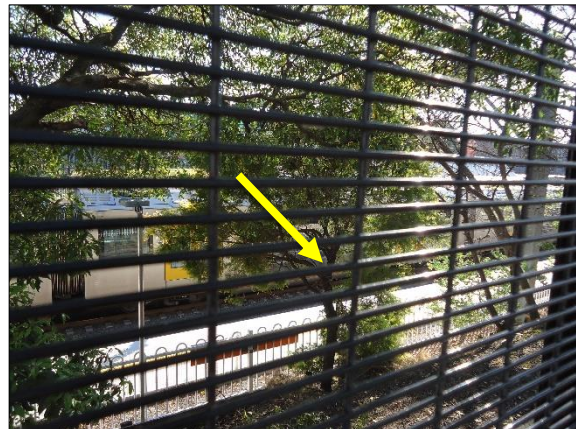
**Photograph 6:** Tree 5 *Melaleuca bracteata* (Black Teatree) located adjacent Platform 2.

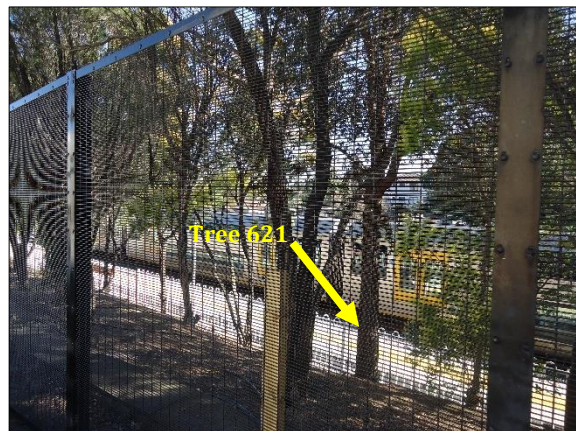
**Photograph 7:** Showing trees adjacent Platform 2. Tree 621 *Syncarpia glomulifera* (Turpentine) is shown for reference.

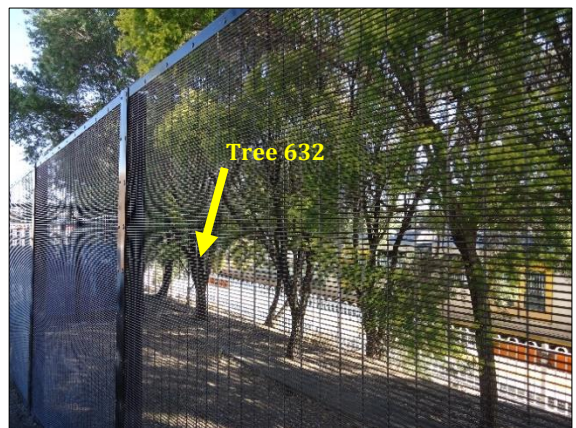
**Photograph 8:** Showing trees adjacent Platform 2. Tree 621 *Callistemon viminalis* (Weeping Bottlebrush) is shown for reference.

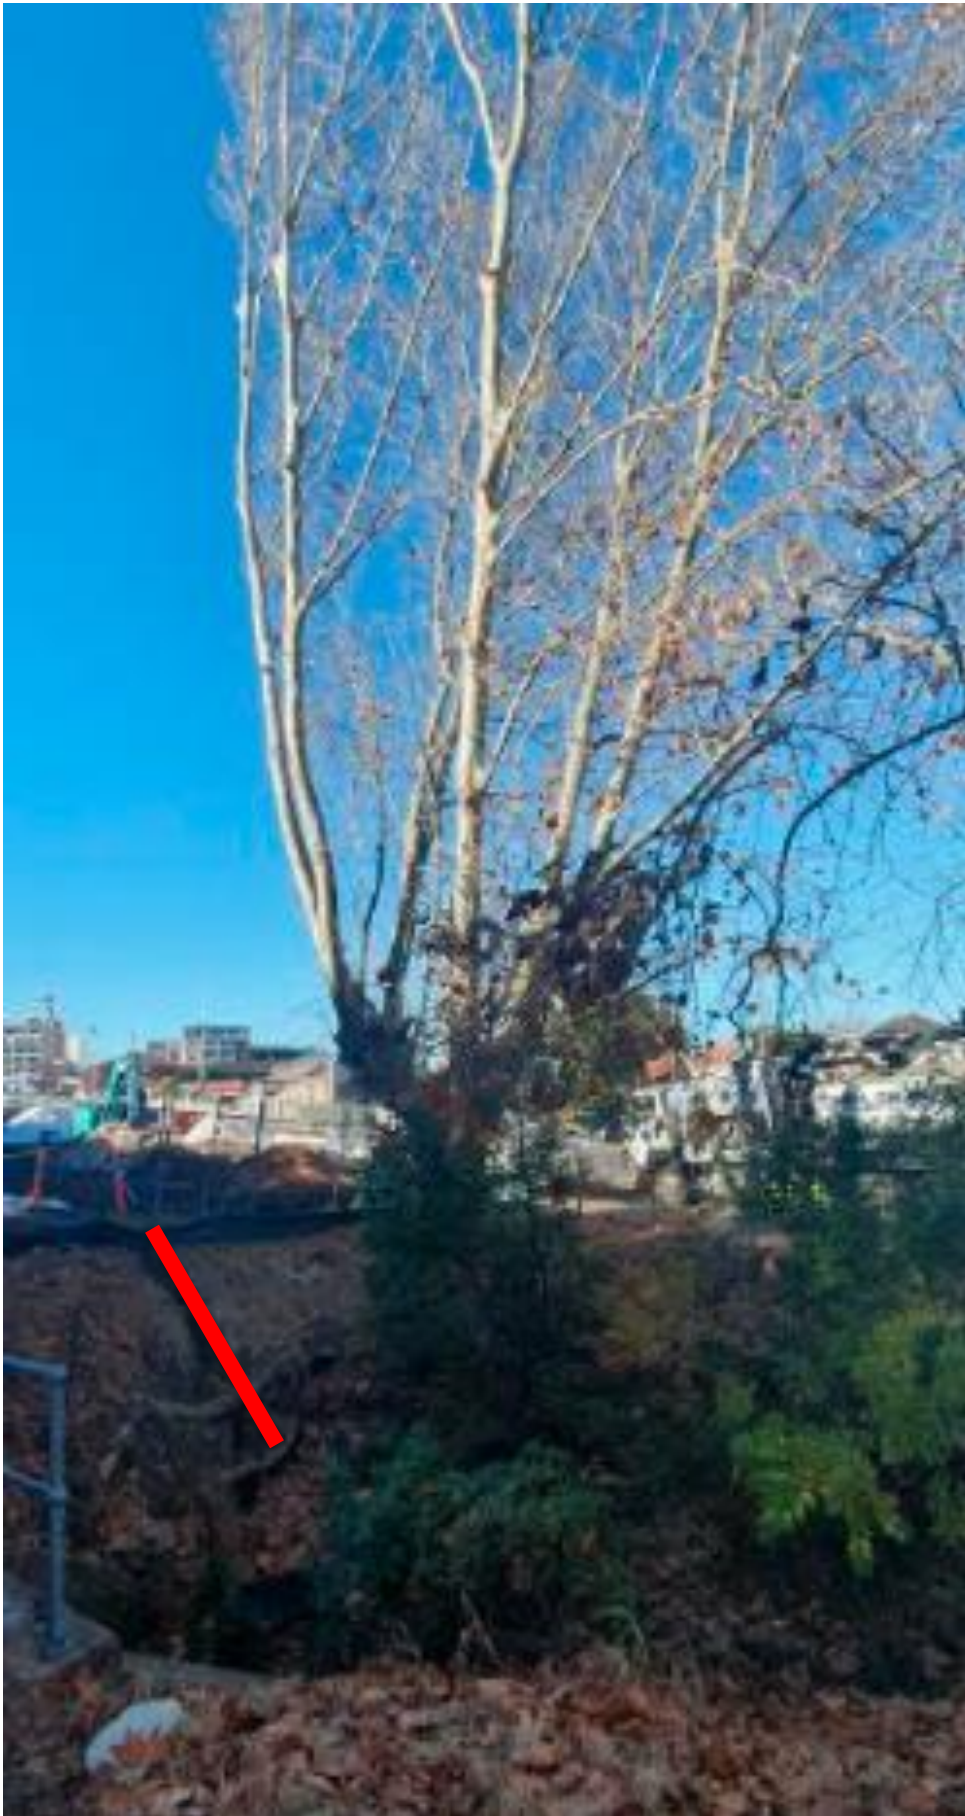
At the time of inspection, it was observed that multiple roots ranging between 100-400mm in diameter will require to be cut/pruned to allow for the proposed drainage infrastructure to be installed. No options for re direction of this service was apparent without huge design changes.

It was concluded that pruning of such root sizes (within the TPZ, bordering the SRZ) in all likelihood has the potential to result in decline/and or whole tree failure.

Image of the subject tree (Tree 94) taken on the 15<sup>th</sup> June 2021 (red line shows approximate location of required excavations).

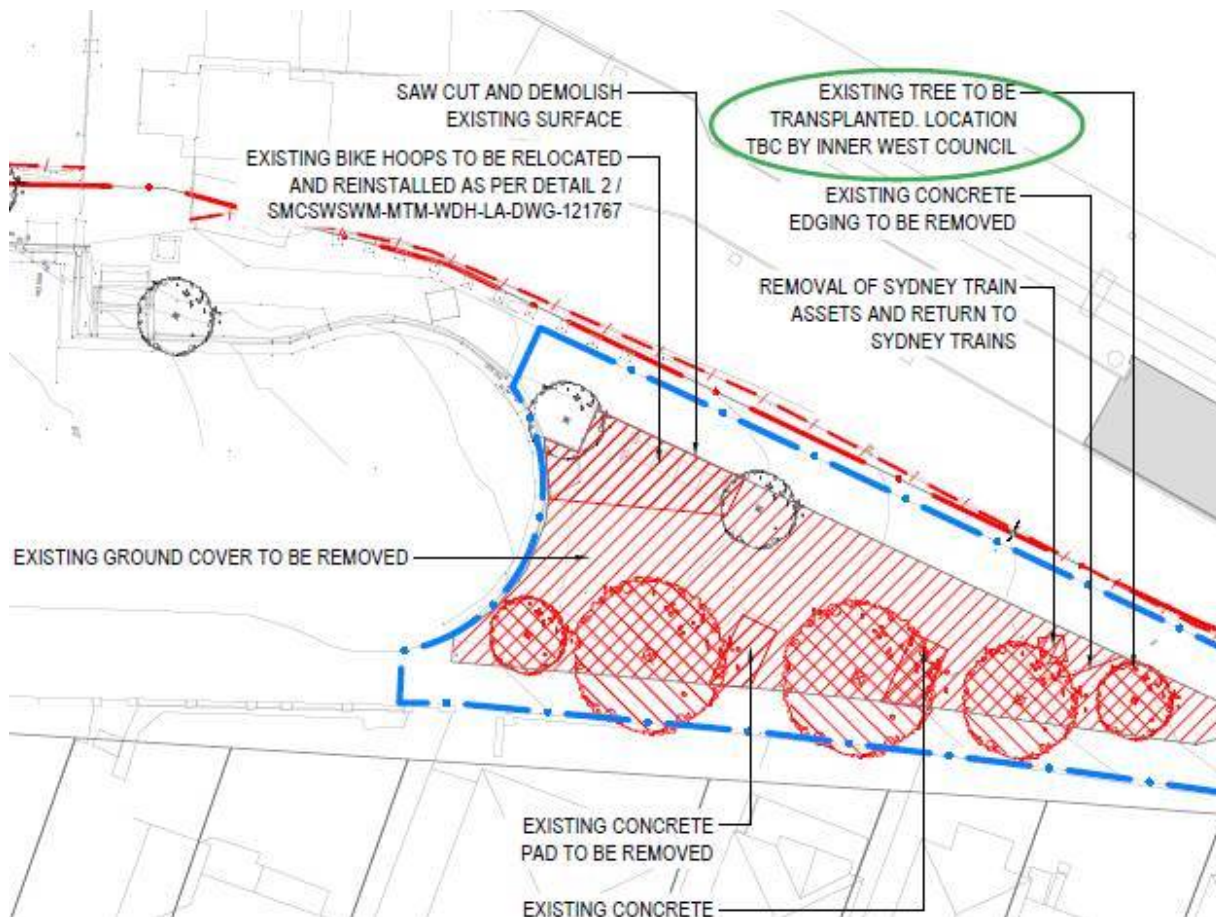
In short, the design has nominated a singular tree at Dulwich Hill Station to be relocated (see below design excerpt and street view image of tree circled in red). The tree is quite young and doesn't offer any significant value which leads me to ask whether IWC actually wish to retain the tree. Relocating the tree will pose a few logistical issues given that we (Downer) will need to remove the tree being in our PC and the transplant/ relocation works would need to be undertaken by IW Council given that the new location is likely to be outside of the project boundary.

The alternative to transplanting is for the project to remove the tree along with the remaining vegetation (separate tree clearance request) and add to the project tree offset planting. I believe this would be the most favourable option for both parties, however am seeking initial input from Inner West Council.

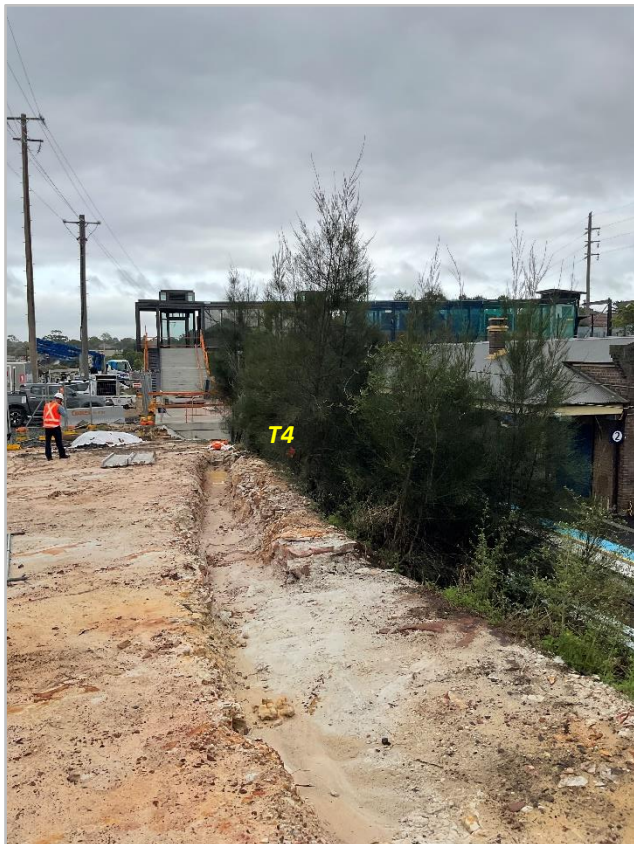
- i. The group of assessed trees were deemed to have a Low retention value with no significant impact on the landscape, furthermore the trees appear to be regenerated suckers, only a couple of years old grown from stumps arising from clearing activities with a likelihood they will be cleared again in future maintenance cycles.
- ii. Under current legislation the group of vegetation does not meet the criteria to be classified as trees, therefore removal does not warrant approval.

*The subject vegetation*

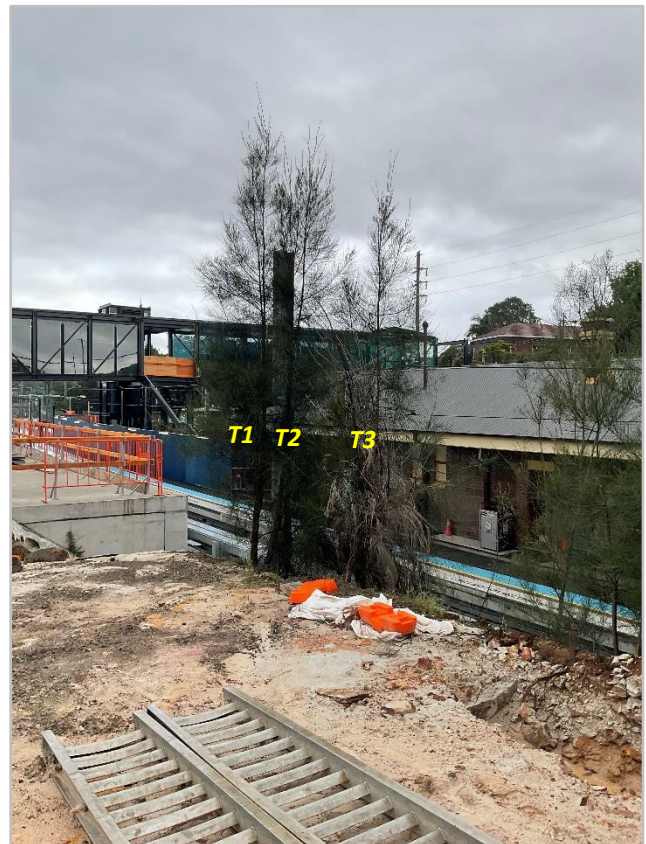
*Group of trees needed to clear for trench*

Trees T1 - T4 are required for removal to enable construction the permanent design precinct concrete footing slab.

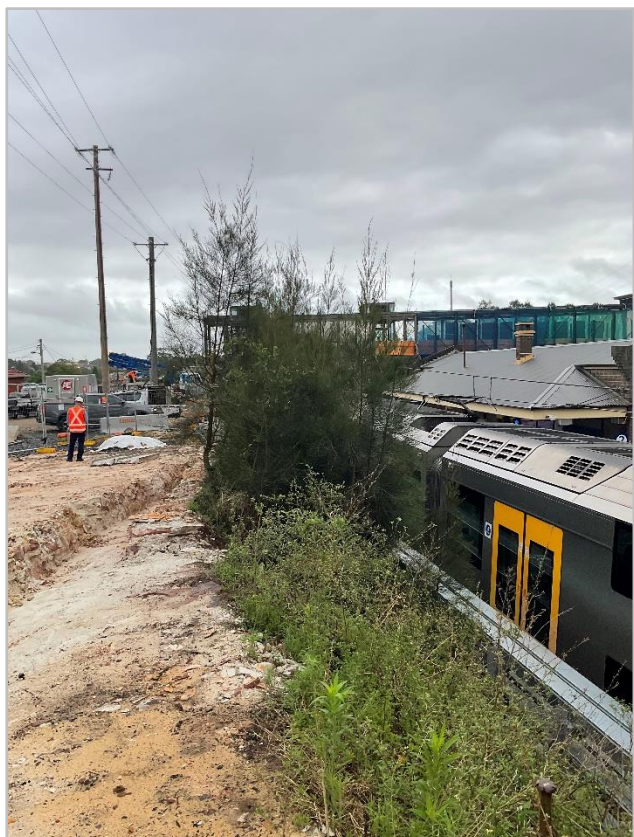
*Vegetation within close proximity to infrastructure*

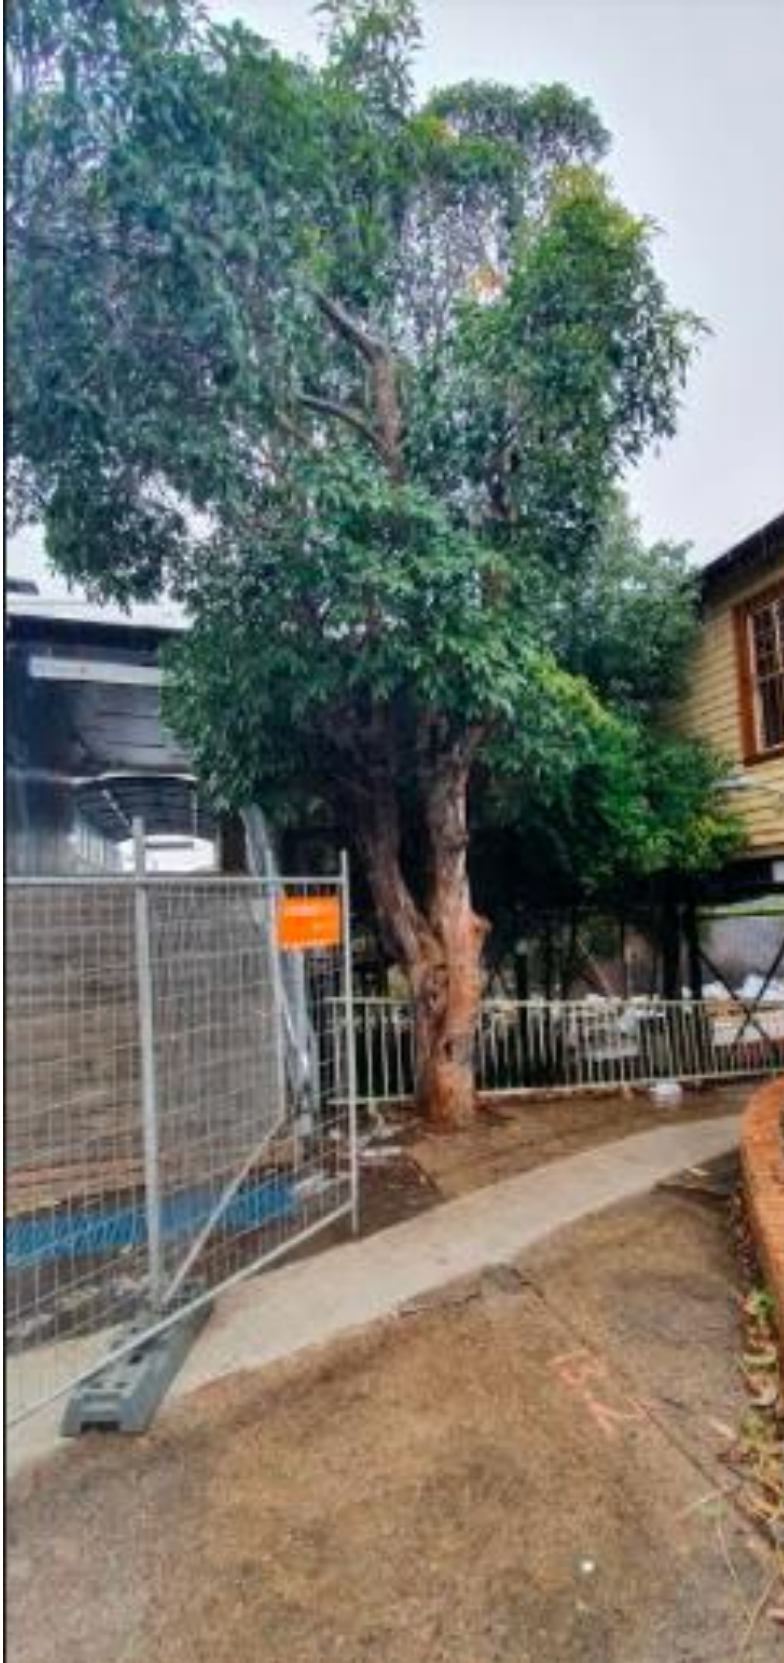
Image of the subject tree taken on the 29<sup>th</sup> June 2021.

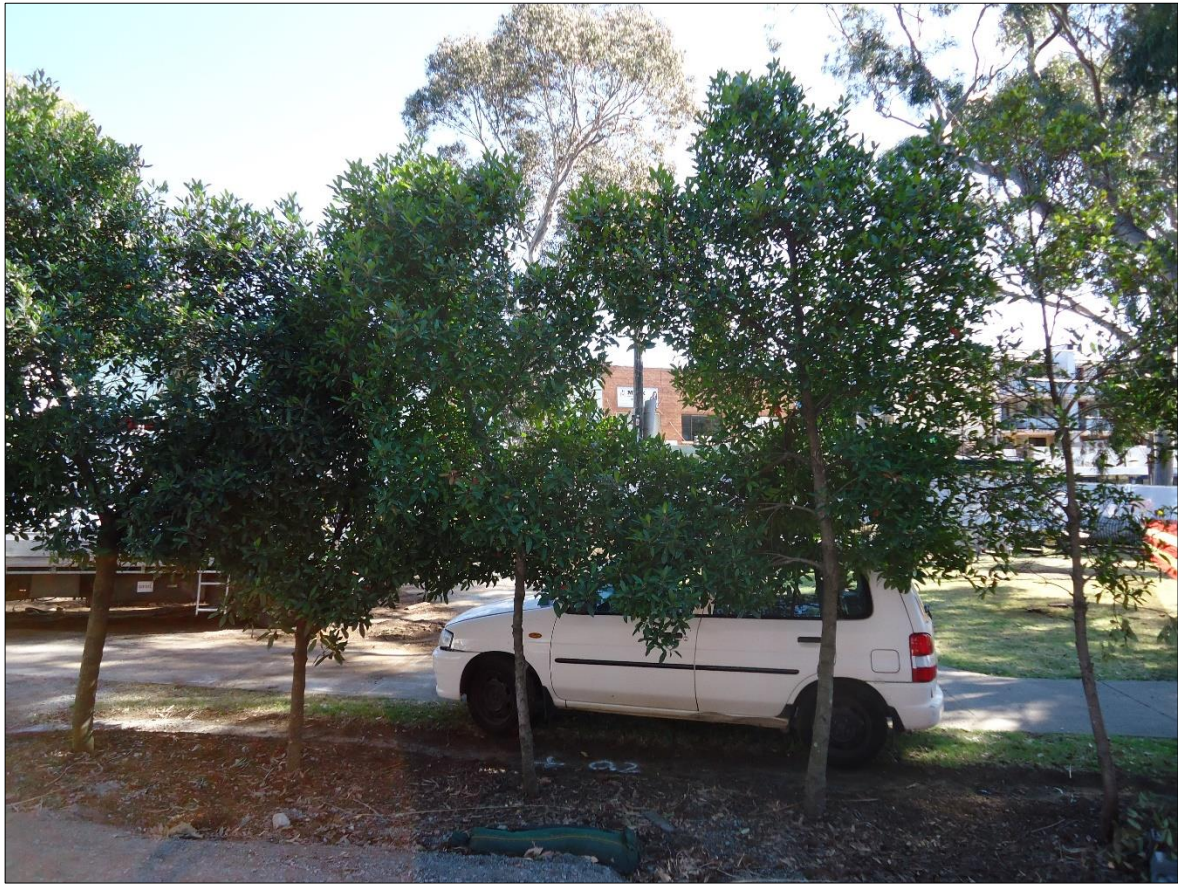
**Photograph 1:** Showing the five *Elaeocarpus reticulatus* (Blueberry Ash) to be removed.

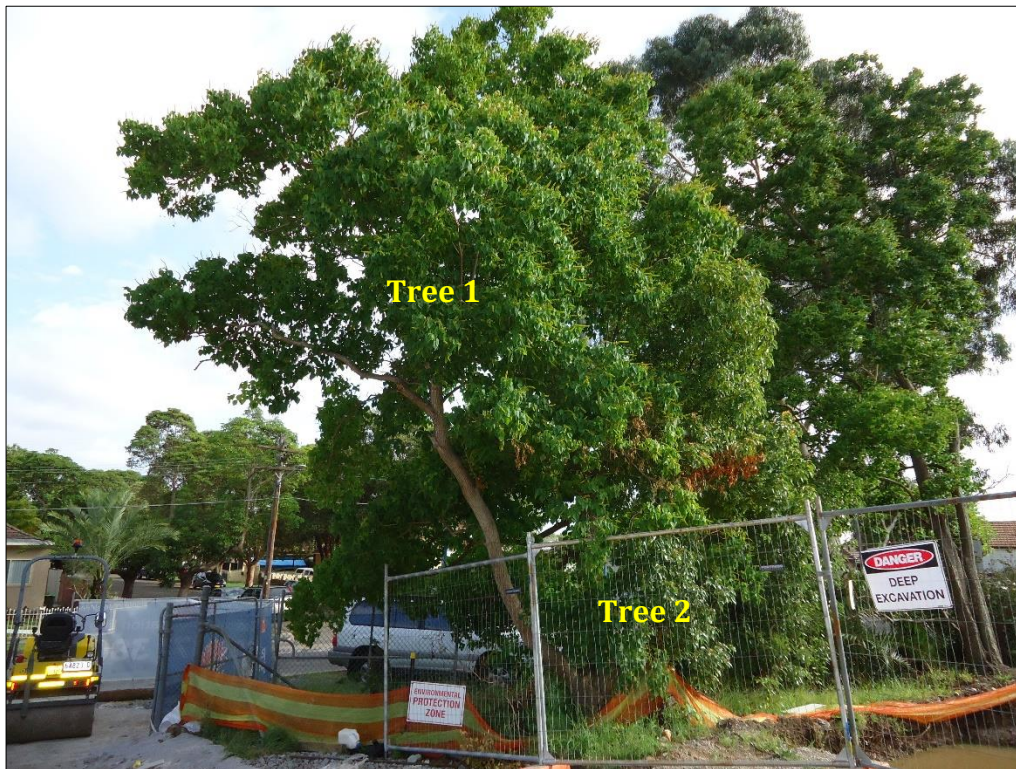
**Photograph 1:** The subject trees as seen from within the rail corridor. Tree 1 *Sapium sebiferum* (Chinese Tallowwood), tree 2 *Cinnamomum camphora* (Camphor Laurel).

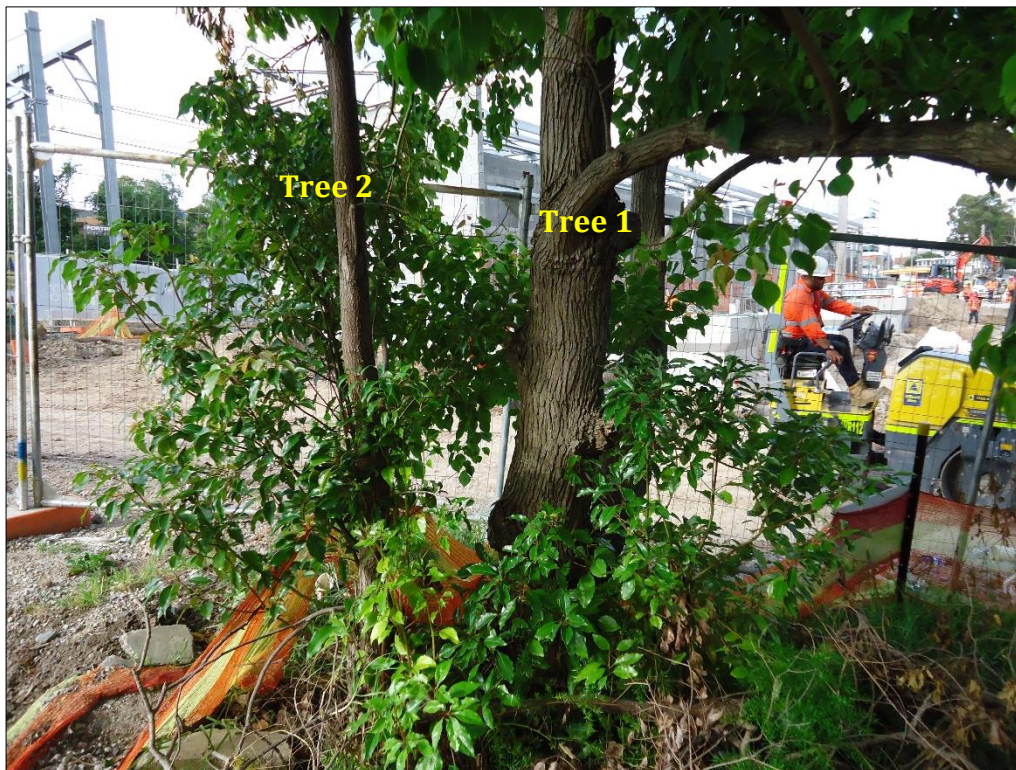
**Photograph 1:** Showing the individual trunks of the subject trees.

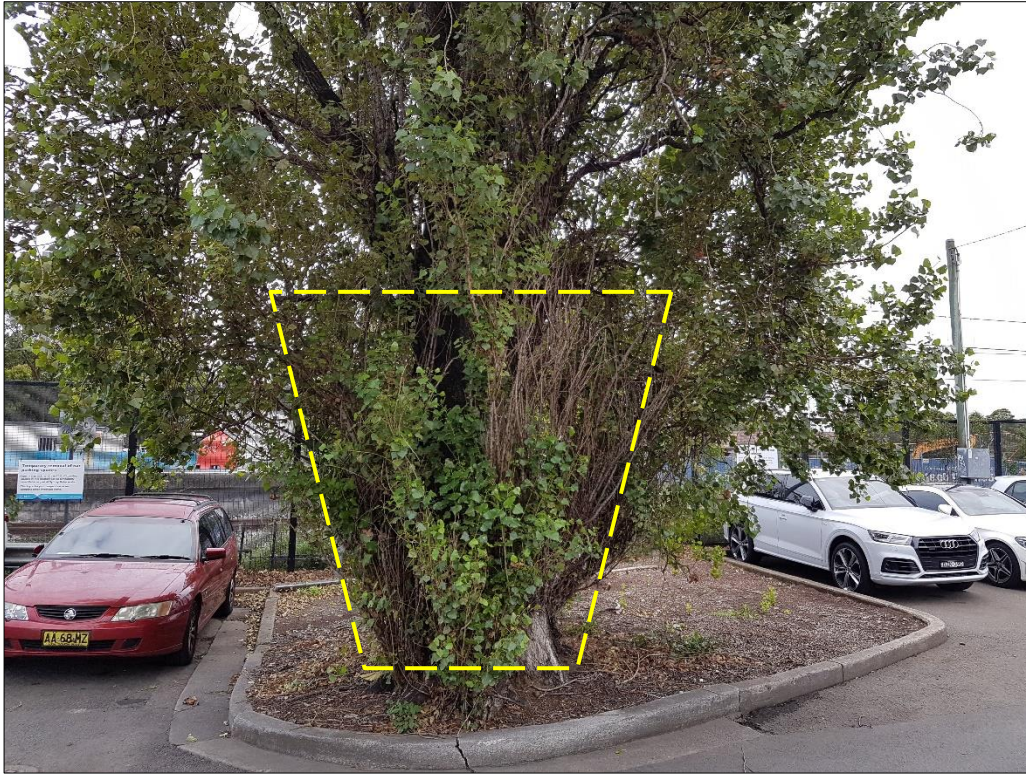
**Photograph 3:** Multiple epicormic shoots originating from the base of the trunk are to be removed.

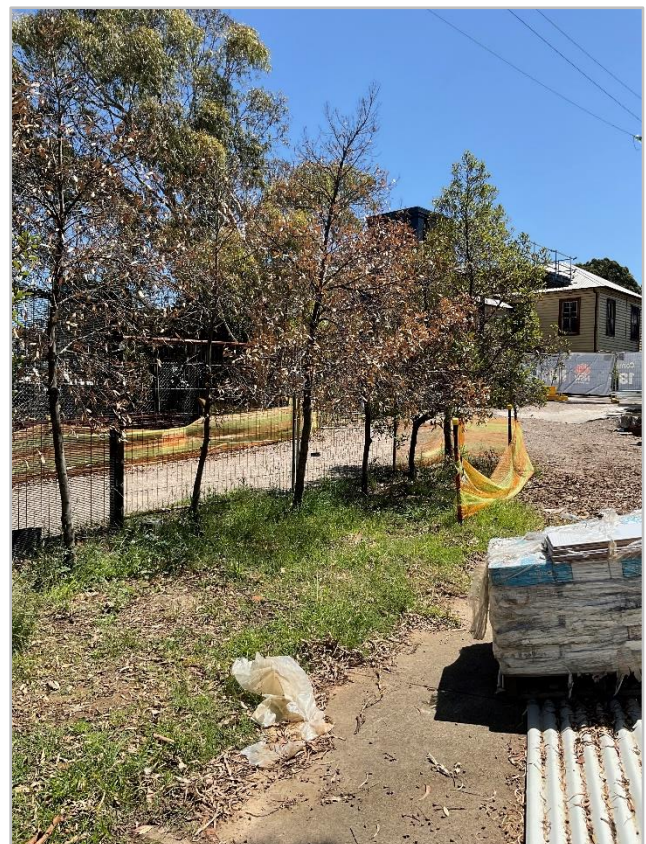
*Dead trees*

- Remove the subject five (5) dead trees concurrent with Compensatory Replanting and a site-specific Plant Health Care regimen.
